Slope Indicator Measurements of Subsurface Movement in Gully Walls

Piet van der Poel, R. G. Spomer, R. F. Piest

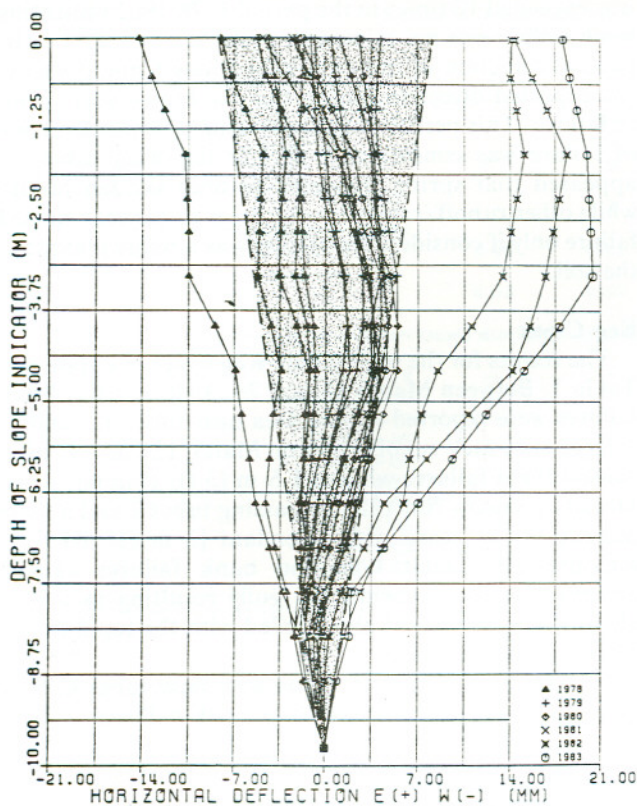
Fig. 3—East-west deflection for tube 6 along Keg Creek.

Fig.3 shows the horizontal deflection in E-W direction for tube 6 along Keg Creek. The shaded area indicates that most of the deflection in 1978, 1979 and 1980 was attributable to or within the range of instrument inaccuracy. The maximum westward movement away

from the channel in 1978 (Fig.3) was probably the result of settlement of the sand backfill. Deflection toward the channel in 1981 was probably a valid response to bank failure. The deflections toward the channel in 1982 and 1983 are not large enough to rule out instrumentation inaccuracy as the possible cause. Fig.4 and 5 show the total horizontal deflections for tube 1 of watershed 1 and tube 5 show the total horizontal deflections for tube 1 of watershed 1 and tube 5 along Keg Creek. The total or combined horizontal deflection-curves generally coincide with the direction which is at right angles to the gully. For tube 1 of watershed 1 (Fig.4) some of the deflection occurred in response to the approaching headcut and total failure took place in August 1981. In Fig.5 the scale has been greatly reduced to display the large deflection for tube 5 of Keg Creek with initial (1979) and final failure in 1982. Fig.6 shows the movement of tube 1 of watershed 1 at the surface assuming straight line movements between points.

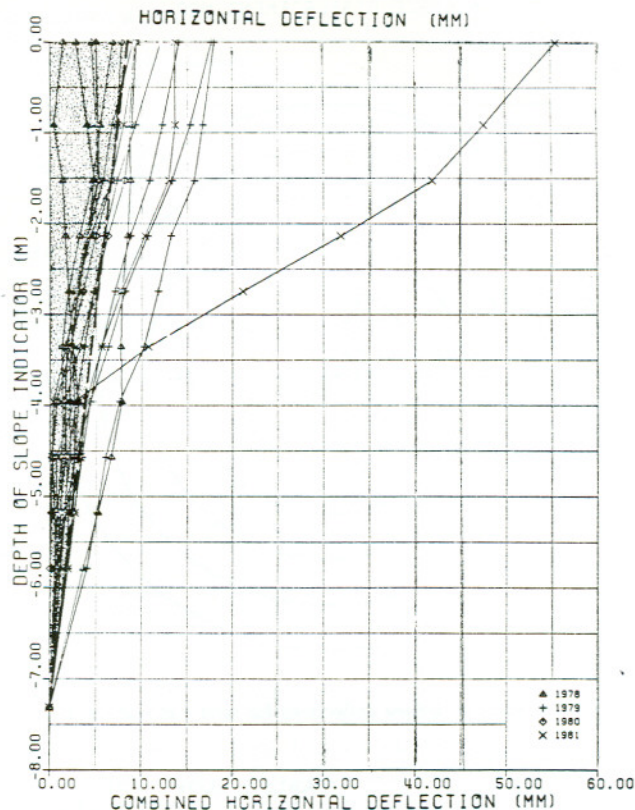
Fig. 4—Total deflection for tube 1 of watershed 1.

The results of the analysis for watershed 1 are shown in Table 2. The depth of failure was usually between 3 and 4 m (10 and 13 ft) with the maximum displacement taking place at the surface. Final failure of tubes 1, 2 and 5 (Tables 1 and 2) was in the direction expected from the position of the tubes with respect to the gully.

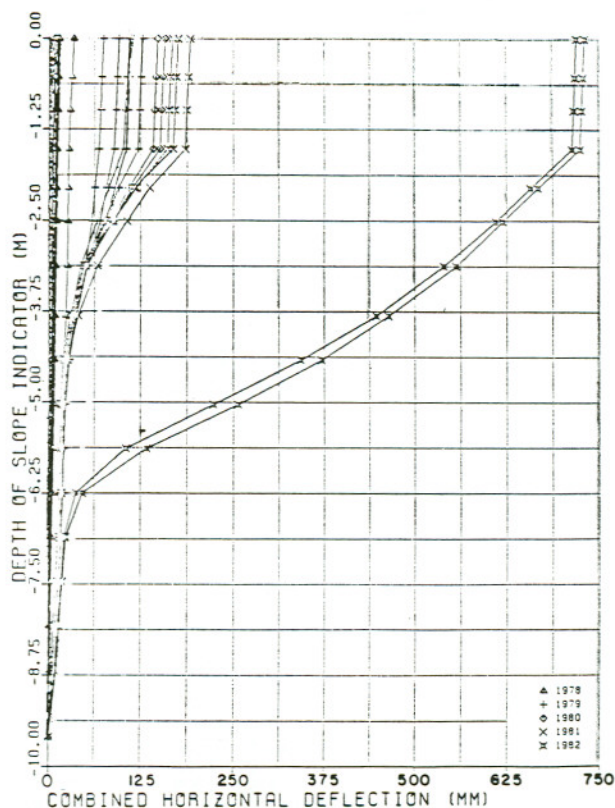
Fig. 5—Total deflection for tube 5 along Keg Creek.

snowmelt, thawing of ground frost, light rain, and a 1.5 m (5 ft) channel scarp advancing through this channel reach. Tube 5 experienced an initial failure and a crack developed which ran through the centerline of the tube. This is represented by the vertical line from 0 to 1.5 m (0-5 ft) depth in Fig.5. In the period preceding failure (5-8-1978/11-29-1978) tube 5 showed movement of about 25 mm (1 in.) in the direction of the failure. This displacement may be seen as an indicator of tension in the ground and as a possible warning for impending failure.

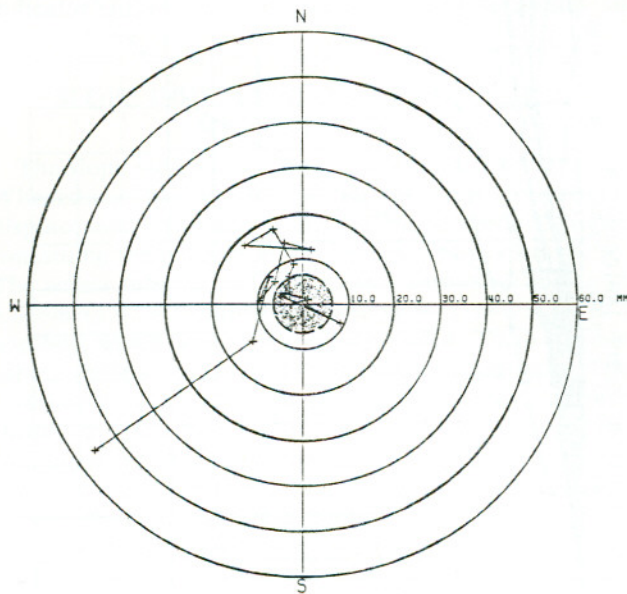
Fig. 6—Path of surface deflections for tube 1 of watershed 1.

For tubes 1 and 2 the general direction of movement at the surface, during the two years before failure, was in the direction of failure (Fig.6). This could indicate that tension in the ground increased before final failure occurred.
