Rehabilitation of an Incised Stream Using Plant Materials: the Dominance of Geomorphic Processes

*F. Douglas Shields, Jr.*¹, *S. Reza Pezeshki*², *Glen V. Wilson*¹, *Weiming Wu*³, and *Seth M. Dabney*¹

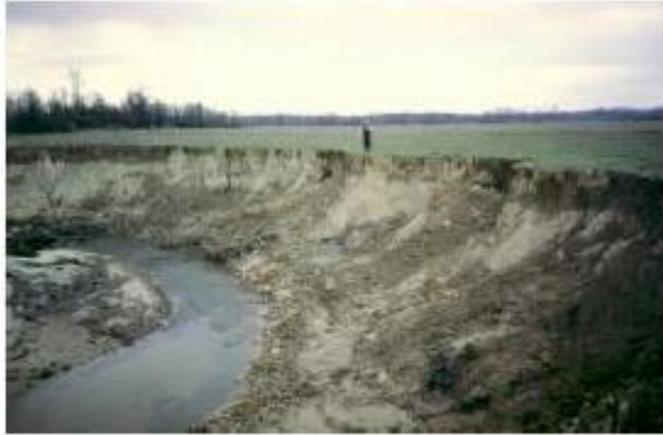
Inputs of sediment to the stream were sporadic because of the episodic nature of bank retreat, headcut advancement, and gully development (Fig. 3). Channel incision triggered the formation of approximately 30 riparian gullies along the study reach because concentrated flows of runoff or floodwaters that returned to the channel following an overbank event produced rapid erosion of the high banks (Dabney et al. 2004). Preliminary estimates suggest that gully erosion produced sediment at a rate equivalent to 42% of the sediment yield for the entire watershed containing the study site (Wilson et al. *unpublished data*). High banks were also sites for piping as a result of seepage erosion because subsurface flows as great as 0.9 m³/s with sediment concentrations as great as 660,000 mg/L emerged from individual pipes during rainy

Fig. 3. Physical instability along Little Topashaw Creek prior to rehabilitation. (A) Bank erosion, (B) headcut advancement, (C) riparian gully erosion.

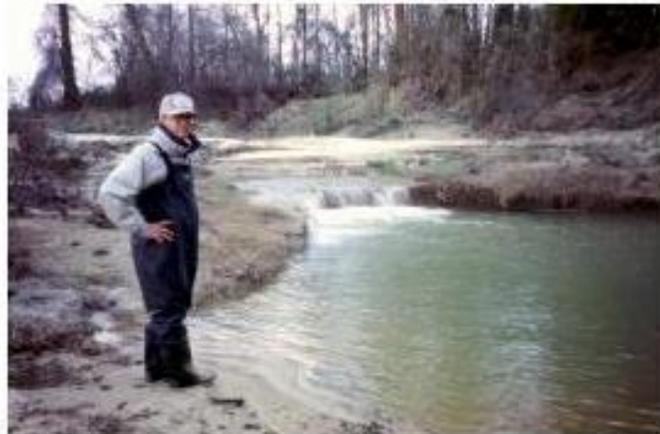
(B)

upstream headcuts (Wallerstein 2000). Headcuts (knickpoints) were found downstream, within the study reach, and upstream. Approximately 60 m of headward migration of a 0.6 m high headcut and bank retreat as great as 7.6 m were observed during a single storm event in the study reach. At least two abandoned meanders in the study reach suggested recent natural neck cutoffs. Concave banks on the outside of meander bends failed because of mass wasting, and sand accreted on large point bars opposite failing banks. Interestingly, several point bars were dissected during high flows, leaving large sand deposits along the toe of concave outer banks.

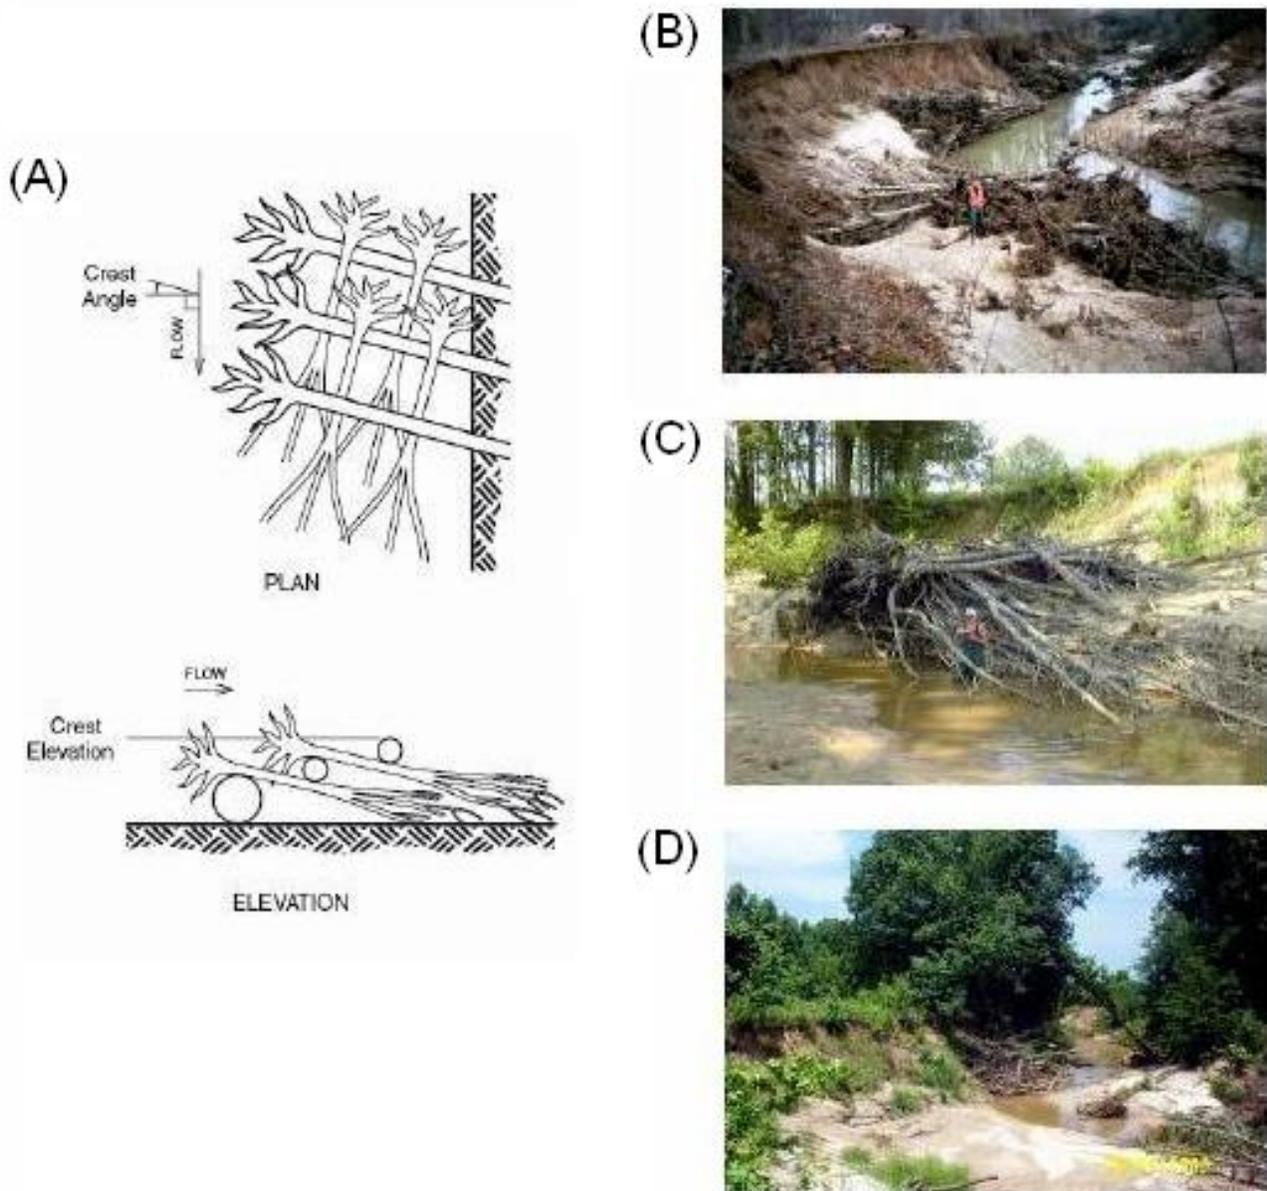
Fig. 4. A large wood (LW) structure deployed at Little Topashaw Creek. (A) Design plan and profile. (B) LW structure 5 months after construction; note sediment deposits within the structure. (C) The same structure in (B) 9 months after construction. (D) The same structure in (B) completely disappeared 3 yr after construction.

structures were destroyed and 35% were heavily damaged. Factors involved in failure included the simplification of LW matrices because of breakage and decay, scour of sediments deposited within the structures (Fig. 4B and C), and the failure of earth anchors (USDA 2006b). Structures that were located in sharp bends were most prone to fail. The damage rates were slightly higher for anchored LW structures (20 of 58 damaged) than for those without earth anchors (4 of 14 damaged). Of all anchors, 47% were located upon inspection 2 yr after construction, and 61% of these were not functional. Evidently, the anchors, which were load tested to 4.5 kN when installed, were undersized. The anchor sizing was based on LW structure design dimensions and the assumption that critical conditions would occur shortly after construction. Accordingly, a relatively high wood density of 750 kg/m^3 was used to compute net buoyant forces. Retrospective computations using as-built dimensions and a wood density of 450 kg/m^3 produced factors of safety well below unity.

For LW structure design, it was assumed that sediments deposited within the LW structure would add ballast to counteract the increased buoyant force associated with the drying of wood as the structure aged. A geomorphic assessment of the rehabilitation reach indicated that the period of channel deepening typical of incised channel evolution was ending; the natural tendency of the system favored the deposition of large sand berms within the enlarged, eroded channel. Initially, substantial volumes of sediment were captured by the LW structures (Fig. 4B). However, in many cases, sediments deposited during the first high flow season were scoured during the second, and approximately 0.3 m of thalweg degradation occurred throughout the reach.

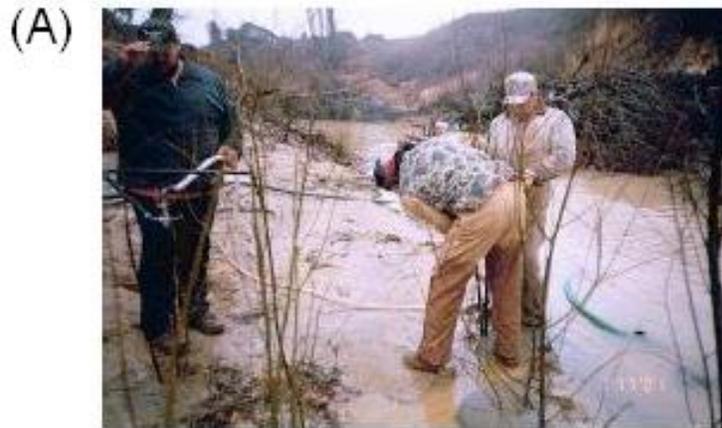
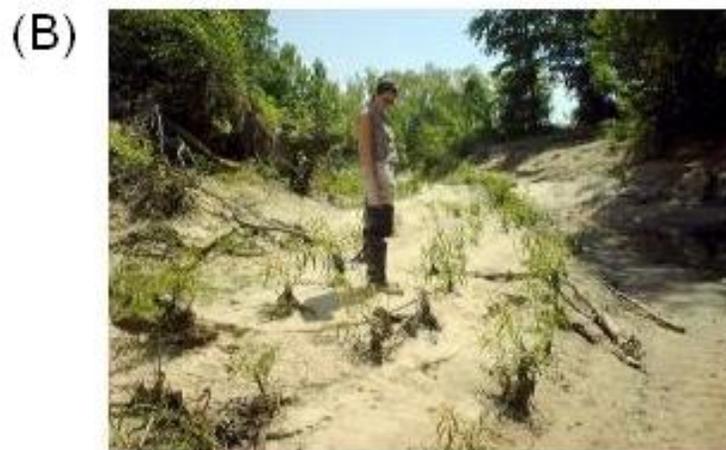
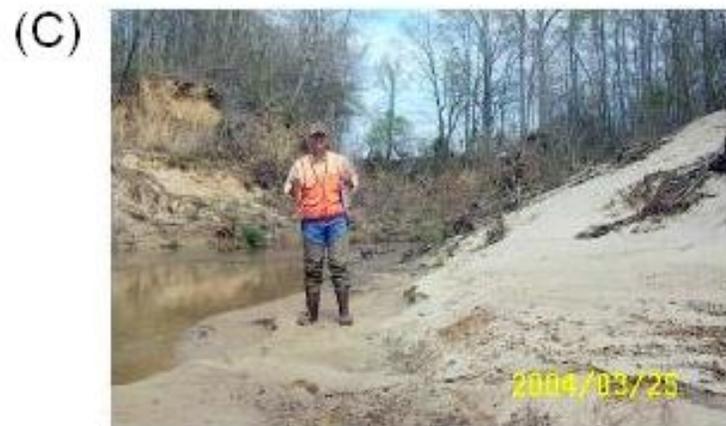
Fig. 5. Willow cuttings planted at Little Topashaw Creek. (A) Willows being planted using water jetting. (B) Initial willow stand 4 months after planting, showing effects of herbivory. (C) The same location in (B) 3 yr later, showing no survivors.

Deep channel incision and the attendant flashy hydrology produced drier conditions in upper banks, particularly in banks with sandy soils, which were common even in steep banks. After two growing seasons, the mean willow survival was only ~50% in study plots that were > 0.5 m above the stream at base flow, whereas survival in lower plots averaged 86% (Pezeshki et al. 2007). The soaking of cuttings before planting was beneficial, resulting in 17% higher mean survival and 6% greater leaf chlorophyll content. The effects of soaking were most pronounced for cuttings that were subjected to

harsh conditions, i.e., drier locations or grazing by beaver (Martin et al. 2005). The soil sand content was also a key factor in willow survival. At the end of the second growing season, survival in plots that had a mean sand content of ~65% was approximately 65%, whereas survival in plots that had a mean sand content of 87% was only 36%.

More than half of the monitored willows survived the first growing season and > 40% survived two seasons. However, a survey of all of the willow plantings at the beginning of the fourth growing season indicated that the survival rate was < 10% (Fig. 5B and C). Reasons for planting failure likely include erosion and sedimentation (channel stability), competition from exotics, and chronic herbivory by beaver (Pezeshki et al. 2007), although there were indications that limited, acute herbivory was not harmful (Li et al. 2005).

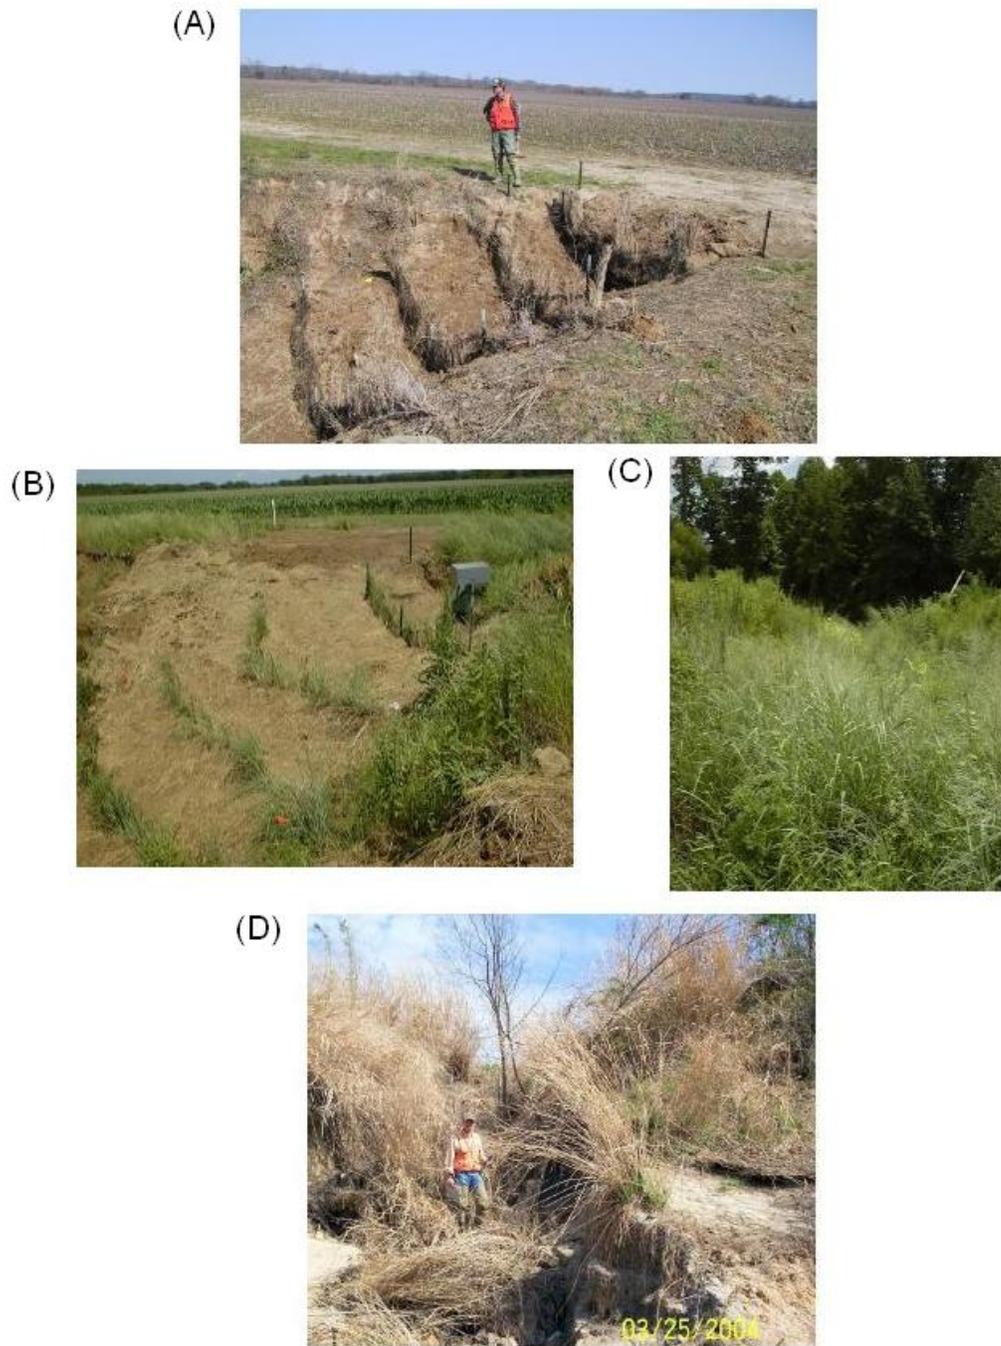
Fig. 6. Riparian gully stabilization using switchgrass hedges at Little Topashaw Creek. (A) Gully immediately after shaping and planting, showing silt fences placed just below each grass hedge. (B), (C) Development of grass during the first growing season. (D) View from the stream channel 3 yr after planting.

Although hedges were successfully established and effectively stabilized riparian gully side slopes (Fig. 6B and C), treated gullies were vulnerable to headcuts > 0.5 m high that advanced from the stream channel into the gully. Gully control with grass hedges failed in three modes (Dabney et al. 2004, Shields et al. 2005). The most immediate failure occurred at the gully toe, where sand bars up to 2 m deep either buried the hedges or did not provide a stable substrate for grass establishment. Large headcuts developed from the toe and progressed

upslope. The second mode of failure occurred when the gully slope was too steep to allow the formation of plunge pools between hedges, leading to direct impingement of cascading flows onto exposed bare soil surfaces (Dabney et al. 2004). This mode of failure was most common on unshaped inlets. The third and most troublesome failure mode was the gradual grain-by-grain soil detachment that eventually washed the soil away from the grass roots, leading to deep incision through the grass hedges. Visual inspection of all of the treated gullies during the sixth year after treatment showed that all

supported dense stands of switchgrass, but all were being dissected by headcuts 0.5 to 1 m high that advanced headward from the stream channel (Fig. 6D).

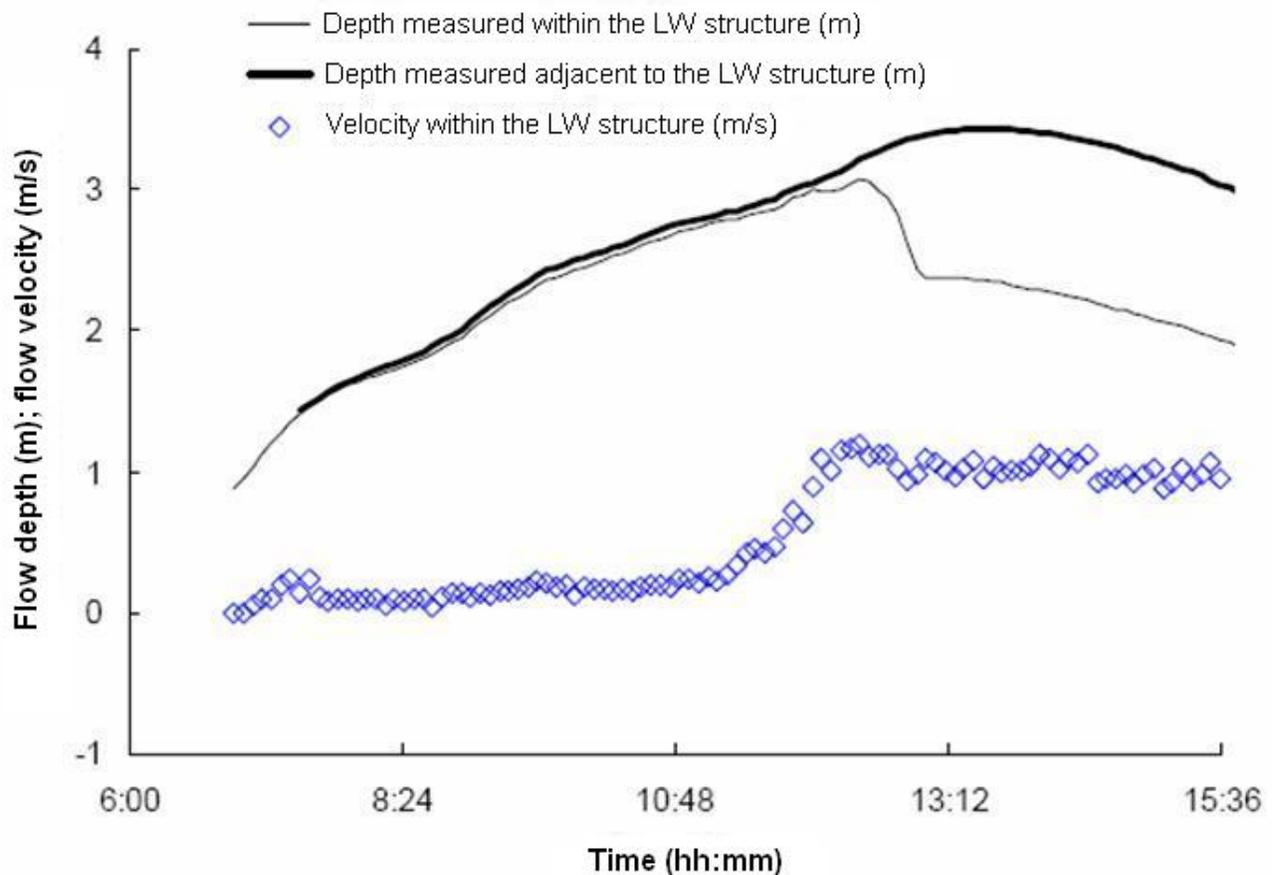
Typical failure processes are illustrated by detailed data from one LW structure. Acoustic Doppler velocity loggers recorded the depth and velocity within and adjacent to an LW structure located at the apex of a bend with a ratio of top width to bend radius of ~ 1.0 . During the rising limb of a large flow event that occurred approximately 16 months after construction, part of the structure apparently shifted, allowing velocities within the structure to increase rapidly from 0.2 to 1.2 m/s, greatly exceeding the critical level for the sandy bed material and approaching the velocity recorded at the adjacent channel centerline (Fig. 9). The structure failed shortly thereafter.

Fig. 9. Water depth measured at the channel centerline adjacent to a large wood (LW) structure during a storm event on Little Topashaw Creek and simultaneous measurements of water depth and velocity within the structure. The sudden drop in the curve representing water depth within the structure corresponds to dislodgement of the log to which the sensor was attached. Note the increase in current velocity just prior to the movement of the log.
