Characterizing the Sediment Impounded by USDA-NRCS Flood Control Dams, Oklahoma

Research Report No. 20

January 2001

A final report prepared for the USDA-NRCS, Stillwater, OK

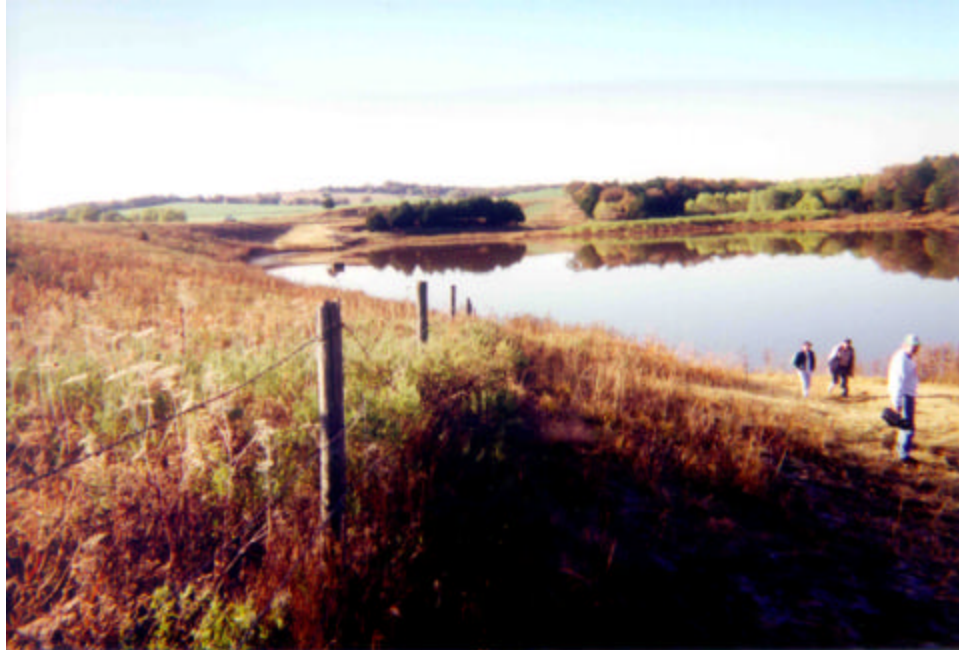
Figure 2-1. Photograph of Sugar Creek #12 looking directly south showing earthen embankment on left, spillway channel in far distance, and reservoir (November 1999).

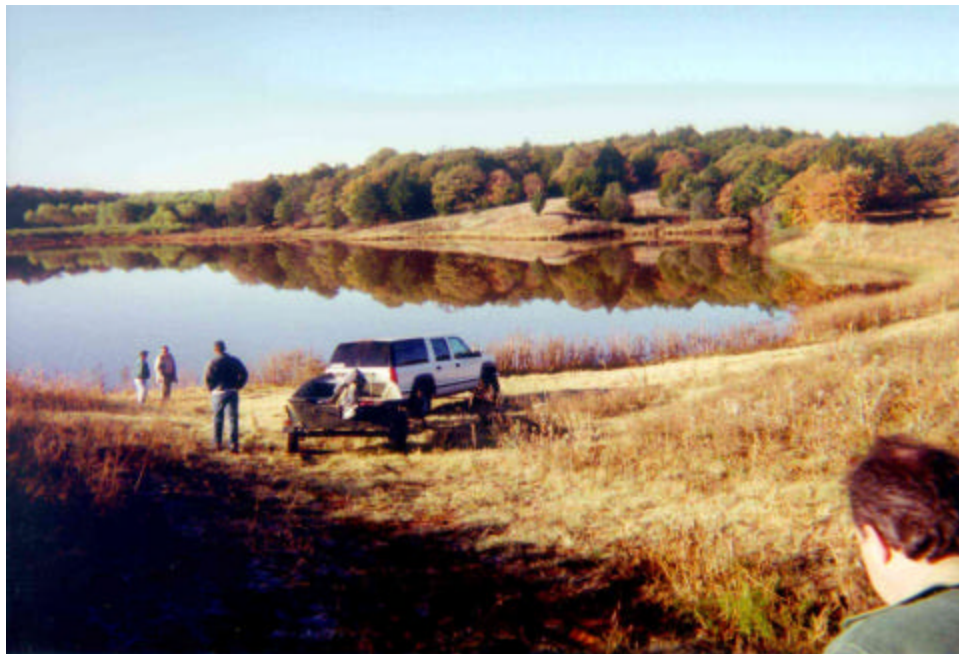
Figure 2-2. Photograph of Sugar Creek #12 looking toward the southwest showing the reservoir and the main tributary on right (November 1999).

Sugar Creek #12 is located near Hinton, OK, and it is a relatively small lake (19 acres) with a mud bottom and fairly shallow water depths (0.6 to 2 m; Figures 2-1, 2-2, and 2-3). Dam construction was completed on April 6, 1964. This structure has an upstream drainage area of 2,016 acres. The main stream supplying the lake is considered unstable due to the presence of actively migrating knickpoints, and excessive sedimentation rates have significantly decreased storage capacity. No boat ramp is available, and access for small vessels is difficult but tolerable.

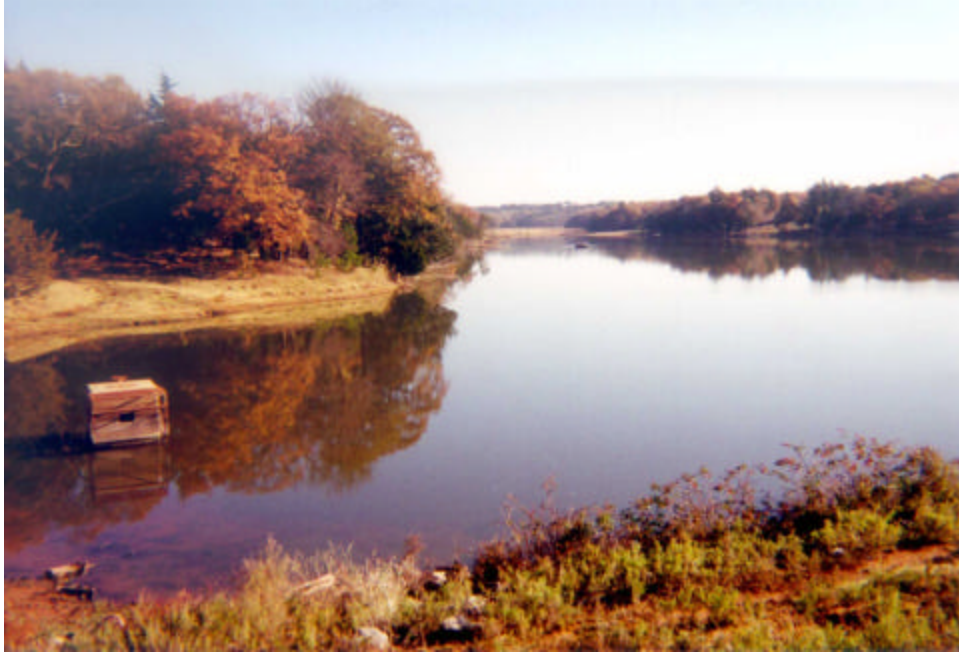
Figure 2-5. Photograph of Sugar Creek #14 looking northeast from the embankment showing reservoir, primary spillway drain on left, and main tributary source in far distance (November 1999).

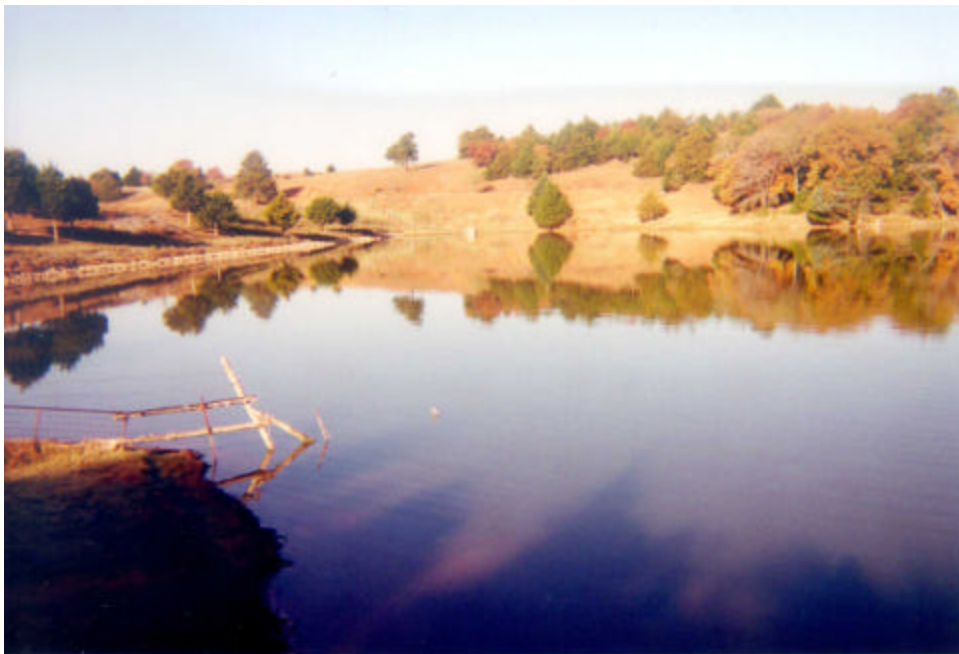
Figure 2-6. Photograph of Sugar Creek #14 looking directly west showing reservoir, earthen embankment of left, and primary spillway drain in far distance (November 1999).

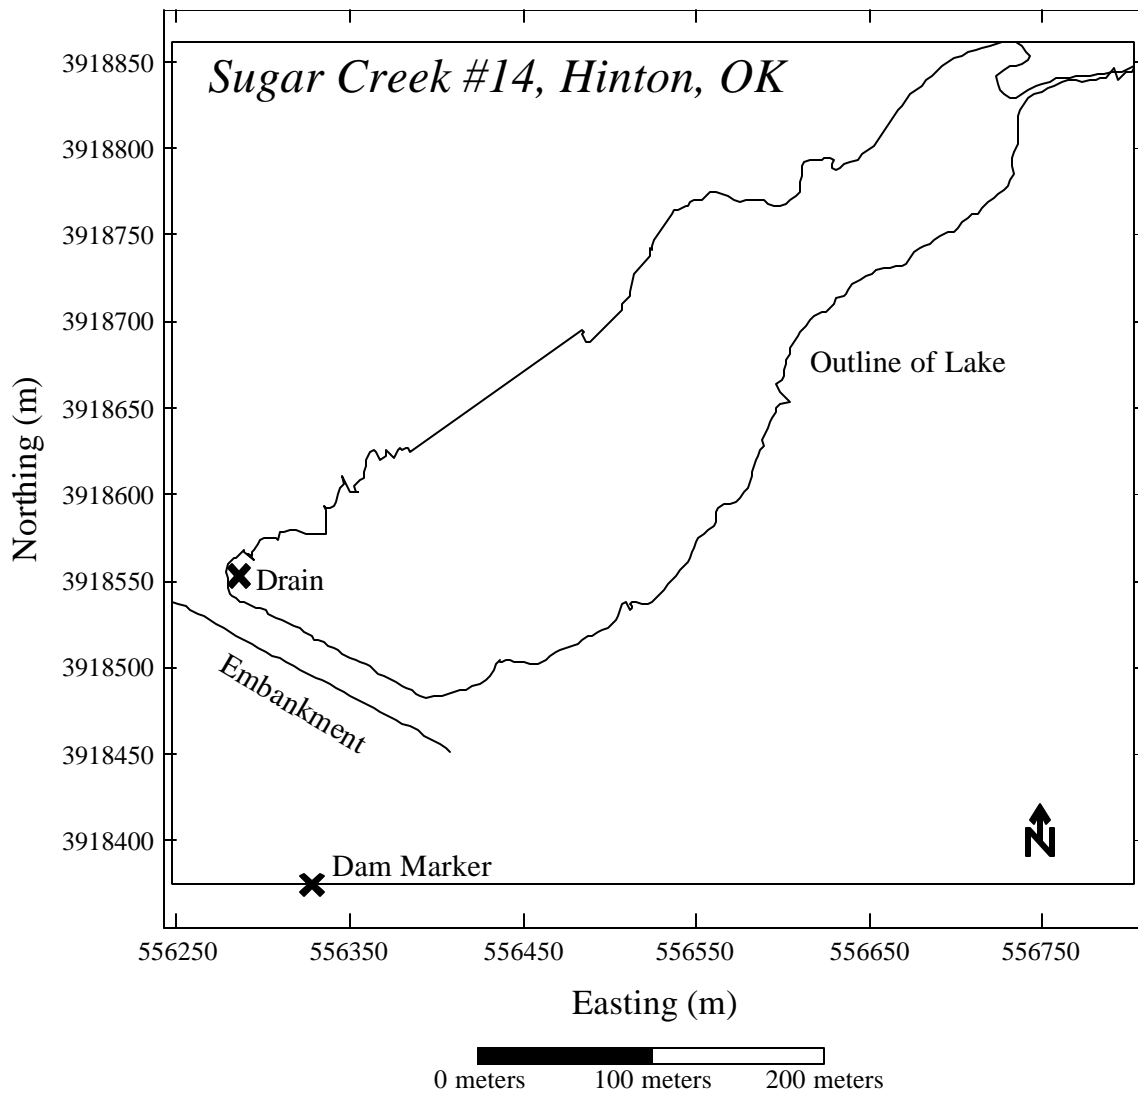
Figure 2-7. Base map of Sugar Creek #14 constructed from a hand-held global positioning system receiver with differential corrections applied. Shown are the outline of the lake, the centerline of the earthen embankment, the primary spillway drain, and the cement dam marker. All positions are in UTM coordinates.

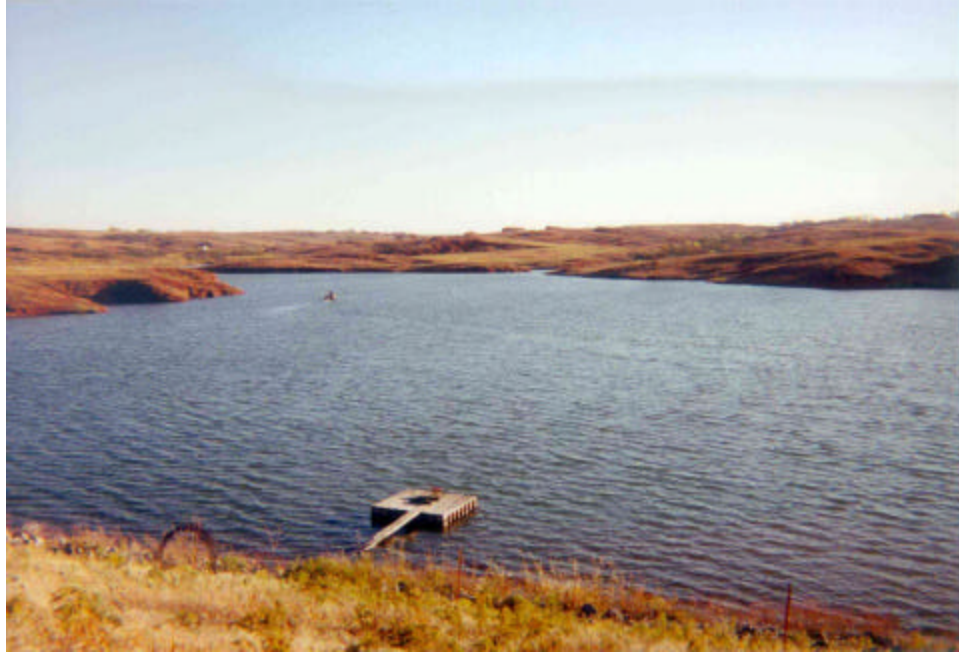
Figure 2-8. Photograph of Sergeant Major #4 looking almost directly south from the embankment showing reservoir, primary spillway drain in foreground, and the vessel used during seismic surveying in the distance (November 1999).

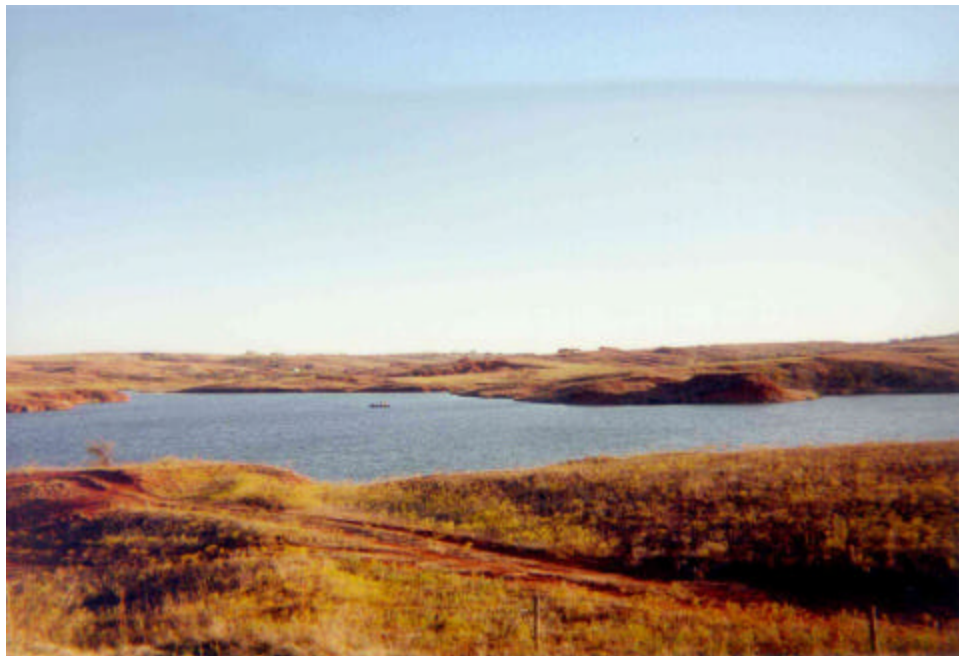
Figure 2-9. Photograph of Sergeant Major #4 looking southeast from access road showing the reservoir and the vessel used during seismic surveying in the distance (November 1999).

Sergeant Major #4 is located near Cheyenne, OK and was constructed in 1955. It is a moderately sized structure, with a lake surface area of about 35 acres (Figures 2-8, 2-9, and 2-10), and has an upstream drainage area of 3,735 acres. This site was chosen for investigation because it has become the sole municipal source of water for the town of Cheyenne and preserving water quality is a major concern. At least three surface water sources as well as some underground springs feed the lake. Water depth ranges from 2 to 10 m, and near-vertical banks of terrigenous siliclastic rocks characterize the lake boundary. Some exposed salt deposits (primarily gypsum) also occur within the watershed. Access to the site for small vessels is good.

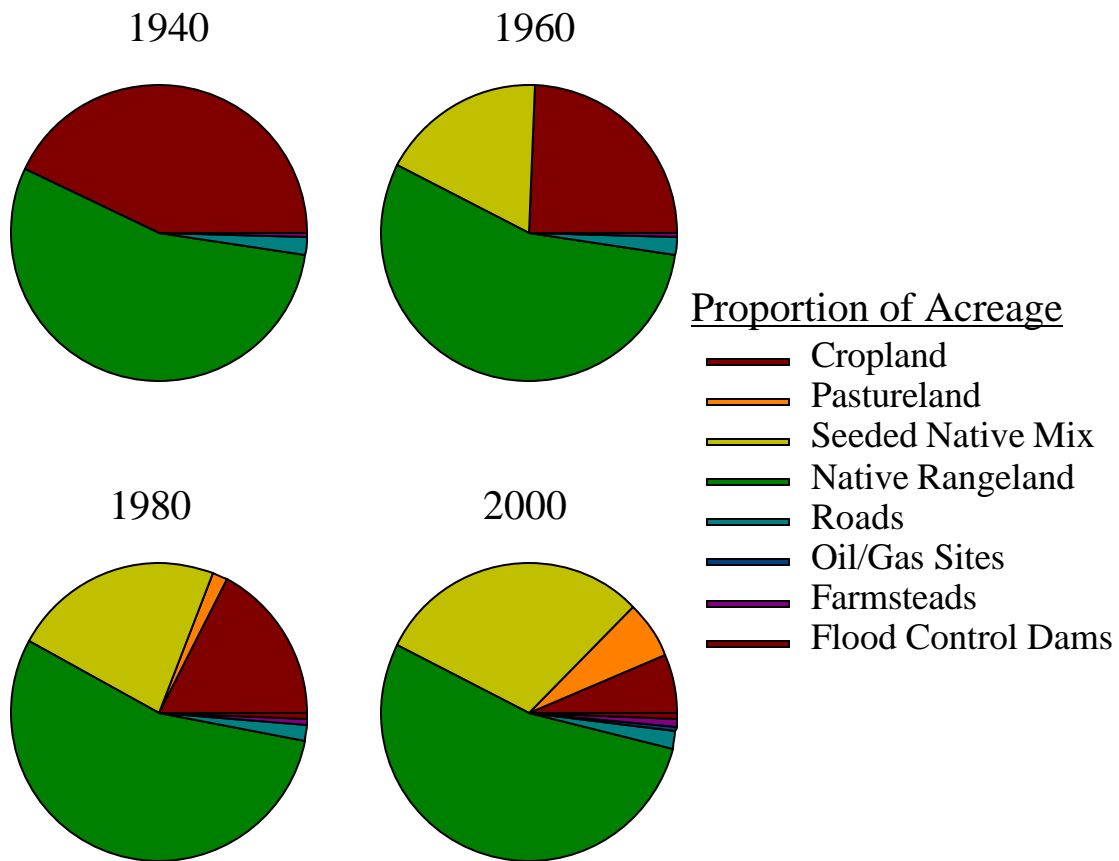
Figure 2-11. Temporal variation in the land use within the watershed of Sergeant Major #4.

In 1940, land use within the watershed of Sergeant Major #4 was predominantly native rangeland and cropland, which included cotton and row crops with a rotation of small grains (Table 2-2; Figure 2-11; data from the USDA-NRCS field office in Cheyenne, OK). In 1960, the amount of cropland decreased by nearly 50% and these areas were replaced with seeded native grass mix. The acreage of native rangeland remained unchanged. By 1980, the amount of cropland decreased by nearly 30%, replaced almost entirely by seeded native mix. By 2000, the amount of cropland decreased by nearly 65%, seeded native mix increased by 32%, and the amount of pastureland increased by 265%. The amount of native rangeland remained the same. In summary, the watershed of Sergeant Major #4 has evolved from a rangeland and cultivated watershed to a predominantly rangeland and grassland watershed with minor amounts of cropland and pastureland.

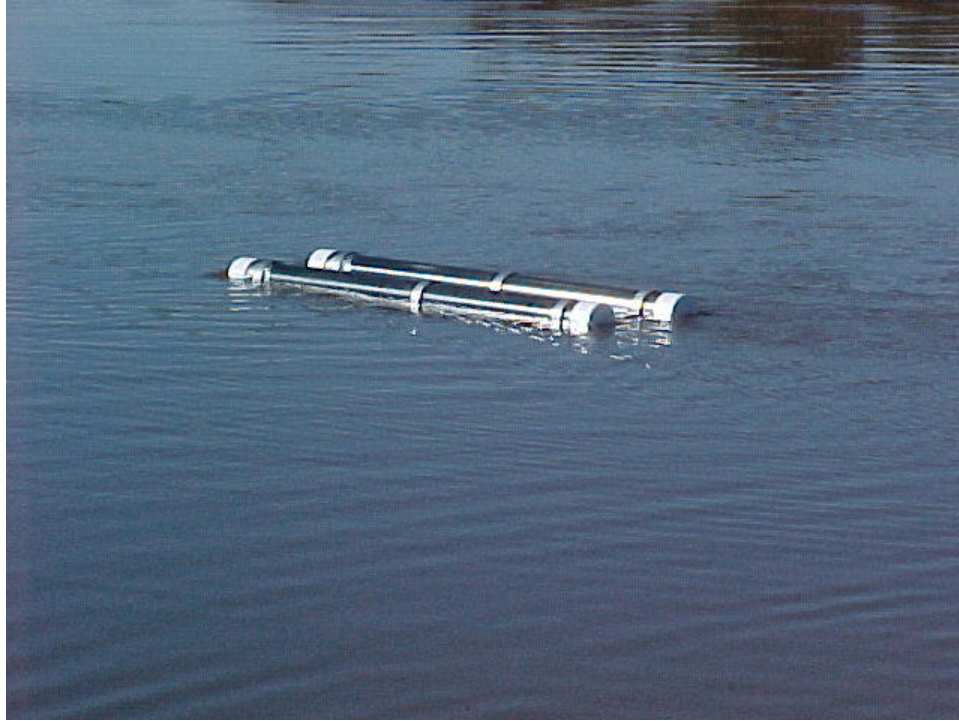
Figure 3-2. Photograph of the catamaran being towed by the vessel. The catamaran is about 7 meters from the vessel, and it is moving toward the left (taken at Sugar Creek #12, November 1999).

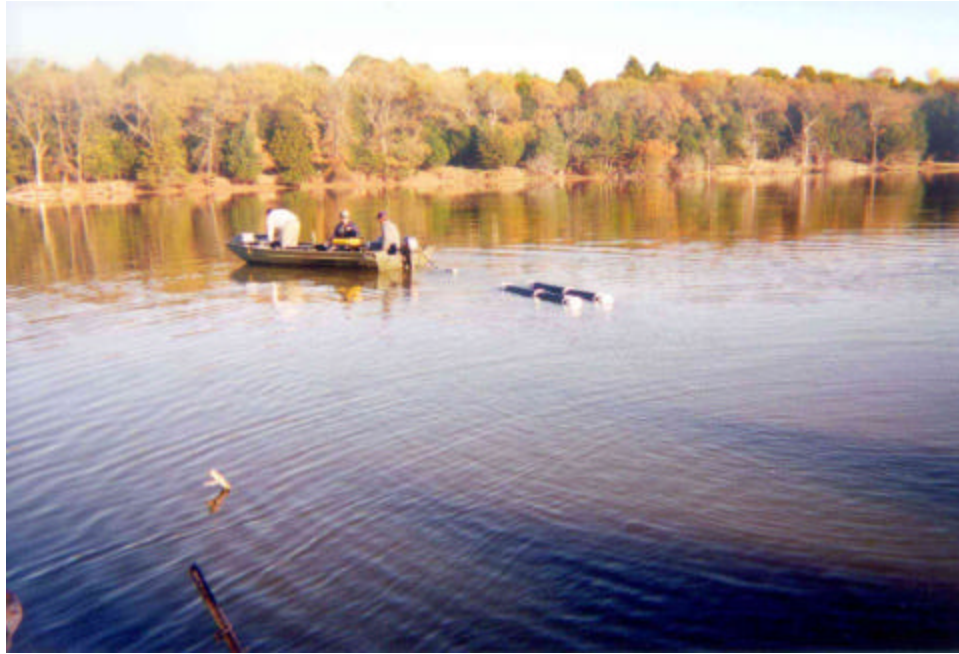
Figure 3-4. Photograph of general operating procedure for the seismic surveying and the number of personnel required (taken at Sugar Creek #14, November 1999).

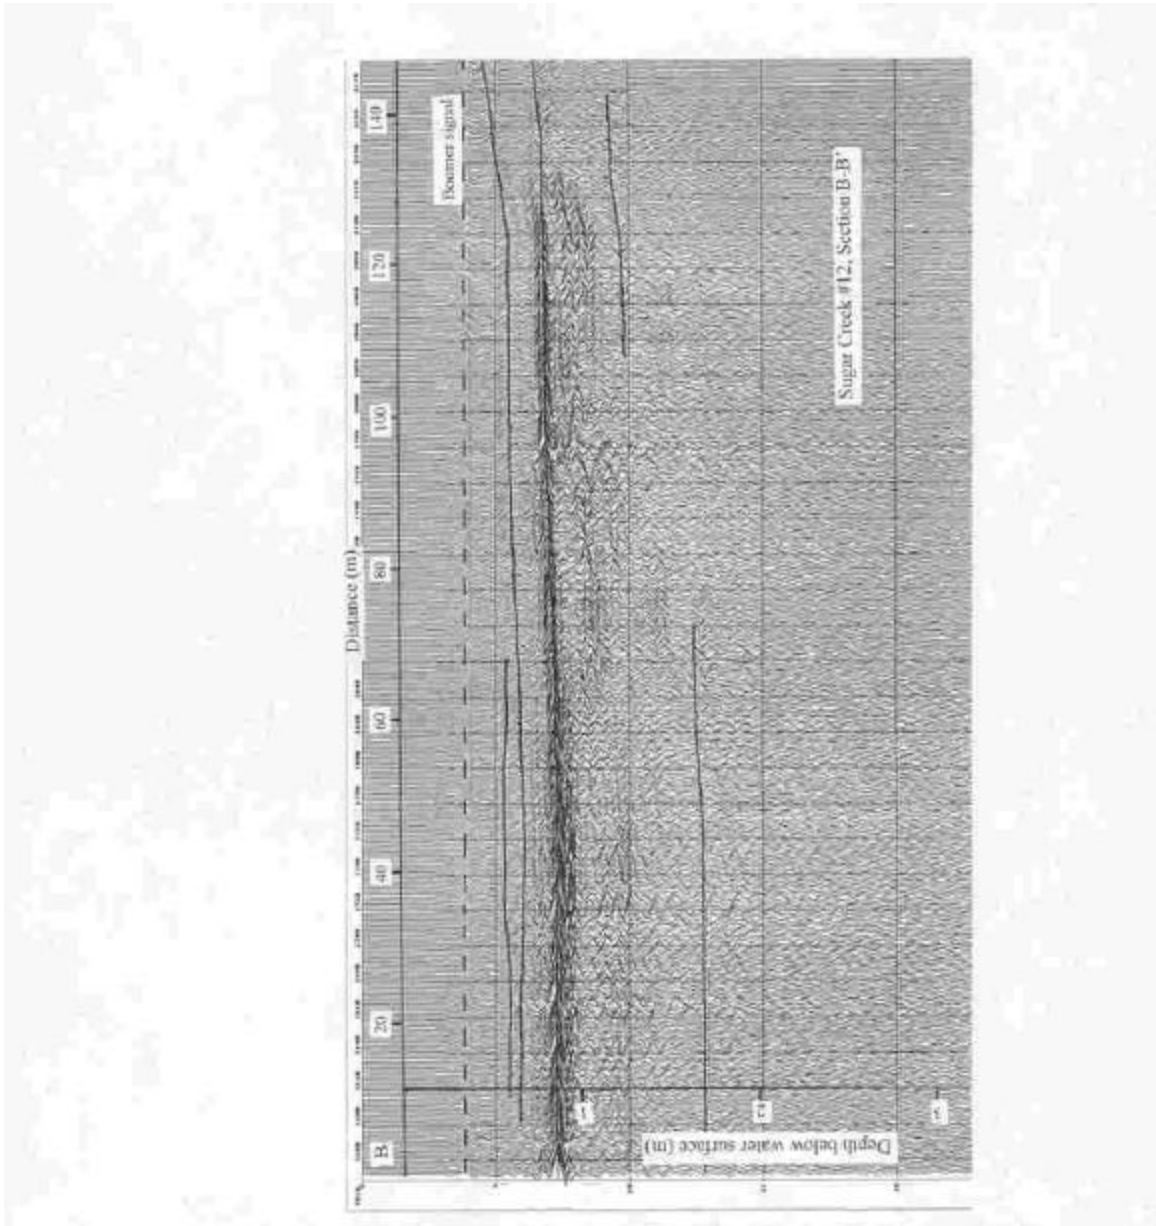
Figure 3-7. Seismogram of section B-B' from Sugar Creek #12 (next page; refer to Figure 3-5). Dashed line is location of boomer (approximately 0.5 m below the water surface), the first solid line represents the water-sediment interface, and the solid lines at depth are interpreted seismic reflectors identified but not verified. Depth and length scales are shown, and total length of seismic record is 158 m.

In general, the following observations can be made. The sediment near the water-sediment interface is quite soft, and it is represented by weak or low-amplitude reflectors (Figure 3-6, 3-7, and 3-8). The thickness of this reflector is about 0.15 to 0.2 m and it does not vary in thickness across the basin. However, this reflector does appear to thicken towards the southern part of the lake (towards B'; see Figure 3-7). At a depth of approximately 0.4 m, a very strong seismic reflector is observed, and this reflector is ubiquitous in all the seismic records. This strong seismic reflector caused most of the seismic reverberations due to its strong seismic properties and its close proximity to the water surface and seismic receiver. Again, this seismic reflector is observed basin wide, and may represent a change in sediment composition such as a sand or gravel layer, a change in sediment density such as variation in mineralogy or relative compaction, have a biological origin, or represent some kind of hard-pan. Because this reflector has such strong seismic characteristics, it is virtually impossible to observe and verify any deep horizons.

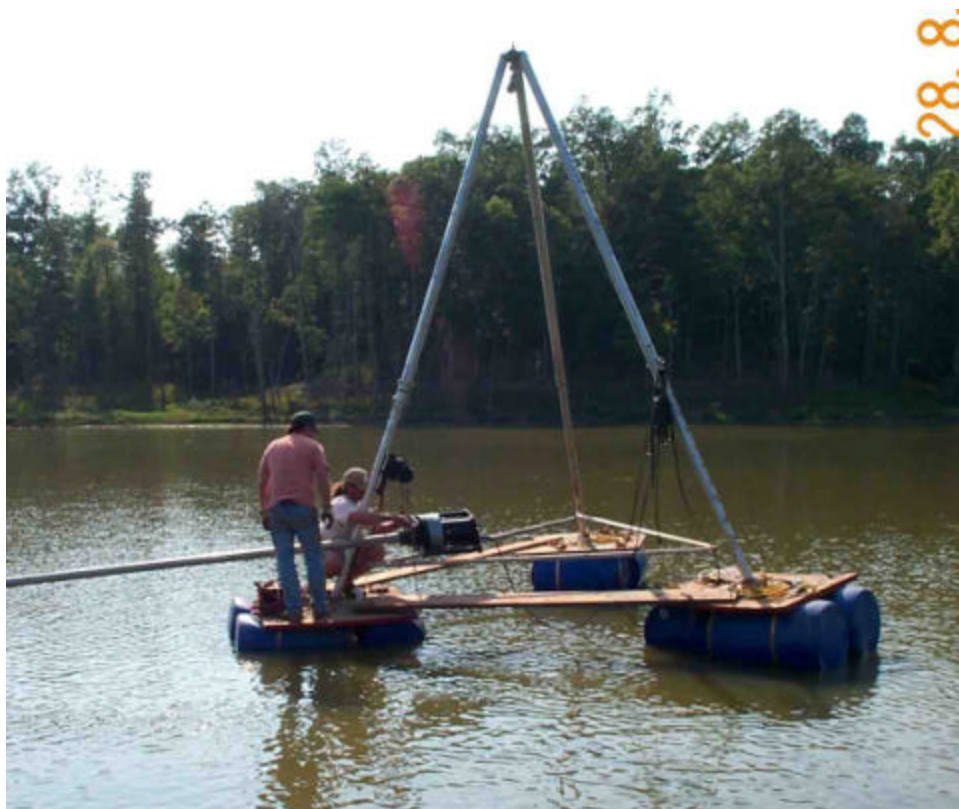
Figure 4-1. Photograph of floating vibracore system showing the tripod and portable rafts. A core pipe is being connected to the vibracore head.

A commercially available vibracoring system was used in this study (Figures 4-1, 4-2, and 4-3). This system uses a 1-HP motor that drives a pair of weights (masses) eccentrically mounted on two shafts and housed within a water-tight aluminum chamber (Figure 4-3). When in operation, the masses rotate in opposite directions causing the chamber to vibrate at frequencies ranging from 6000 to 8000 RPM depending upon the sediment substrate. The chamber (driver) is connected to the top of an aluminum irrigation pipe 1.5-mm thick, 76-mm wide, and over 3-m long and cabled to a 4.2-m high aluminum tripod fitted with a battery-operated winch (Figures 4-1, 4-2, and 4-3). Since the driver is sealed, the entire system can be immersed in water. A simple check valve placed into the flange connecting the core pipe to the driver induces internal suction during core extraction. The tripod is mounted to a raft that can be easily carried and assembled on site, towed with a small boat, and anchored into position (Figure 4-2).

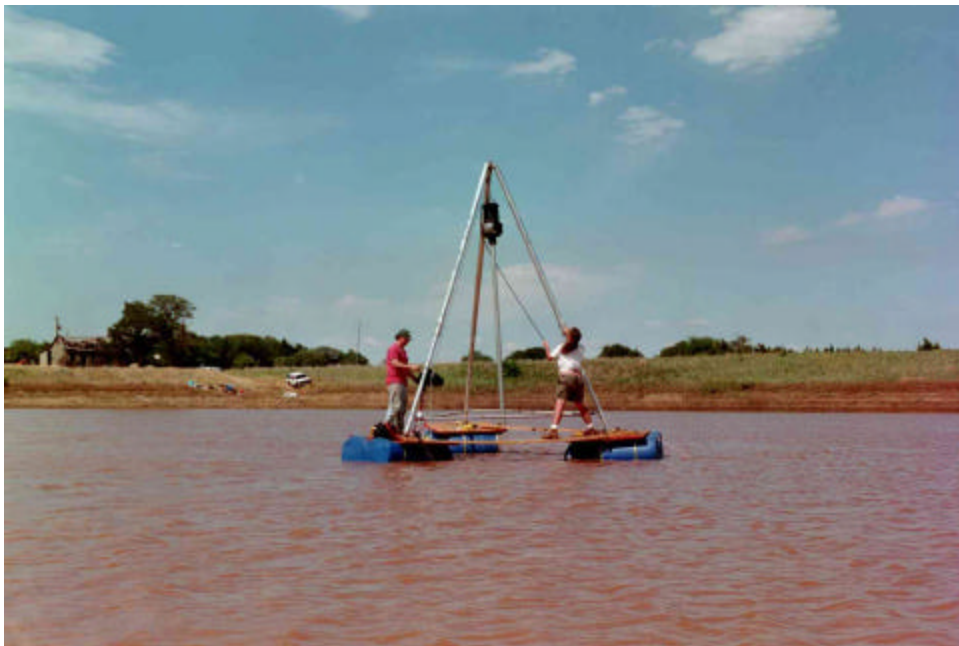
Figure 4-2. Photograph of floating vibracore system showing the tripod and portable rafts. The pipe is being positioned to obtain a core (June 1999).

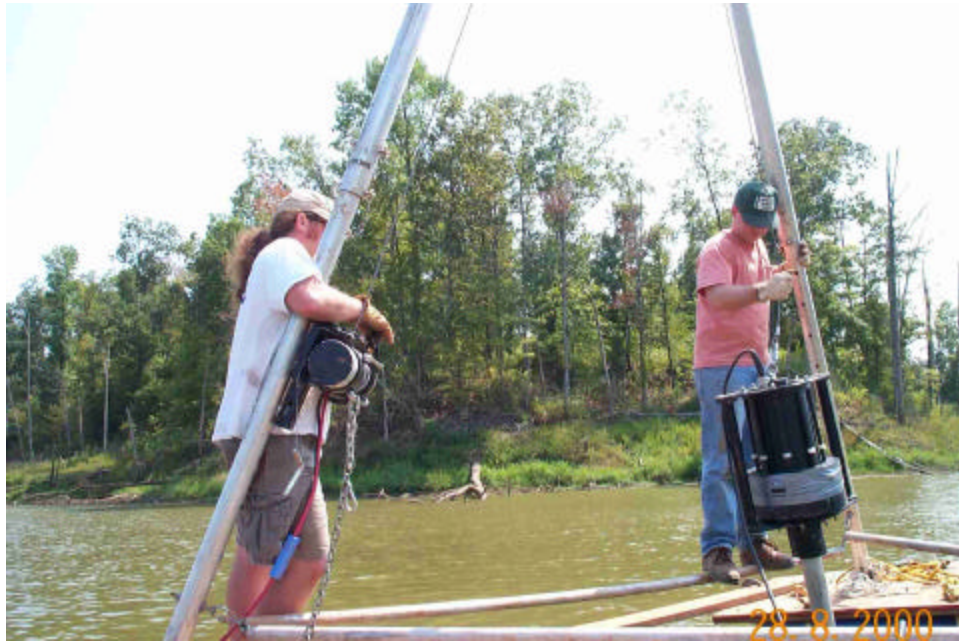
Figure 4-3. Photograph of vibracore system showing the tripod, vibracore head, and winch and cable assembly.

Once the core was driven into the sediment, the vibrating motion was stopped and the winch lifted the core to the water surface (Figure 4-3). When successful, the core typically had a hard sediment bottom that acted as a seal. If excessive sand or gravel was present at the bottom of the core, the entire contents of the pipe would be lost during lifting. The position of the raft was recorded with a hand-held GPS receiver whose data were differentially corrected using available base station information. The core was transferred to the boat and transported to shore. Each core was opened on site by cutting the aluminum pipe length-wise on both sides with a circular saw, and the top half of the pipe was carefully lifted from the sediment (Figure 4-4). Typical photographs of the sediment within a core are shown in Figure 4-5.

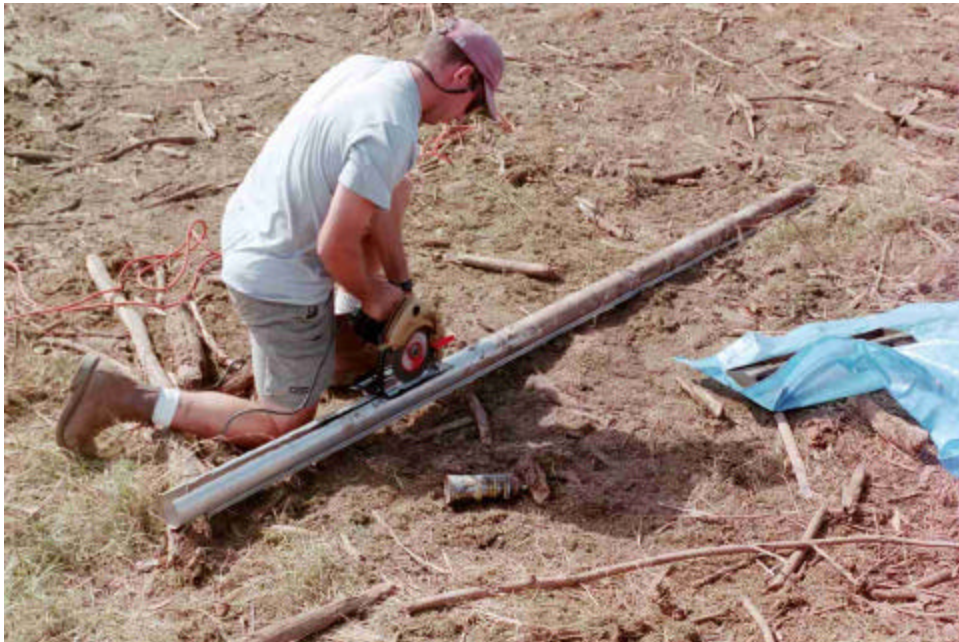
Figure 4-4. Photograph of extracted core being cut open on-site (June 1999).

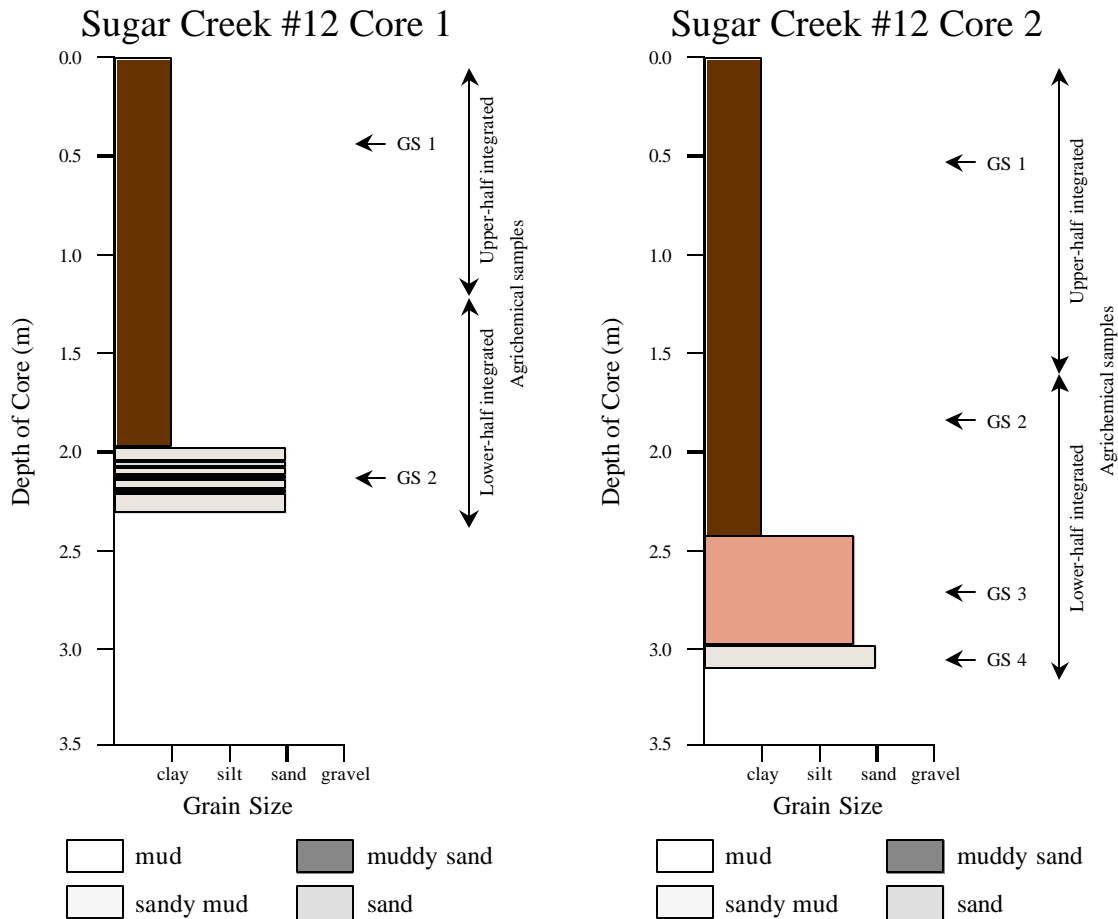
Figure 4-7. Stratigraphic logs of Core 1 (left) and Core 2 (right) obtained at Sugar Creek #12 (see Figure 4-6 for exact location). Also shown are schematic textural and color characteristics of the units and the location of samples obtained for analysis including sediment and agrichemical analysis.

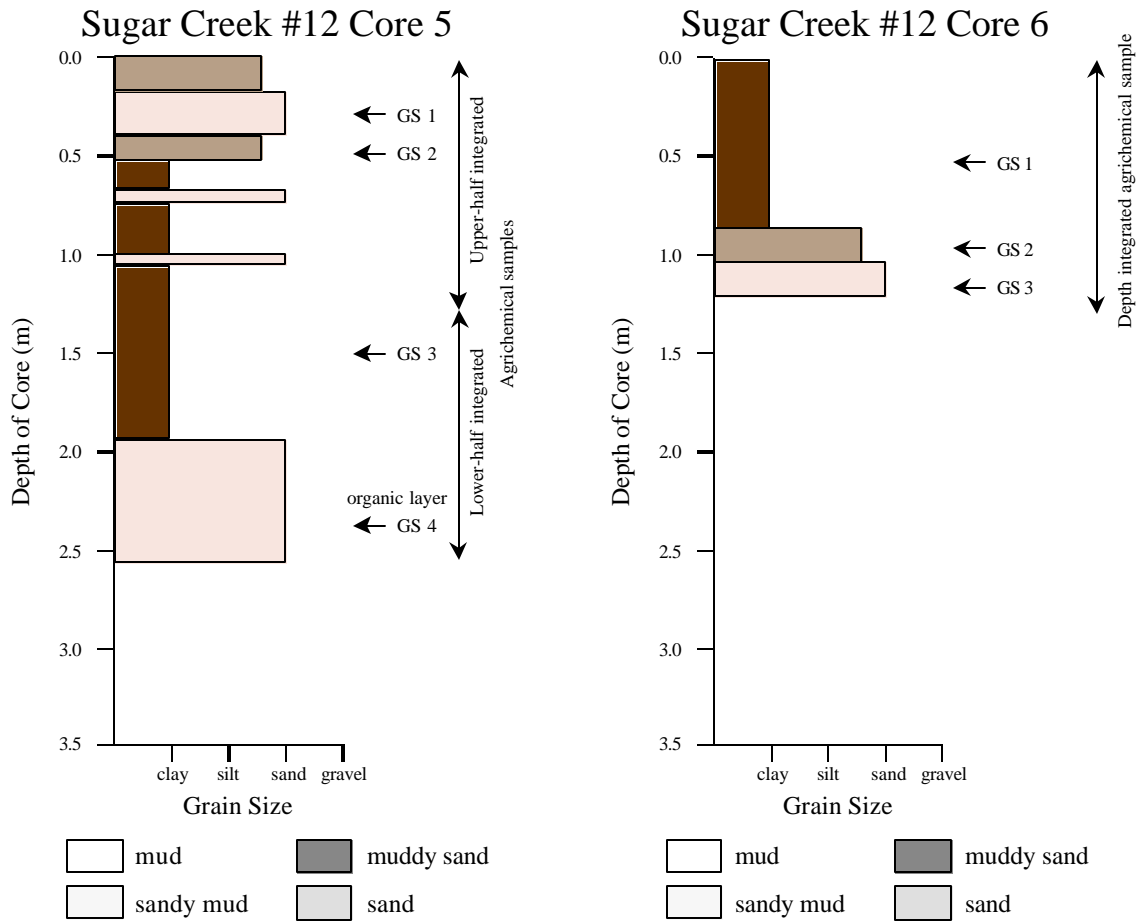
Figure 4-9. Stratigraphic logs of Core 5 (left) and Core 6 (right) obtained at Sugar Creek #12 (see Figure 4-6 for exact location). Also shown are schematic textural and color characteristics of the units and the location of samples obtained for analysis including sediment and agrichemical analysis.

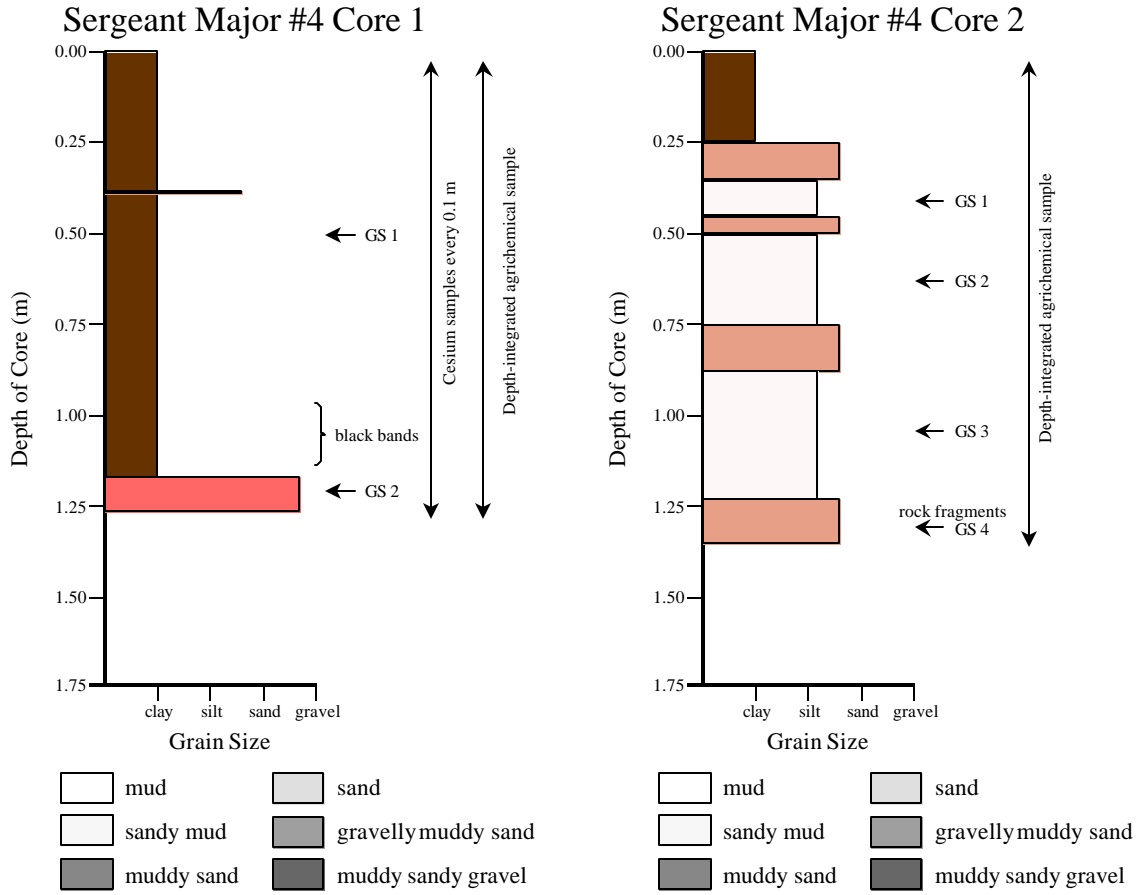
Figure 4-13. Stratigraphic logs of Core 1 (left) and Core 2 (right) obtained at Sergeant Major #4 (see Figure 4-12 for exact location). Also shown are schematic textural and color characteristics of the units and the location of samples obtained for analysis including sediment, ¹³⁷Cs, and agricultural analysis.

In general, the cores at Sergeant Major #4 are composed of gravel, sand, silt, and clay. In places, alternating layers of black and red-brown silt and clay (varves) are present (see Core 1, Figure 4-13; and Core 4, Figure 4-14). Very thick accumulations, up to 1.1 m, of silt and clay are common (see Core 1, Figure 4-13; and Core 4, Figure 4-14), but also common are large sand accumulations of up to 1 m (see Core 2, Figure 4-13; and Core 4, Figure 4-14). The thick silt and clay unit in Core 1 has a very thin (ca. 5 mm) sand unit (Figure 4-13). Gravel is observed near the base of Core 1 (Figure 4-13) and Core 4 (Figure 4-14), and rock fragments are present near the base of Core 2 (Figure 4-13). Roots are observed near the base of Cores 3 and 4 and a layer rich in organic material is present within the silt and clay layer of Core 3 (Figure 4-14).

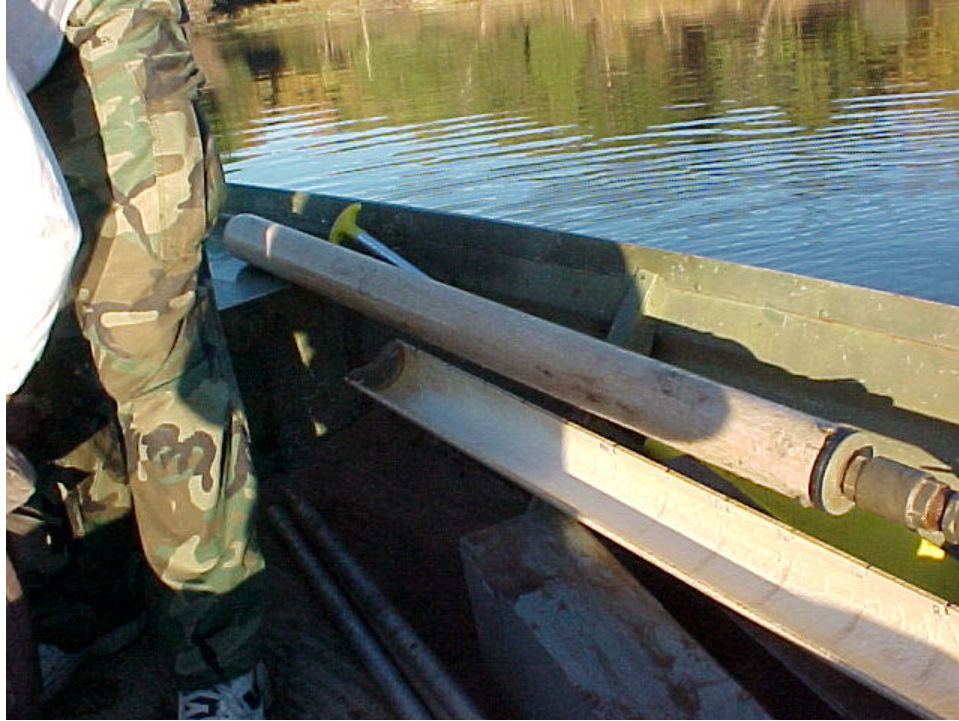
Figure 5-1. Photograph of the sediment coring tube used to obtain sediment samples (taken at Sugar Creek #12, October 1999).

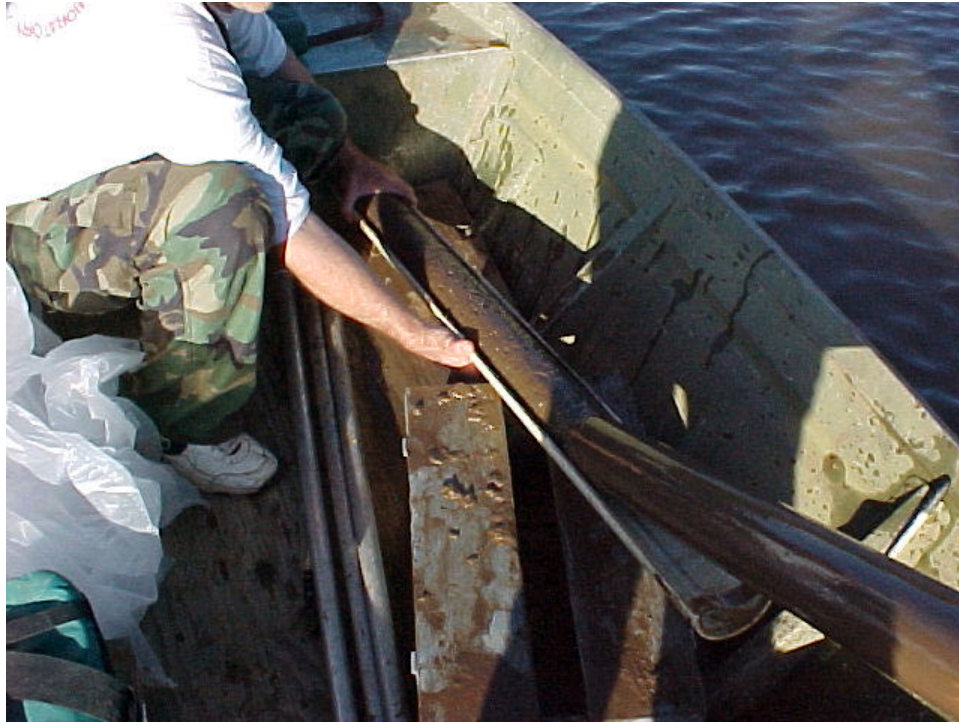
Figure 5-3. Photograph of the sediment core being extruded into core catcher (taken at Sugar Creek #12, October 1999). Core is extruded by tipping core and shaking out contents.

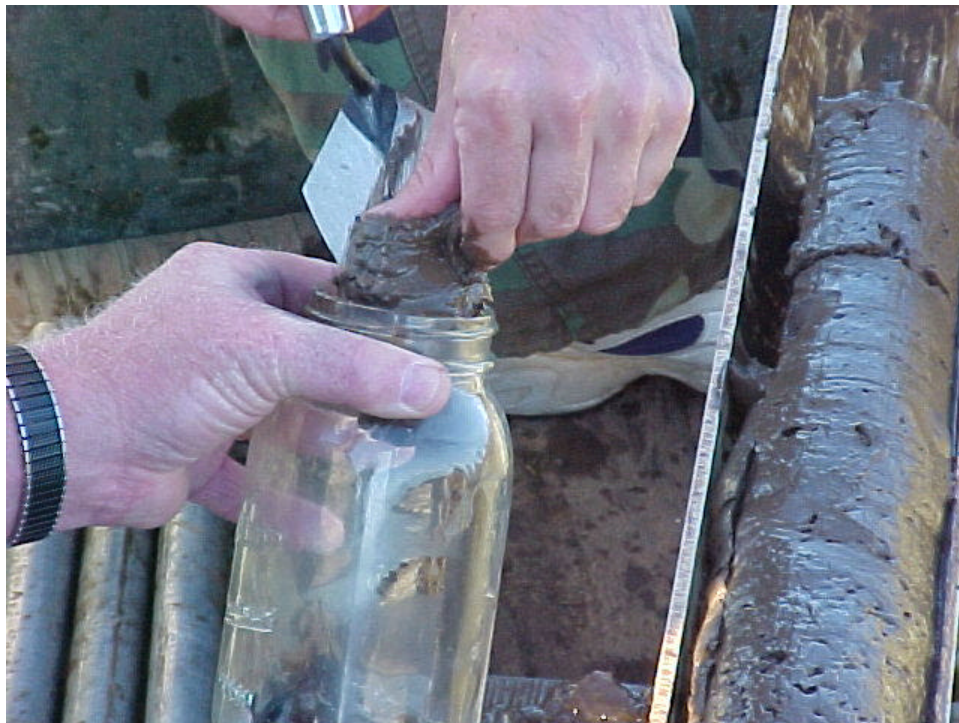
Figure 5-4. Photograph of the sediment from core being placed into sample bottles for later analysis (taken at Sugar Creek #12, October 1999).

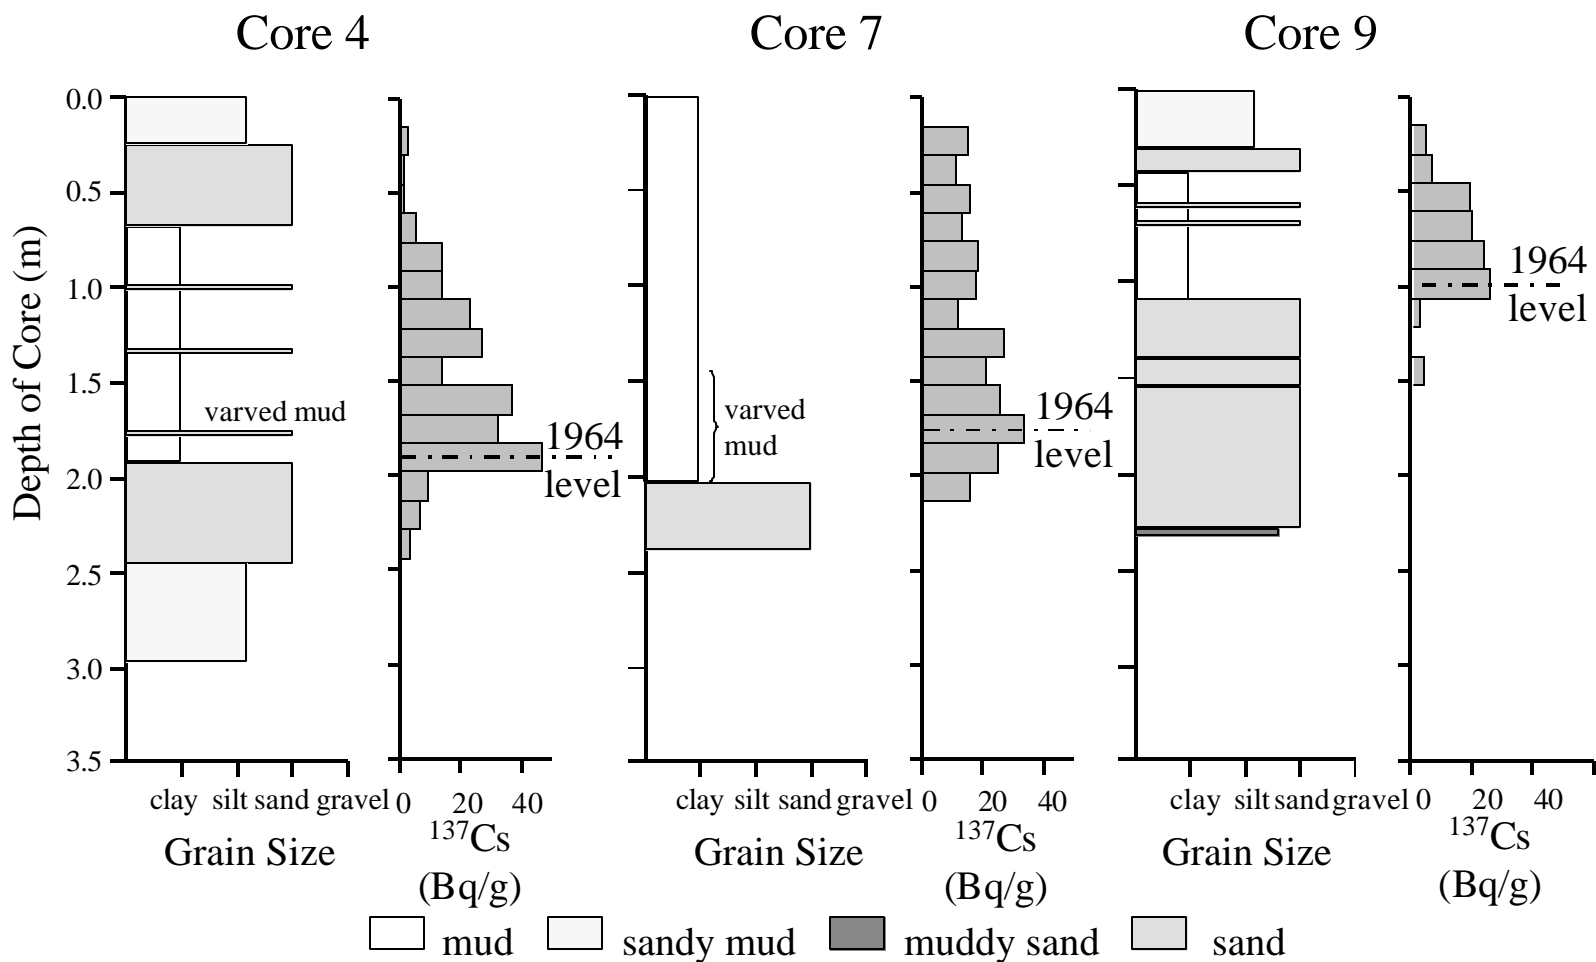
Figure 6-1. Comparison of stratigraphic logs at Sugar Creek #12 with ^{137}Cs results. The 1964 level is identified and shown.
