# Saving Little Topashaw

Eroded southern creek offers lessons on undoing years of harm to watersheds

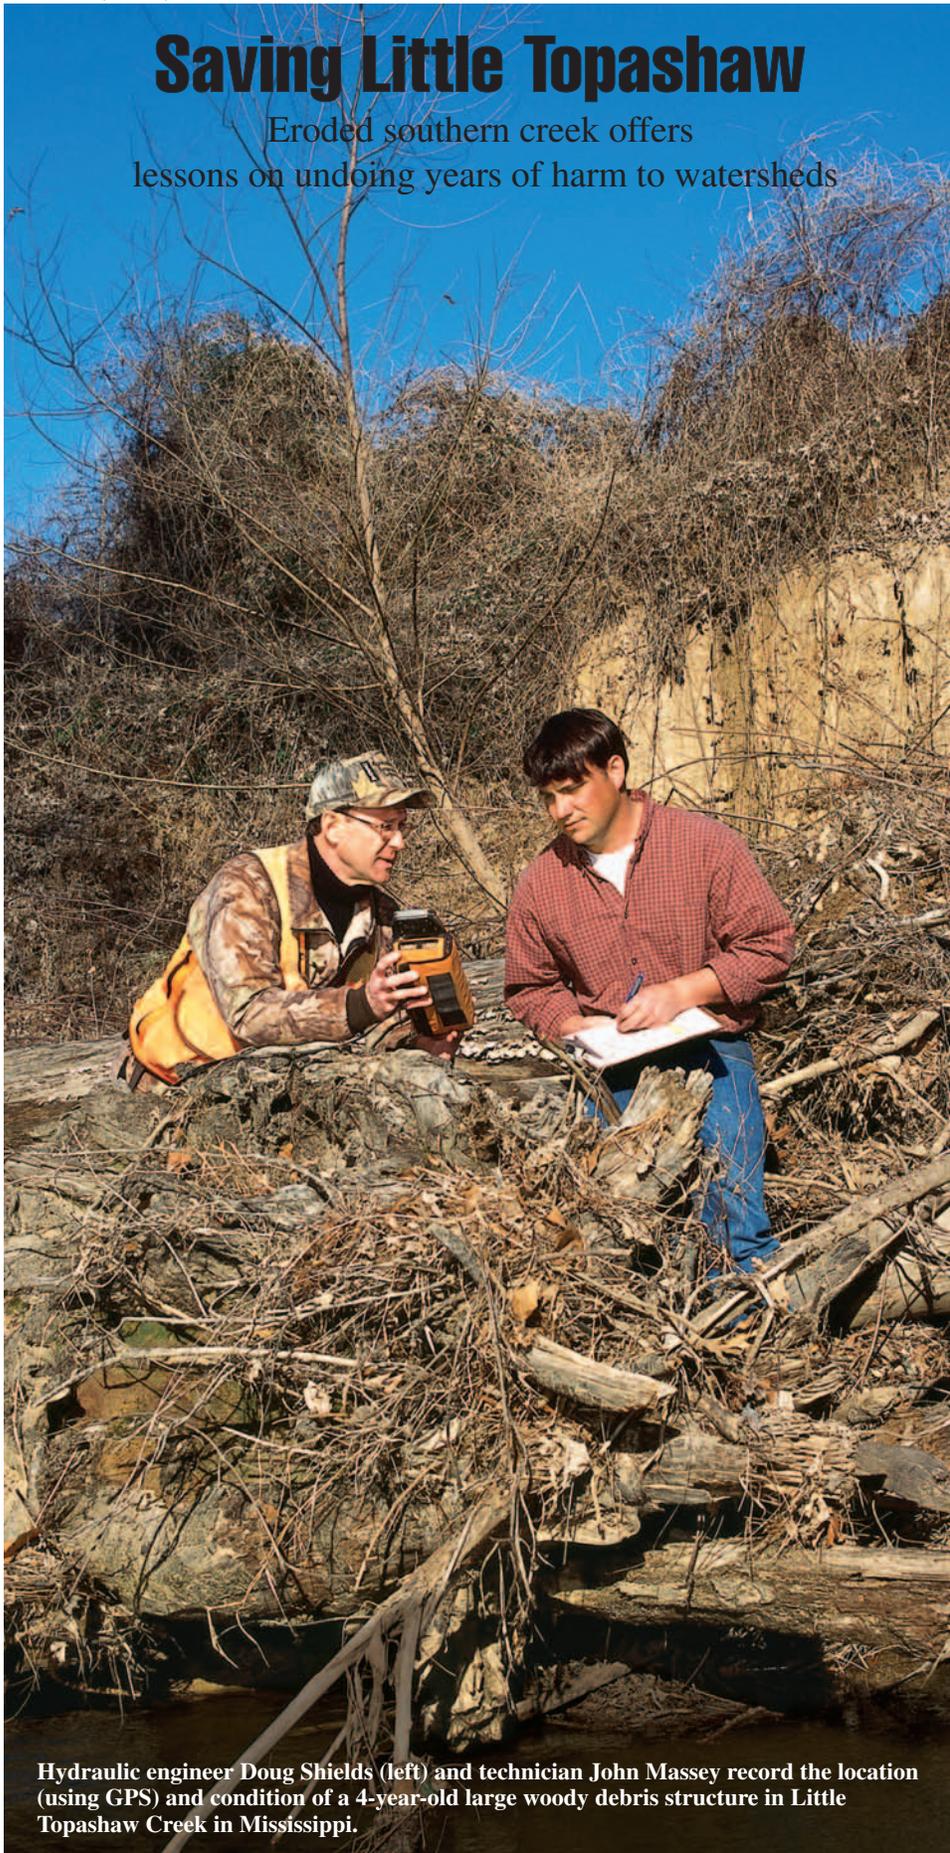
Hydraulic engineer Doug Shields (left) and technician John Massey record the location (using GPS) and condition of a 4-year-old large woody debris structure in Little Topashaw Creek in Mississippi.

In outfitting their segment of the creek with 72 debris structures, the team sought to replicate an essential component of stream aquatic habitat.

Unfortunately, many of the structures—consisting of uprooted trees stacked in crossing layers and anchored with steel cables to the streambed—have

failed during the 3 years since they were built. “We pushed the envelope with our design,” says Shields, “but we think the failures have led us to produce even better guidelines than if we had achieved 100 percent success.”

The structures reduce sediment transport, triggering natural deposition to heal channels enlarged by years of erosion. Shields says they cost about \$25 per foot of treated bank, or 20 to 50 percent of the cost of recent stone bank-stabilization projects in the region.

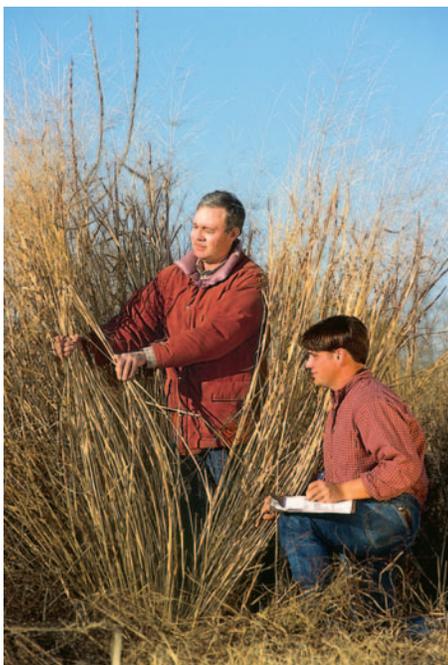
PEGGY GREB (K11202-1)

Technicians Calvin Vick (left) and John Massey measure switchgrass stem density and geometry at the upstream end of a riparian gully at Little Topashaw Creek.

Well-established grass hedges can remain erect against waterflow that ponds to depths of up to 1.5 feet, he says. Dabney has planted switchgrass (*Panicum virgatum*) in gullies along Little Topashaw because “it’s robust, it’s tolerant of cold weather, and it’s a native grass.”

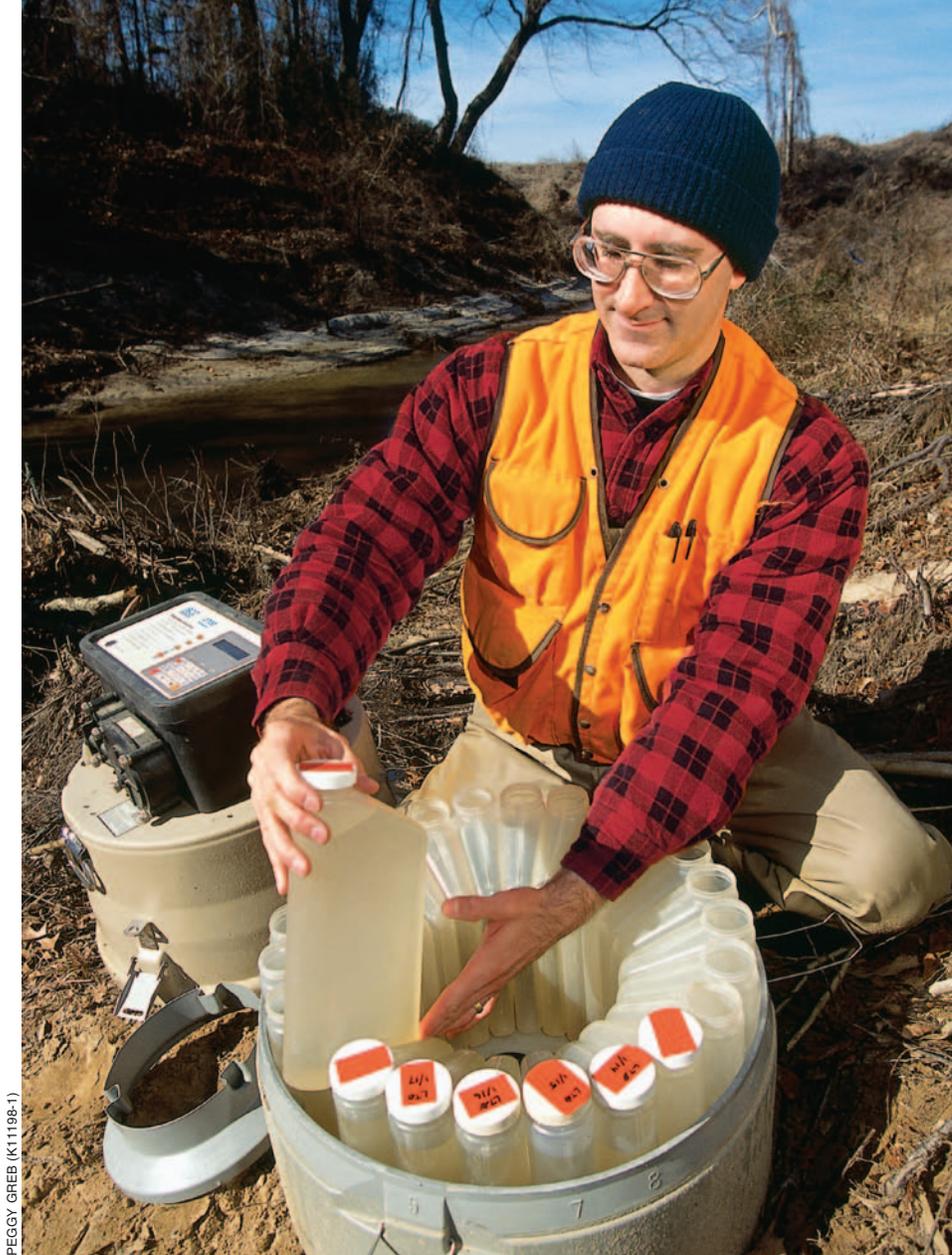
PEGGY GREB (K11198-1)

**Biologist Richard Lizotte removes water quality samples from an automated water sampler on Little Topashaw Creek.**
