U.S. Sheep Station Experiment Station Grazing and Associated Activities Project

Hydrology Report

Prepared by:
Jenny Fryxell
Hydrologist

for:
The U.S Sheep Experiment Station, Agricultural Research Station, Dubois Idaho
May 13, 2011

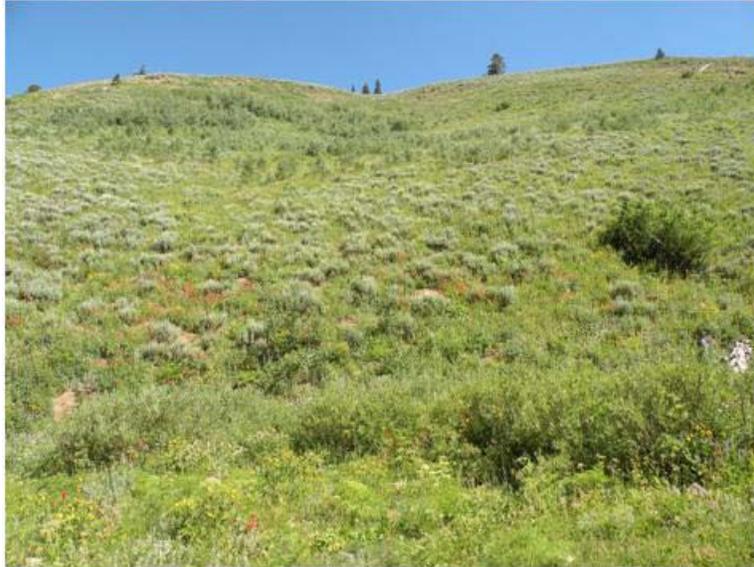
Watershed condition generally appeared consistent throughout this Grazing Area, based on the ride through in 2008. Three data points were taken as the area was very consistent in appearance. Uplands were generally well vegetated with little evidence of surface runoff or erosion (Figure 6). No evidence of desertification was observed in the field. Desertification occurs when the amount of dry-land biological productivity is reduced. There are several reasons why desertification occurs, and grazing can be one of them, or there can be several factors causing this to occur (<http://www.britannica.com/EBchecked/topic/159114/desertification>).

The average of 43 percent cover is low as only three points were taken. One point had a total cover value of zero as it was taken on the road. The other two values were 80 and 50 percent cover, which are much more representative of watershed conditions in the allotment (Table 5). Three Proper Functioning Condition (PFC) surveys were conducted within this grazing area. Two locations received a rating of PFC and one location received a rating of Functional-at-Risk (FAR). Please refer to the “Channel and Floodplain Conditions” section in this report.

Figure 6. Views of uplands, Big Mountain Grazing Area (western summer range)

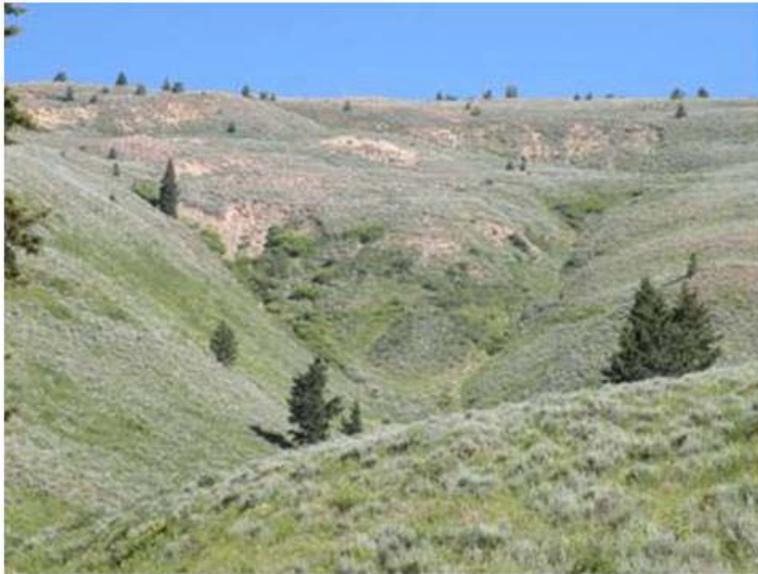
Bare soils were primarily associated with steep southwest facing ridges and were largely due to active slip faces, which are a function of the underlying Cretaceous siltstone and sandstone geology (Figure 7). These slumps start with a convex shape, and then evolve into a convex shape, where they appear to stabilize and re-vegetate. No evidence such as trailing, trampling or bed grounds was noted in association with these slumps. As a result, these areas of disturbance are considered to be “natural” and not related to grazing activities. Bare ground was also noted in association with bed grounds (Figure 8).

Figure 7. Views of slumps originating in Cretaceous sediments, view to the north

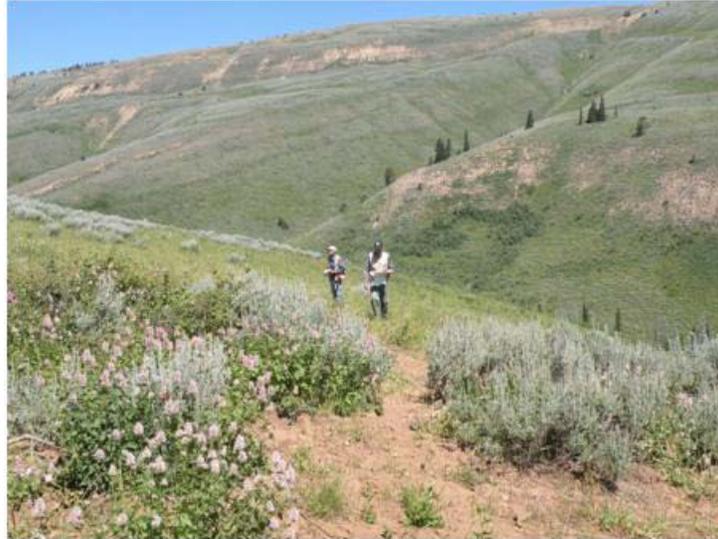
However, these areas were very limited spatially in their extent. The main bedding area observed had a surface condition rating of two, with soil hydrology and nutrient cycling rated as fair.

Figure 8. Edge of bedground, Big Mountain Grazing Area, view to northwest

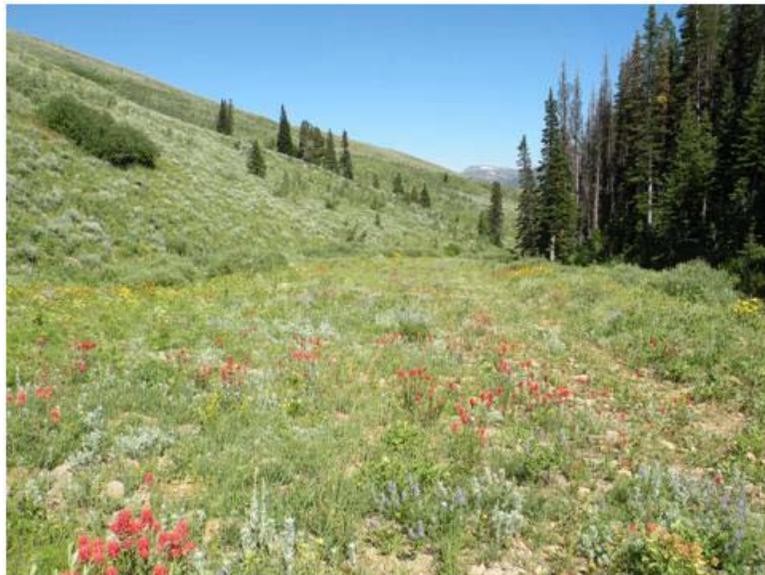
An old road leading to the J.R.Simplot mine is located in the bottom of the Spring Creek drainage. The road is confining the drainage in places, leading to increased downcutting and increased channel confinement. Erosion of the road prism was observed in several places. However, the road surface is generally well vegetated, which acts a sediment filter.

Very little evidence of surface runoff and erosion, related to the road surface was noted (Figure 9). Road reclamation activities, such as culvert removal, were conducted in 1997 (USDA ARS 2009).

Figure 9. Revegetated roadbed leading to closed phosphate mine, bottom of Spring Creek drainage

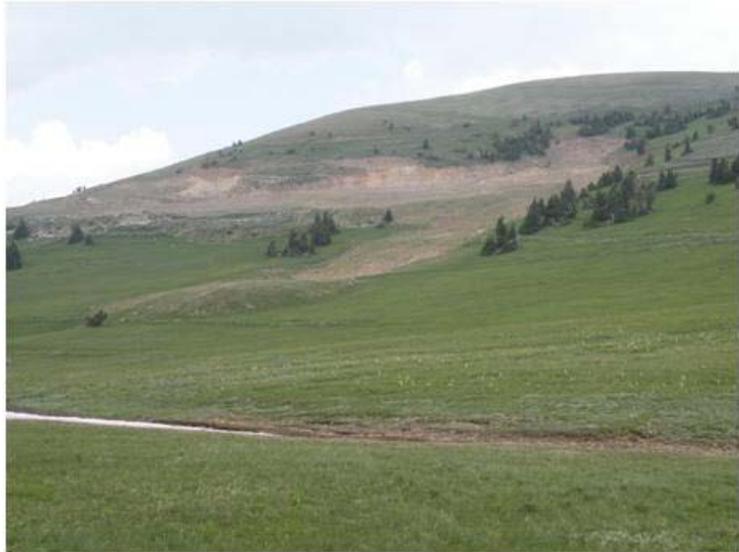
Field work was also done at and near the mine site to assess existing upland watershed conditions (Fryxell 2008). Snow patches were present and melting at the time of the visit, resulting in bare patches of ground, but green vegetation shoots were noted, indicating vegetative growth was slow in the areas, due to melting snow. Ground cover appeared to be consistent in distribution and percentage over the area, ranging from 65-80 percent cover; however in the area of the mine itself ground cover minimal ground cover was much less (estimated down to 25-30 percent). Rock fragments were abundant on the ground surface at this location and formed a type of ground cover, likely reducing soil erosion (Figure 10). At the mine site proper no active areas of erosion were noted, except at where a small drainage exists from the settling pond. Some relatively minor channel widening and downcutting has occurred for a small distance downstream. Down below the mine a small drainage runs roughly east/west, which some very minor amounts of bank trampling. However, large elk herds are known to frequent the area, which are thought to be the cause of this as water is provided for the sheep as this stream is intermittent (Figure 11). The mine road was also viewed from near this location and appeared to be consistently well vegetated and not a source of surface runoff or accelerated erosion (Figure 12).

Figure 10. View of uplands near J.R. Simplot Phosphate Mine, note small drainage in middle ground of photograph

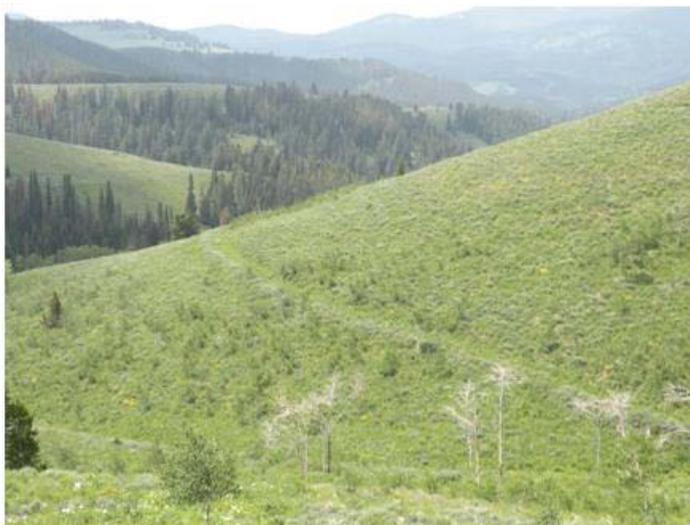
Figure 12. View of revegetated mine road, near J.R. Simplot Phosphate Mine

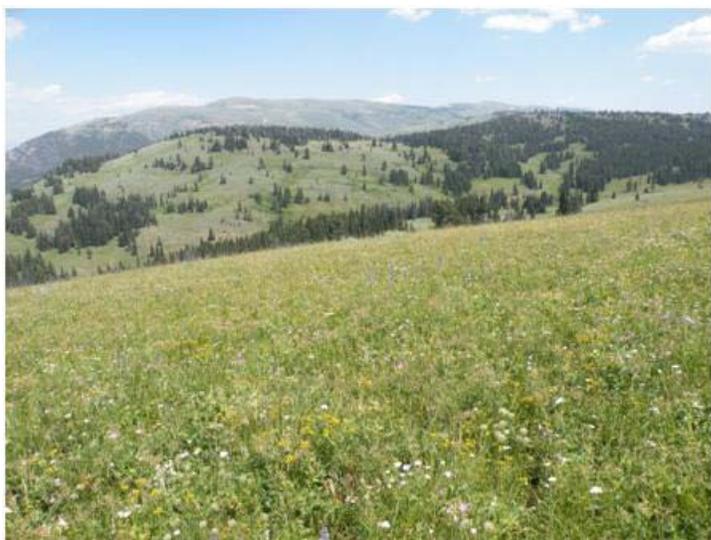
Watershed conditions appeared to be good and consistent within the Odell Grazing Area. No evidence of desertification was observed in the field. Twelve GPS points were taken throughout the Grazing Area. Although soil surface conditions varied from a “2” to a “4”, the average was 3.6 indicating fully hydrologic function and almost minimal signs of impairment (Table 5). For the points taken the average total cover approached 64 percent and appeared to be consistent throughout the Grazing Area (Figure 13). No evidence of rilling and gully, or other signs of surface overland flow were noted on uplands. Six PFC surveys were conducted and all received ratings of PFC. Please refer to the “Channel and Floodplain Conditions” section later in this report for additional detail.

Figure 13. West Odell Grazing Area (West Summer Range) looking to the northeast

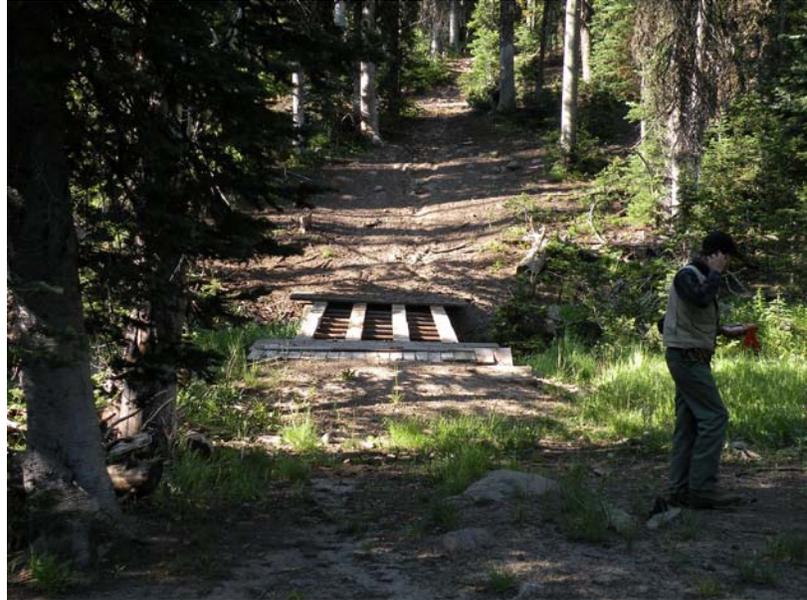
At all four crossings streams were observed to be in proper functioning condition. No evidence was observed indicating that stream morphology has been impacted, in any significant way, up or downstream of the crossings. There were no overt indications or evidence of excessive sediment within the associated channels. In addition there was no indication of heavy or unusual browsing on associated riparian vegetation. OD 4 is located in SW $\frac{1}{4}$, Section 11 T15S R2W, and is the major crossing of the four within the Odell grazing area. A secondary crossing lies nearby to the west. At the main crossing bare ground was associated with this driveway and was estimated to be 15 ft wide and 51 ft long on the north side of the Creek, and roughly an estimated 79 ft long and 25 ft wide on the south side of the drainage (Figure 15).

Although soil stability and hydrology and nutrient cycling were rated as impaired in this area, active erosion features were noted only on the far side of the crossing. Rilling and incipient gullying were noted and were adjacent to, and perpendicular to the stream crossing. Minor bank hardening was also noted. Although some extra sediment was being derived from this driveway, no detrimental bimodal distribution of sediment was observed in the streambed.

As a result, it did not appear that sediment contributions are exceeding natural sediment loads being carried by this stream. In addition, bank degradation was confined to where the driveway crosses Odell Creek.

Figure 15. Sheep driveway crossing at Odell Creek, upstream to readers right

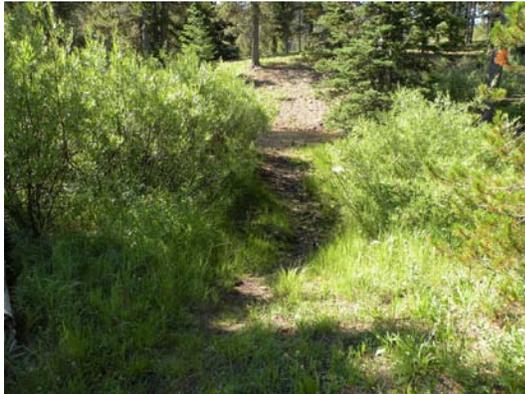
At OD5 the entry into the stream crossing is an estimated five feet wide with the exit onto a steeper sloped, which is largely bare of vegetation, and somewhat compacted. There were no well developed rills or gullies leading down to the Creek (Figure 16, Figure 17). Substrate in the stream bottom appeared to not be dominated by fines, with sub-angular siltstones to cobbles predominating. There did not appear to be a bi-modal sediment distribution.

Figure 16. Entry to sheep driveway, OD 5

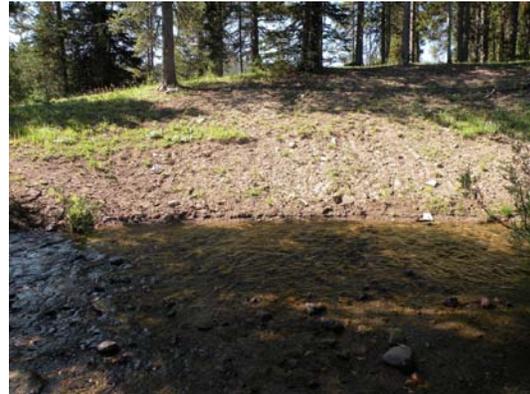
Figure 17. Close up of exit of sheep driveway, OD 5

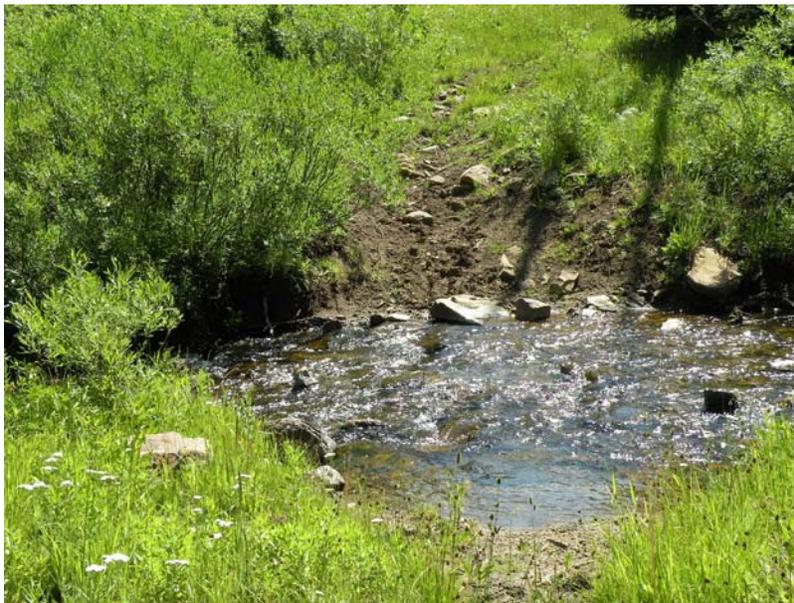
At OD 7 minor bank degradation was present at the two stream crossing areas, with one of the crossing exhibiting revegetation. Minor sediment contributions to the stream are derived from these trampled areas. However, there were no rills or gullies observed and there was no observable bimodal sediment distribution of stream substrate, which would indicate an unusually high percentage of fines for this mountain stream. Adjacent uplands were in good health with a well distributed groundcover of broadleaf forbs and grasses (Figure 18). The driveway crossing at OD 8 was in good shape and had not been

Figure 18. Driveway crossing at OD 7

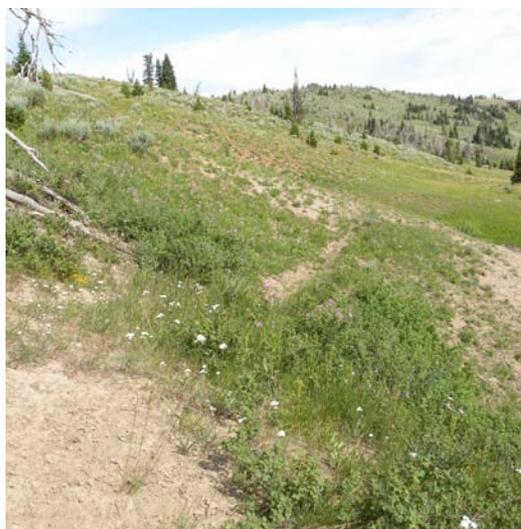
Observed surface conditions ranged between condition classes 1 and 4. No evidence of desertification was observed in the field. The range of total percent cover varied from 0-95, with an average cover of 64 percent. Nine total GPS points were taken. Uplands were remarkably consistent in vegetative cover. No sources of upland erosion, consisting of rills and gullies were noted. Surface condition class is estimated to between condition class 3 and 4 for the grazing area except for the road to for the observed bedding areas and the road to Blair Lake. Some evidence of overland flow was noted in association with melting snow fields and was confined to within 50 feet of these areas, and no erosional features were noted in association with the melt water. Earth-flows and slumps were occasionally present and are associated with unstable stratigraphic layers.

Figure 19. Views of uplands in Toms Creek Grazing Area

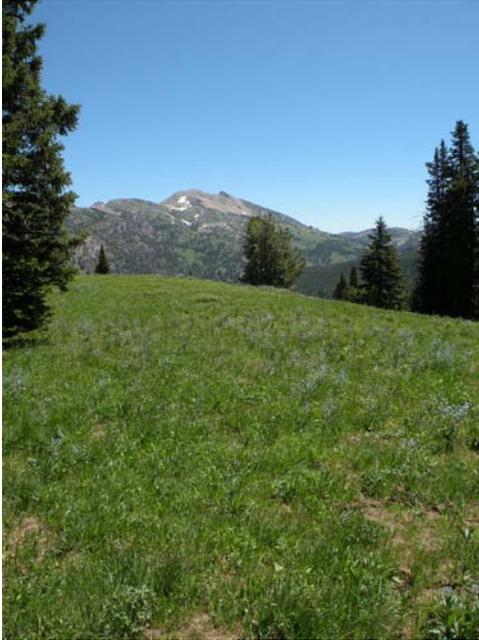
Figure 20. Vegetation and recovery of trailing, east portion, North Fork Toms Creek (Bighorn Dolomite Area)

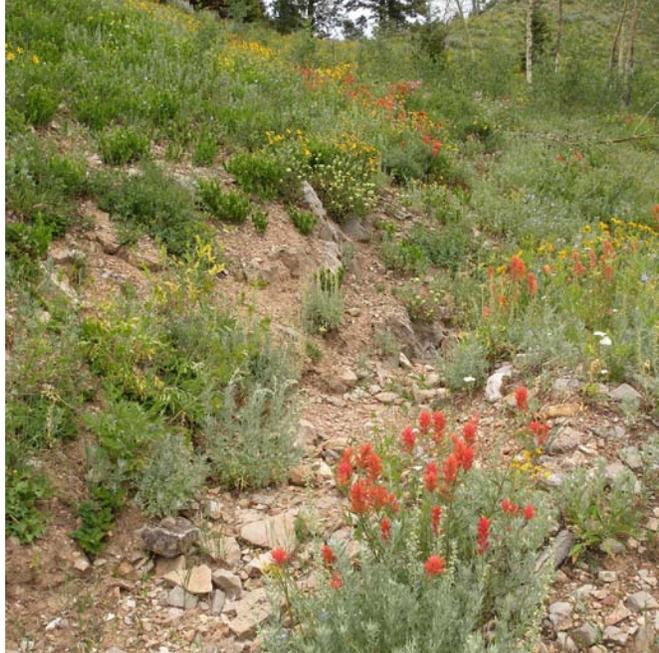
Figure 21. Views of intermittent drainage, North Fork Toms Creek, Park Shale Area

To the south an abrupt and dramatic change in vegetative cover was observed, as vegetation becomes largely absent on the uppermost and steepest portions of the western half of these headwaters (Figure 21). On the lower portions of this area, where slope gradients are shallow vegetative cover becomes consistent and lush. Trees are sporadic in both the northern and southern portions of these headwaters due to poor site productivity. This area is underlain by the Cambrian Park Shale, which overlies the Bighorn Dolomite (Moffet 2009, Fryxell 2009, Witkind 1976). Even though cover is largely lacking there was no observed evidence of overland surface flow, rills, gullies or mass movement. To the north and west additional trailing was noticed, but as mentioned above these areas are now green due to revegetation. The North Fork of Toms Creek appears to be ephemeral to intermittent. Channel definition increased in a downstream direction, reflecting increased flow volumes. The channel was classified as a Rosgen A3, characterized as a steep, entrenched, cascading, step pool stream, in proper functioning condition. Uplands were not observed to be eroding or contributing excessive amounts of sediment (Fryxell 2009).

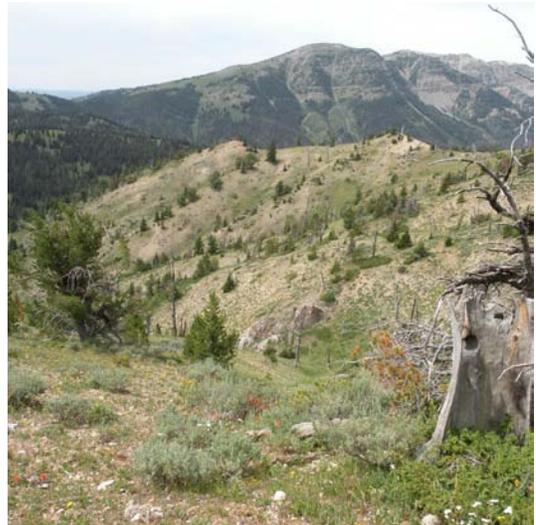
One area of uplands was of special interest, which is located at the head of the North Fork of Toms Creek, which has been an area of past debate (Figure 22). This area burned by a forest fire sometime between 1880 and 1930. Burned trees still stand and charcoal is still found in upper portions of the soil horizon. Slopes tend to be steep (over 10 percent) with poor site productivity (Jacobson 2009a). Past debate has been regarding supposed over-grazing practices by the Sheep Station. This area was reviewed with Sheep Station, Soil Conservation Service personnel and University of Idaho staff to review upland conditions. Sheep Station notes on the meeting state: “Soil Conservation personnel believe grazing abuse by the Sheep Station had not occurred, that the site was as good as could be expected, that no current erosion was occurring, and the overall trend was up” (Jacobson 2009a).

Figure 22. View looking west to area underlain by Park Shale, west half of North Fork of Toms Creek

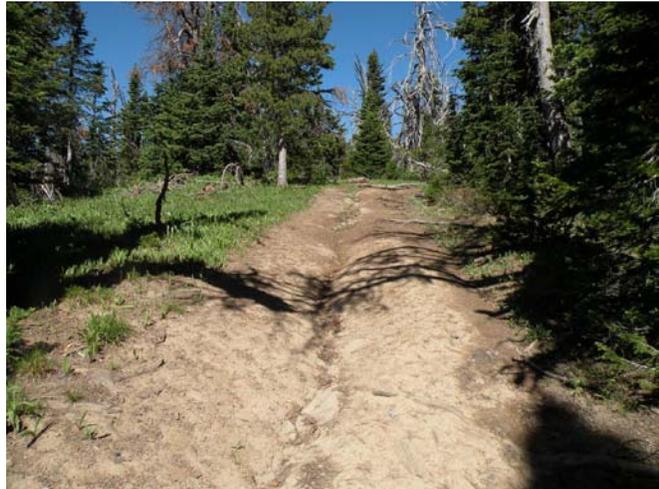
The only areas receiving a surface condition class rating of 1 was the road, which starts on Forest Service-administered land, which leads towards Blair Lake. The initial portion of the road has been put to bed by the Forest Service in the summer of 2008, when it was ripped and seeded. From the ARS/Forest boundary to near Blair Lake, various degrees of rilling, rutting, and gully development were observed (Figure 23). Near the ARS/Forest Service boundary minimal slash is in place but has not been effective in diverting

Figure 23. Road ruts on road to Blair Lake

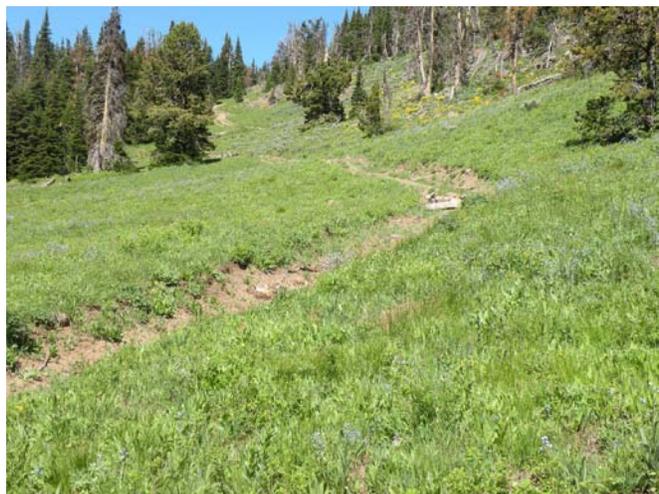
Figure 24. Road and erosion, lower portion of road to Blair Lake

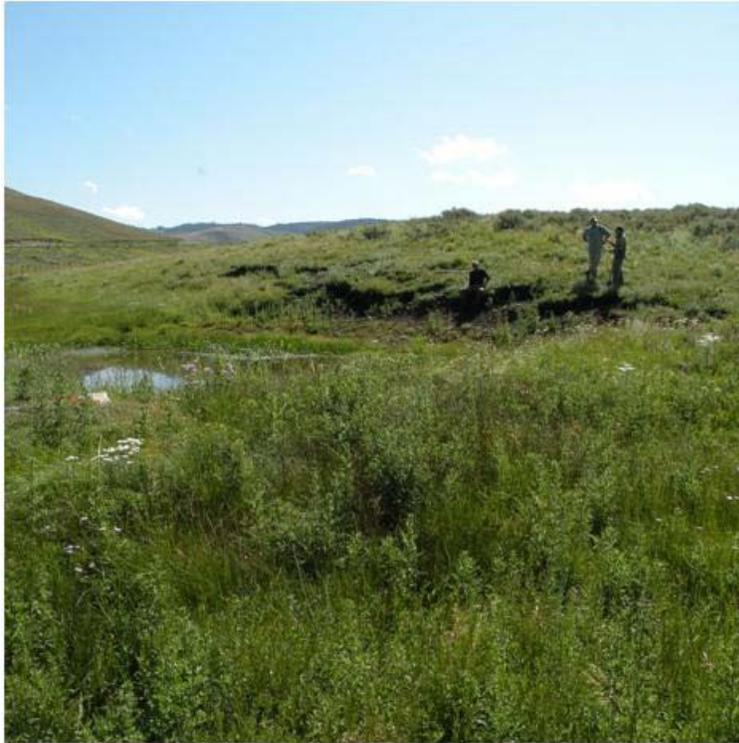
Figure 26. Disturbance around watering pond

An earthen dam was formed to develop a watering pond for the sheep. Trailing from “upstream” and “downstream” directions was noted leading to this pond. This pond area is roughly rectangular in shape and covers an estimated 132 sq. feet. Bank trampling is present and has resulted in vertical bank development on the south side of the pond. Bank height was variable ranging from several inches up to 18 inches or so (Figure 26). Bare and compact ground was present immediately around the pond. The pond and associated bare and compact ground is less than an estimated half-acre. No headcutting

above the pond was noted and no down cutting below was noted. Areas below the pond were noted to be especially lush and well vegetated and included equisetum or horsetail, indicative of chronically moist soils.

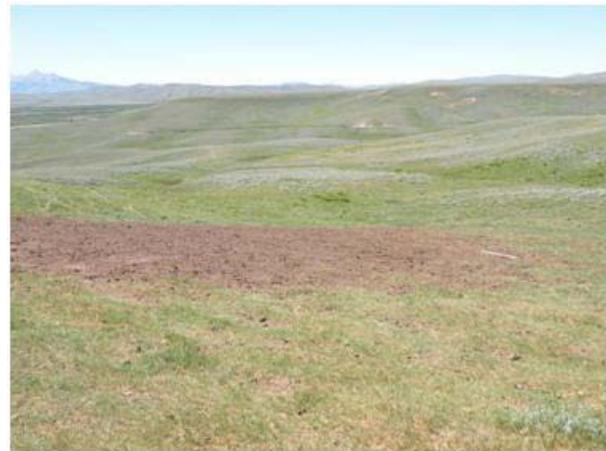
Two bedding area was observed within the grazing area. One area, on the shoulder of a hilltop was an estimated 50 ft by 50 ft with no vegetation. Although vegetation was absent and the surface condition was rated as condition class 2 there were no observable features indicating surface overland flow, erosion and sediment transport (Figure 27).

Figure 27. View of bedding area, Humphrey Grazing Area, view to north/northwest

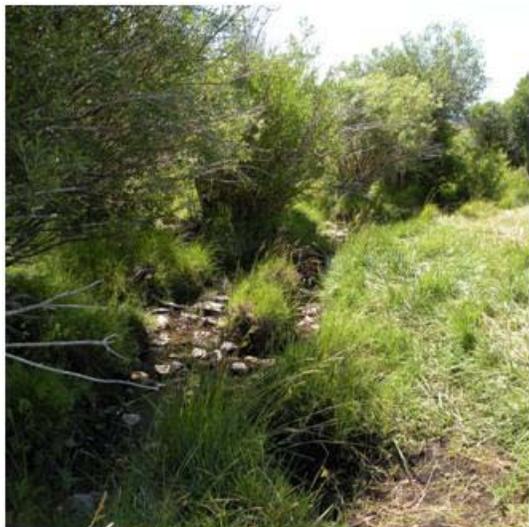
The second bedding area was noted immediately adjacent to the perennial stream found in the northeastern-most quarter of the grazing area, which is used for watering the sheep. Evidence of use includes bank trampling, some vertical bank development less than ten inches high, trampling in areas next to the stream and some accumulation of fines in areas where water velocity would be less during higher flow. Some channel over-widening was also observed as were small vegetated islands (Figure 28). Despite these indicators of use during watering riparian vegetation was well developed with a variety of age classes, and some hedging due to browsing was noted (Figure 29). Equisetum and iris were also noted. There was no evidence of channel dewatering. Upstream from this area the amount of use varied and channel width decreased.

Figure 28. Perennial stream, Humphrey Grazing Area

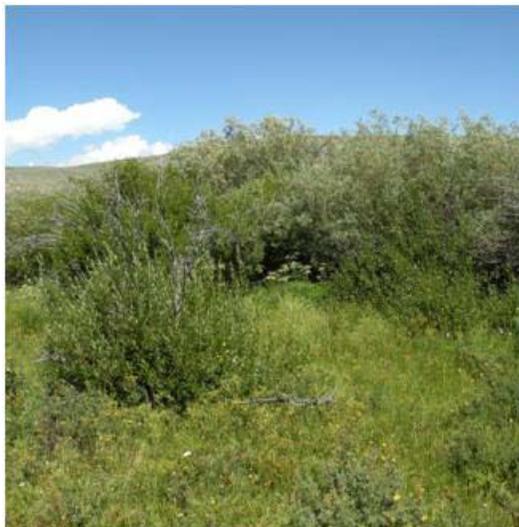
Figure 29. Riparian vegetation, perennial stream, Humphrey Grazing Area

Downstream from the area of use channel width also decreased and the absence of excessive fines was observed. Bank incision also decreased both up and downstream from the area of use. The channel was observed to be in proper functioning condition below and above the area of use.

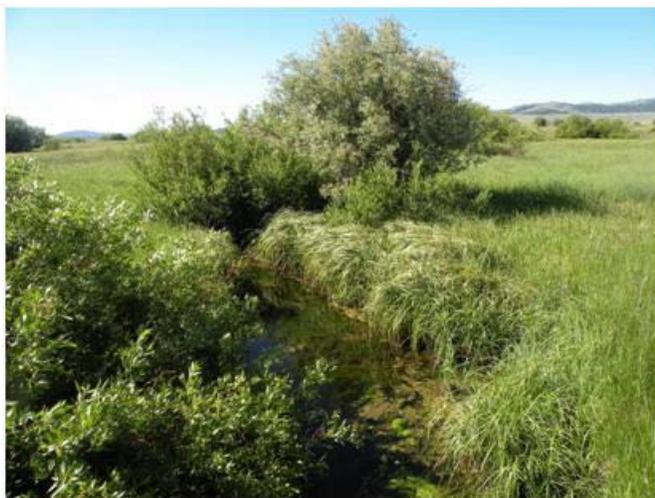
The second perennial drainage in this grazing area is located on Beaver Creek, which is in the far western portion of the area. Beaver Creek, where it crosses the road, is a Rosgen E3/E4 channel type, roughly five feet wide, with an anastomosing channel pattern (Figure 30). These channels are defined as low gradient and meandering, characterized by little deposition, and typically found in the bottom of broad low gradient valleys with fine alluvium or lacustrine soils. The banks were stable and well vegetated and show recovery from past over-widening (Rosgen 1994, Moser and Fryxell 2008). No evidence of degradation related to present grazing activities were noted. However, within the length of reach used for watering there was some decline in condition. This portion of the stream was rated as in the lower end of the proper functioning condition due to channel over-widening, development of “vegetated islands” due to trampling, minor vertical bank development and the presence of fines, due to livestock watering.

Figure 30. Beaver Creek, Humphrey Grazing Area

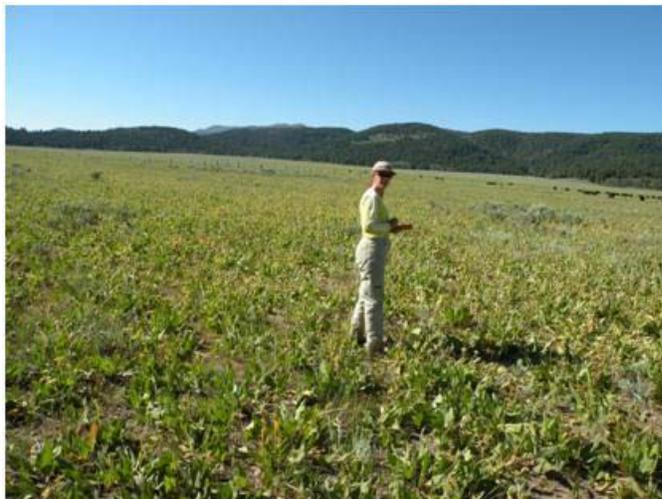
Figure 31. Arrow leaf balsam root field, Henninger Ranch property

In several areas desert-like pavement, consisting of a gravelly surface, was present. These areas lacked any vegetative diversity and consisted of only arrow leaf balsam root (Figure 31). The very low gradient surfaces may lend themselves to the effects of wind erosion (Moser and Fryxell 2008). Two PFC surveys were conducted at this property on Moose and Dry Creeks. Both received ratings of Functional-at-Risk due to flow diversion and rip-rapping.

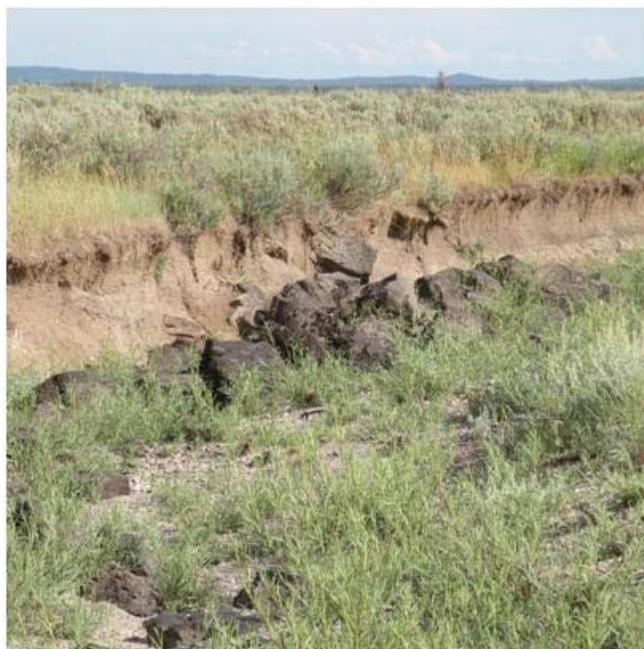
Irrigation practices were ongoing at the ranch prior to the property's purchase by ARS and a well developed network of irrigation ditches is still present today (Jacobson 2009a). The remains of a historical head-gate, located in the channel proper, are still present. Additional historical management of the channel is evidence by rip-rapping (Jacobson 2009a). The rip-rap has been there so long that portions of it have become entrained as part of the channel bedload and pieces are found deposited within the channels banks (Figure 32).

Figure 32. Historical rip-rapping, Dry Creek, Henninger Ranch

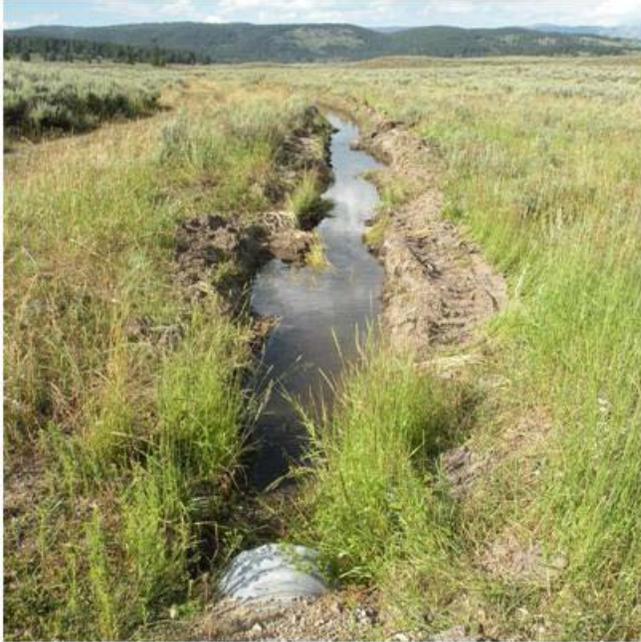
Figure 33. Ditching and maintenance, Henninger Ranch

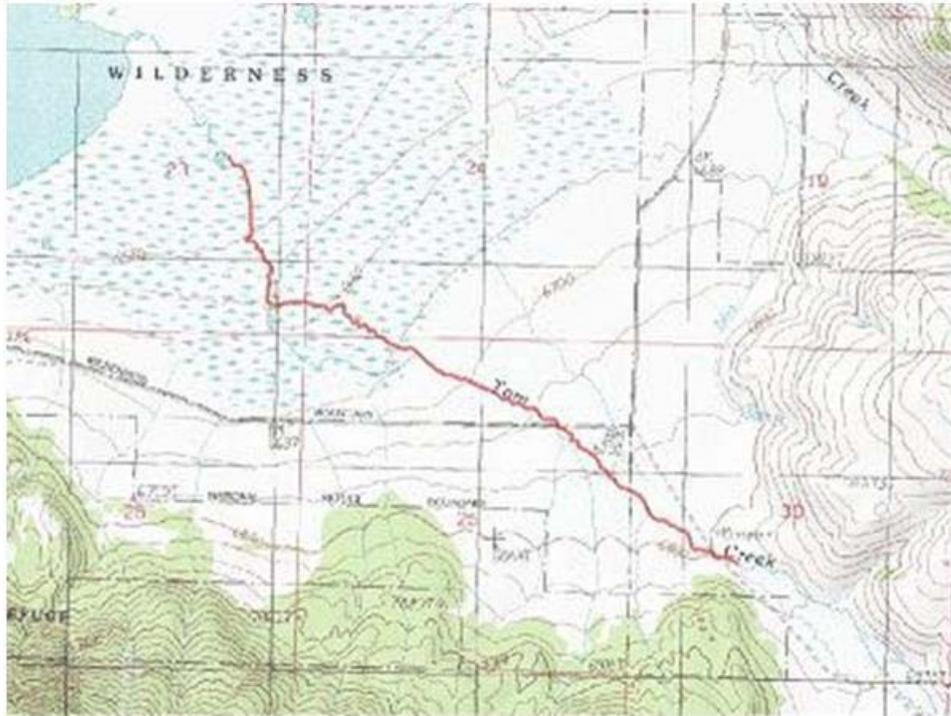
A similar situation exists with Tom Creek. Probable causes of impairment are grazing in riparian or shoreline zones and irrigated crop production Probable causes of impairment are listed as grazing related sources and irrigated crop production (Montana 2009, 2006e). No grazing related sources of sediment and siltation, alterations to flow or to stream side vegetation were observed during the field seasons of 2008 or 2009 in the headwaters of Tom Creek (Moser and Fryxell 2008 and Fryxell 2009). However, the map for this reach indicates that the entire listed segment does not extend beyond the valley floor, in front of the north boundary of the Centennials (Figure 34).

Figure 34. Location of the impaired reach on Tom Creek

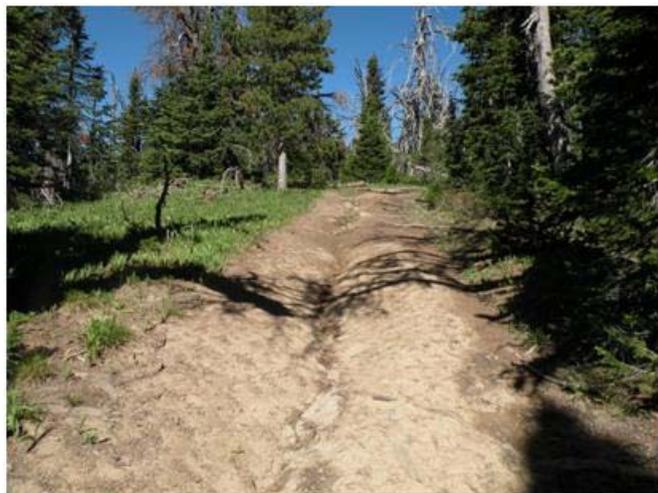
Figure 40. Road ruts on road to Blair Lake

- Blair Lake M2: From crest of hill down to first meadows (Figure 40): Rills and gullies are starting to develop on the compacted road surface. Install water bars at the first gradient breaks to get the water off the road. Install subsequent water bars at gradient breaks until the open meadows are reached. Extend water bar at least six feet into adjacent hillside along contour or at a slight angle to the slopes gradient. Hand crews would be used to implement the recommended measures. Knock rut edges down, and fill in ruts. Place small diameter (four inches or less) brush consistently over the length of the ruts to slow any surface runoff and encourage deposition of fine grained
