# **Final Hydrology Report for the U.S. Sheep Experiment Station Grazing and Associated Activities Project Final Environmental Impact Statement**

**Prepared by:**

Jenny Fryxell, Hydrologist, TEAMS Enterprise

USDA Agriculture Research Station

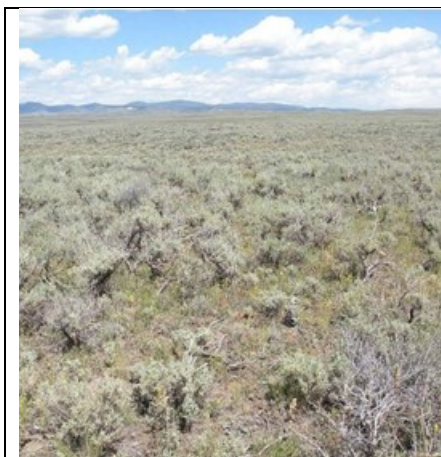
In general, alluvial flats found on lower basin floors are dominated by sagebrush and underlying basalt flows. Areas underlain by basalt flows lack defined drainages due to the basalts high permeability and porosity. Adjacent lower elevation flatlands are very well drained and have moderate grassland productivity (Figure 5). Road densities by 6<sup>th</sup> level watershed are summarized in Table 3. These are all the watersheds involved in the Proposed Action. Table 4 summarizes the miles of road within 300 feet of streams on the Headquarters property. There are 2.7 miles of existing firebreak around the Headquarters buildings. The firebreak is roughly 20 feet wide and is comprised of mineral soil. The total area of the firebreak is 65 acres. No streams, springs, or wetlands are adjacent to the firebreak.

**Figure 5. Views of Typical Alluvial Flats Underlain by Basalt, Headquarters Property**

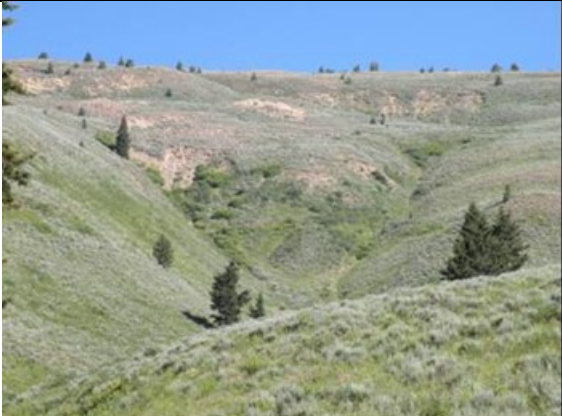
Bare soils were primarily associated with steep southwest facing ridges and were largely due to active slip faces, which are a function of the underlying Cretaceous siltstone and sandstone geology (Figure 7). These slumps start with a convex shape, and then evolve into a concave shape, where they appear to stabilize and re-vegetate. No evidence such as trailing, trampling, or bed grounds was noted in association with these slumps. As a result, these areas of disturbance are considered “natural” and not related to grazing activities.

| <b>Figure 6. Views of Uplands, Big Mountain Grazing Unit (Western Summer Range)</b> | <b>Figure 7. Views of Slumps Originating in Cretaceous Sediments, View to the North</b> |

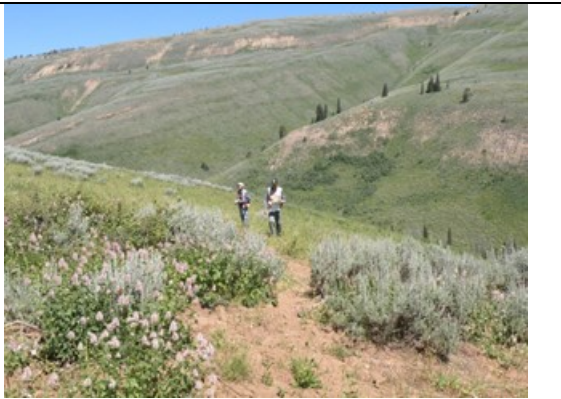
Bare ground was also noted in association with bed grounds (Figure 8). However, these areas were very limited spatially in extent. The main bedding area observed had a surface condition rating of two, with soil hydrology and nutrient cycling rated as fair.

| <b>Figure 8. Edge of Bedground, Big Mountain Grazing Area, View to Northwest</b> | <b>Figure 9. Revegetated Roadbed Leading to Closed Phosphate Mine, Bottom of Spring Creek Drainage</b> |

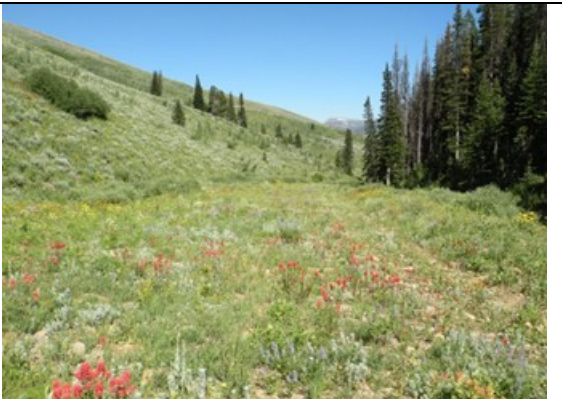
An old road leading to the J.R.Simplot mine is located in the bottom of the Spring Creek drainage. The road is confining the drainage in places, leading to increased down-cutting and increased channel confinement. Erosion of the road prism was observed in several places. However, the road surface is generally well vegetated, which acts a sediment filter.

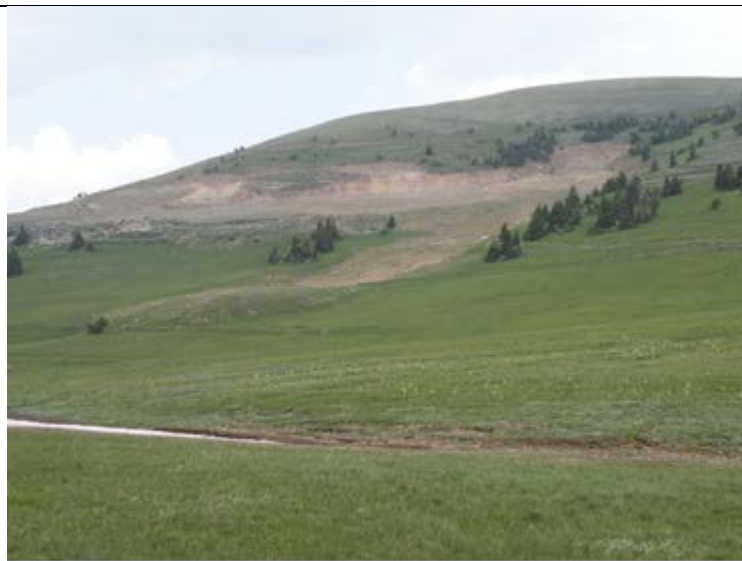
Fieldwork was also done at and near the mine site to assess existing upland watershed conditions (Fryxell, 2008). Snow patches were present and melting at the time of the visit, resulting in bare patches of ground, but green vegetation shoots were noted, indicating vegetative growth was slow in the areas, due to melting snow. Ground cover appeared to be consistent in distribution and percentage over the area, ranging from 65-80% cover; however in the area of the mine itself ground cover minimal ground cover was much less (estimated down to 25-30%). Rock fragments were abundant on the ground surface at this location and formed a type of ground cover, likely reducing soil erosion (Figure 10 ). At the mine site proper, no active areas of erosion were noted, except at where a small drainage exists from the settling pond. Some relatively minor channel widening and down-cutting has occurred for a small distance downstream. Down below the mine a small drainage runs roughly east/west, which some very

**Figure 10. View of Uplands near J.R. Simplot Phosphate Mine, Note small drainage in middle ground of photograph**

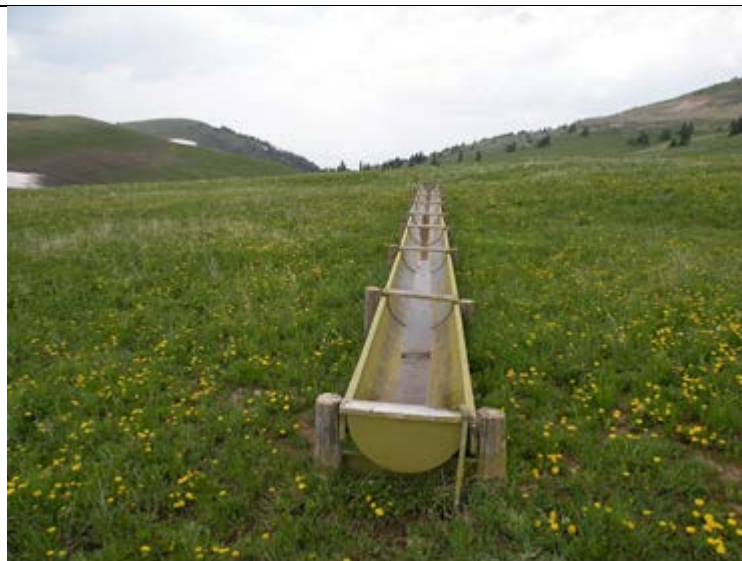
**Figure 11. View of Vegetation Growth Adjacent to Water Trough**

This portion of the grazing area had been rested in 2007, however vegetative recovery appeared to be consistent around these water developments, indicating that detrimental compaction and degradation of soil hydrology has not occurred to the extent that it impairs vegetative growth (Figure 11).

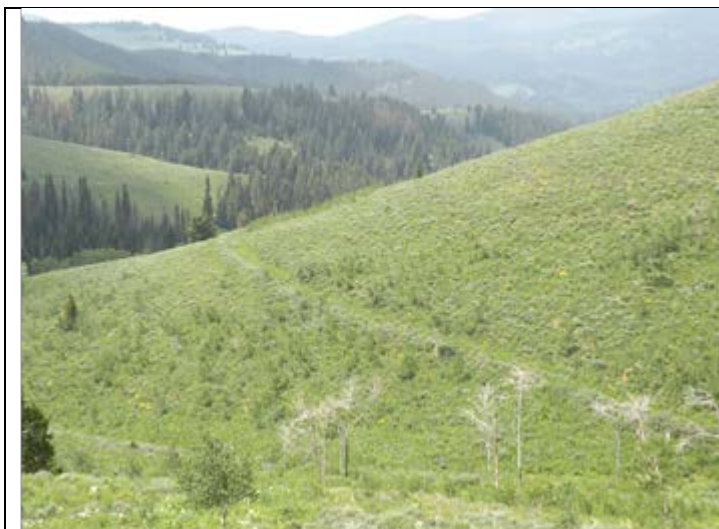
minor amounts of bank trampling. However, large elk herds are known to frequent the area, which are thought to be the cause of this as water is provided for the sheep, as this stream is intermittent (Figure 11 ). The mine road was also viewed from near this location and appeared to be consistently well vegetated and not a source of surface runoff or accelerated erosion (Figure 12)

**Figure 12. View of Revegetated Mine Road, near J.R. Simplot Phosphate Mine**

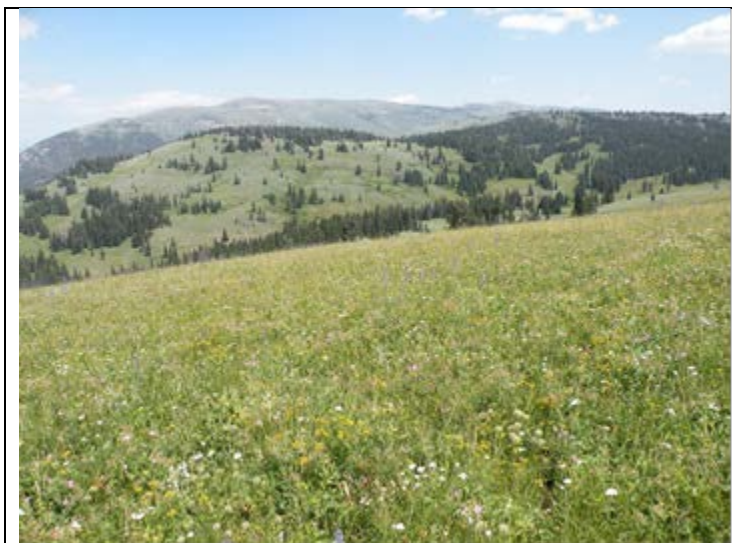
Watershed conditions appeared to be good and consistent within the West Odell grazing unit. No evidence of desertification was observed in the field. Twelve GPS points were taken throughout the Grazing Area. Although soil surface conditions varied from a “2” to a “4,” the average was 3.6 indicating fully hydrologic function and almost minimal signs of impairment (Table 5). For the points taken, the average total cover approached 64% and appeared to be consistent

**Figure 13. West Odell Grazing Unit (West Summer Range) Looking to the Northeast**

throughout the grazing unit (Figure 13). No evidence of rilling and gully, or other signs of surface overland flow were noted on uplands. Six PFC surveys were conducted and all received ratings of PFC. Please refer to the “Channel, Riparian and Floodplain Conditions” section later in this report for additional detail.

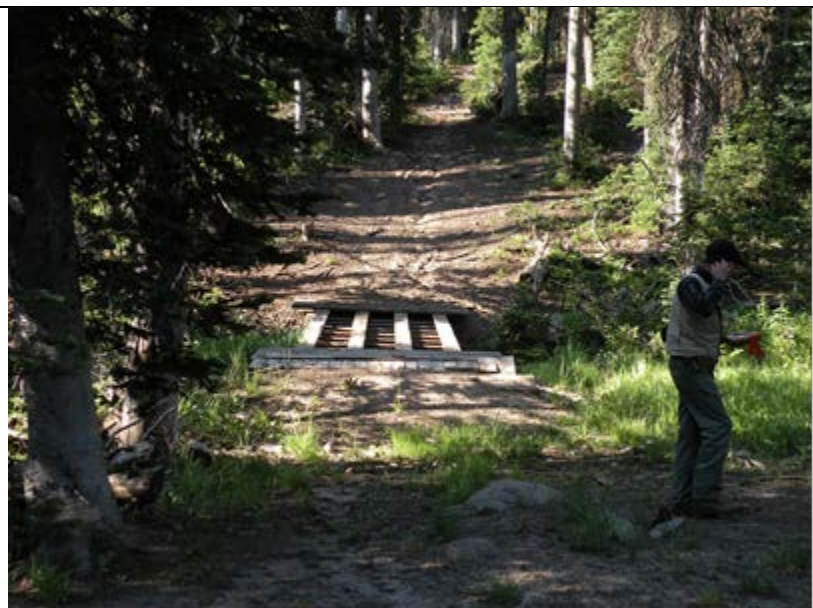
Although soil stability, hydrology, and nutrient cycling were rated as impaired in this area, active erosion features were noted only on the far side of the crossing. Rilling and incipient gullying were noted and were adjacent to, and perpendicular to the stream crossing. Minor bank hardening

was also noted. Although some extra sediment was being derived from this trail, no detrimental bimodal distribution of sediment was observed in the streambed.

**Figure 15. Sheep Driveway Crossing at Odell Creek, Upstream to Readers Right**

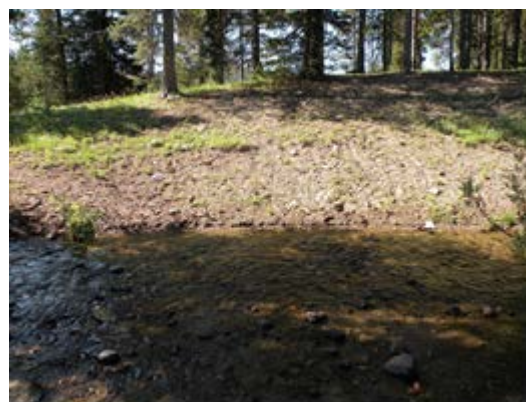
At OD5, the entry into the stream crossing is an estimated five feet wide with the exit onto a steeper slopped, which is largely bare of vegetation, and somewhat compacted. There were no well-developed rills or gullies leading down to the Creek (Figure 16 and Figure 17 ). Substrate in the stream bottom appeared not to be dominated by fines, with sub-angular siltstones to cobbles predominating. There did not appear to be a bi-modal sediment distribution.

**Figure 17. Close up of Exit of Sheep Driveway, OD 5**

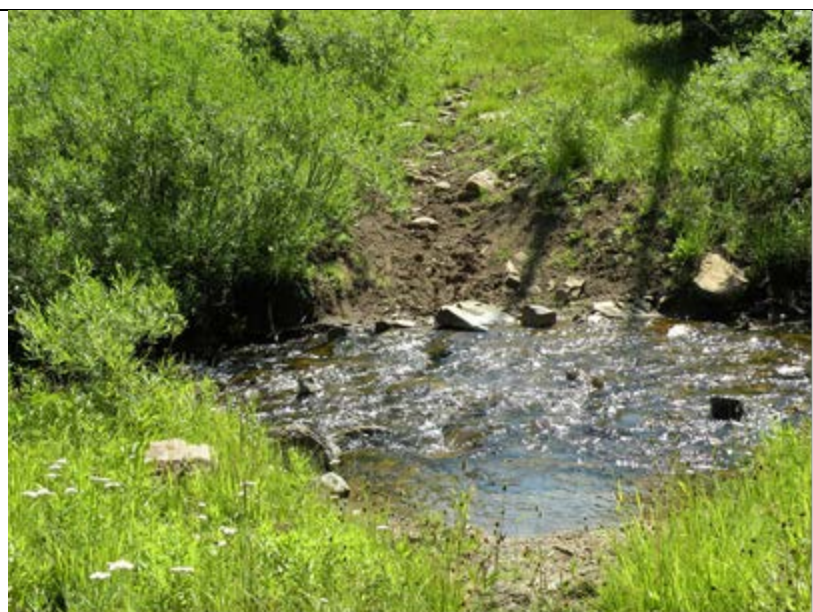
At OD 7, minor bank degradation was present at the two stream crossing areas, with one of the crossing exhibiting revegetation. Minor sediment contributions to the stream are derived from these trampled areas. However, there were no rills or gullies observed and there was no observable bimodal sediment distribution of stream substrate, which would indicate an unusually high percentage of fines for this mountain stream. Adjacent uplands were in good health with a well-distributed groundcover of broadleaf forbs and grasses (Figure 18). The driveway crossing at OD 8 was in good shape and had not been recently used and no rilling or gullies on adjacent uplands were noted. Photographs were not taken at this site.

**Figure 18. Driveway Crossing at OD 7**

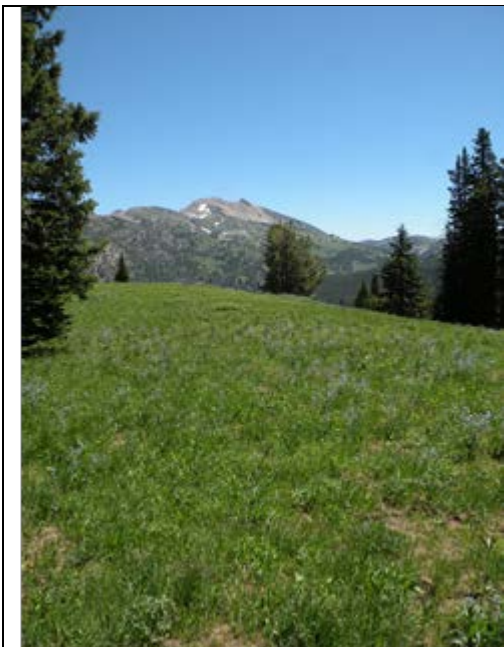
Observed surface conditions ranged between Condition Classes 1 and 4. No evidence of desertification was observed in the field. The range of total percent cover varied from 0-95, with an average cover of 64 percent. Nine total GPS points were taken. Uplands were remarkably consistent in vegetative cover. No sources of upland erosion, consisting of rills and gullies were noted. Surface Condition Class is estimated to between Condition Class 3 and 4 for the grazing area except for the road to for the observed bedding areas and the road to Blair Lake. Some evidence of overland flow was noted in association with melting snow fields and was confined to within 50 feet of these areas, and no erosional features were noted in association with the melt

**Figure 19. Views of Uplands in Tom's Creek Grazing Area**

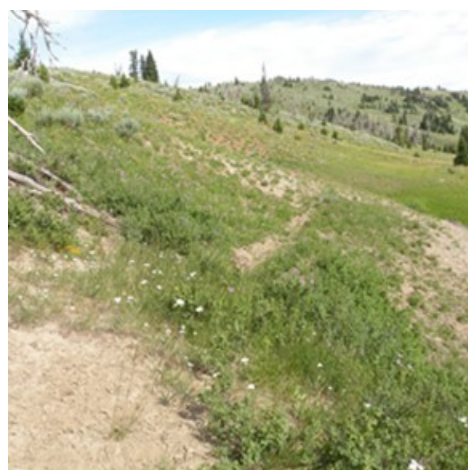
One area of uplands was of special interest, which is located at the head of the North Fork of Tom's Creek, which has been an area of past debate (Figure 20 and Figure 22). This area burned by a forest fire sometime between 1880 and 1930. Burned trees still stand and charcoal is still found in upper portions of the soil horizon. Slopes tend to be steep (over 10%) with poor site productivity (Jacobson, 2009a). Past debate has been regarding supposed over-grazing practices by ARS. This area was reviewed with ARS, Soil Conservation Service personnel and University of Idaho staff to review upland conditions. ARS notes on the meeting state: "Soil Conservation personnel believe grazing abuse by the Sheep Station had not occurred, that the site was as good as could be expected, that no current erosion was occurring, and the overall trend was up" (Jacobson, 2009a).

**Figure 20. Vegetation and Recovery of Trailing, East Portion, North Fork Tom's Creek (Bighorn Dolomite Area)**

In 2009, field work was conducted again to assess this area (Fryxell, 2009). The eastern portion of this headwater supports a consistent vegetative cover, which is being re-established after grazing by both historical and ARS grazing. Relict trailing was noted, but trails are re-vegetating throughout this portion of the headwaters (Fryxell, 2009, Figure 20). This area is designated as Unit 8 Tom's Creek grazing area (Eastern Summer Range) and has had only incidental grazing since 1994 (Jacobson, 2009a, Moffet, 2009). The 2009 field inspection revealed no evidence of rilling or gullies but evidence of naturally occurring soil creep was, as indicated by trees and snags leaning into the hillslope. Soils are stony and provide a notable measure of cover. This portion of the headwaters is underlain by the Cambrian Bighorn Dolomite.

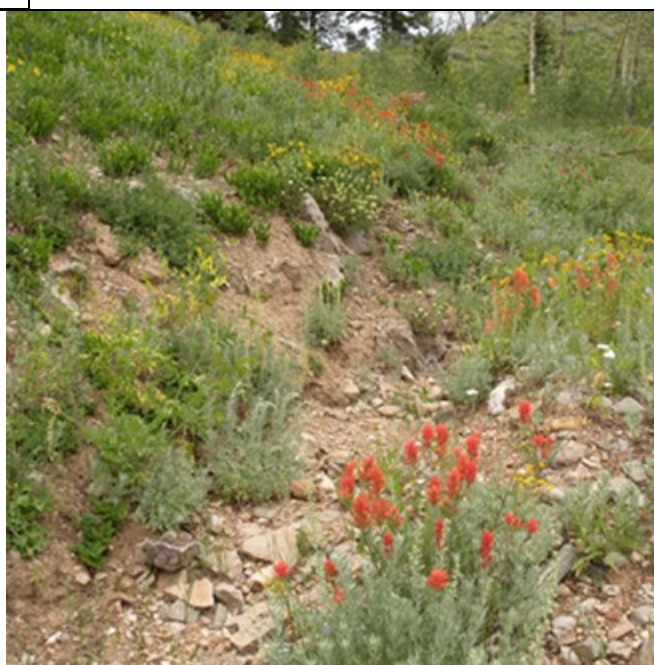
**Figure 21. Views of Intermittent Drainage, North Fork Tom's Creek, Park Shale Area**

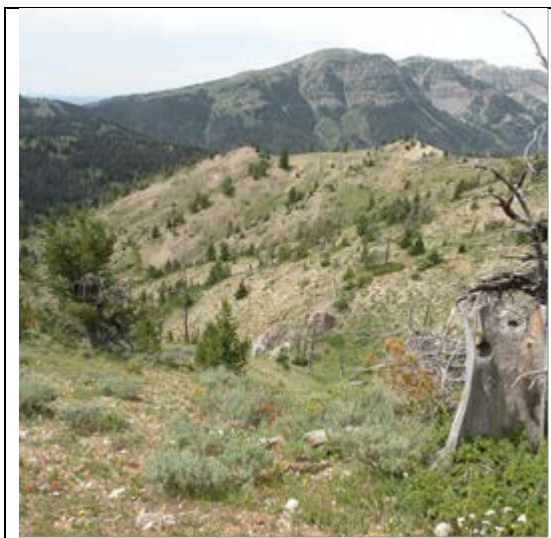
To the south, an abrupt and dramatic change in vegetative cover was observed, as vegetation becomes largely absent on the uppermost and steepest portions of the western half of these headwaters (Figure 21). On the lower portions of this area, where slope gradients are shallow vegetative cover becomes consistent and lush. Trees are sporadic in both the northern and southern portions of these headwaters due to poor site productivity. This area is underlain by the Cambrian Park Shale, which overlies the Bighorn Dolomite (Moffet, 2009, Fryxell 2009, Witkind, 1976). Even though cover is largely lacking there was no observed evidence of overland surface flow, rills, gullies or mass movement. To the north and west additional trailing was noticed, but as mentioned above these areas are now green due to revegetation. The North Fork of Tom's Creek appears to be ephemeral to intermittent. Channel definition increased in a downstream direction, reflecting increased flow volumes. The channel was classified as a Rosgen A3<sup>1</sup>, characterized as a steep, entrenched, cascading, step pool stream, in proper functioning condition. Uplands were not observed to be eroding or contributing excessive amounts of sediment (Fryxell, 2009).

**Figure 22. View Looking West to Area Underlain by Park Shale, West Half of North Fork of Tom's Creek**

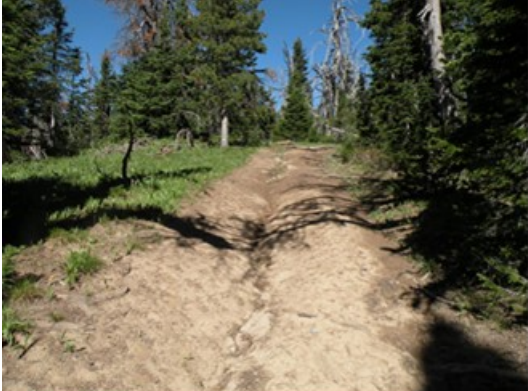
development were observed (Figure 23). Near the ARS/Forest Service boundary, minimal slash is in place but has not been effective in diverting water from the road. Erosion and gully development are the most severe near the end of the road where there is a 15-20 percent grade. Ruts and gullies are one to three feet in depth. An area of at least 1,000 ft x 10 feet by 3 feet is estimated to be involved (Figure 24). Areas adjacent to the road are used to drive the sheep down to the stream, where they cross on their way to Blair Lake.

| <p><b>Figure 23. Road Ruts on Road to Blair Lake</b></p> | <p><b>Figure 24. Road and Erosion, Lower portion of Road to Blair Lake</b></p> |

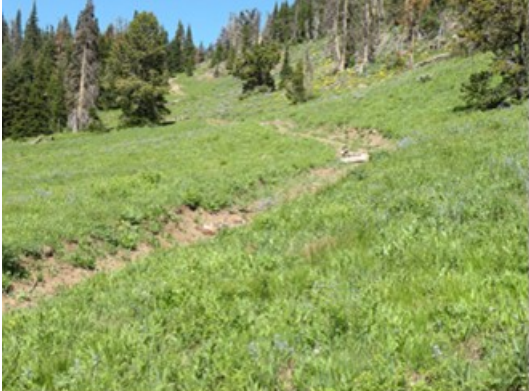
The road ends near a Rosgen A4 type stream (Rosgen, 1994). The road has functioned as a long term chronic source of sediment to this channel. Based on the proximity of the road to the channel and the contributions of sediment over time, this stream received a functional at risk rating. There are no water developments in this grazing area.

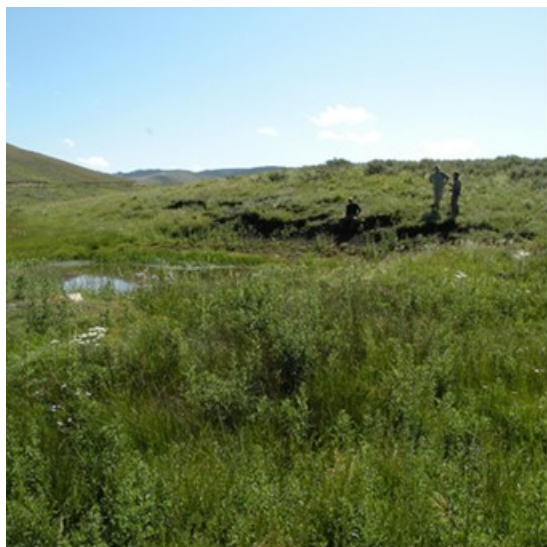
**Figure 27. Disturbance around Watering Pond**

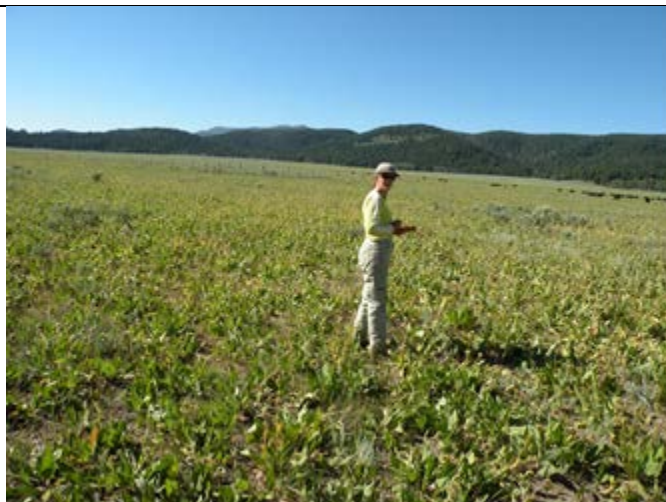
In several areas, desert-like pavement, consisting of a gravelly surface, was present. These areas lacked any vegetative diversity and consisted of only arrow leaf balsam root (Figure 32). The very low gradient surfaces may lend

**Figure 32. Arrow Leaf Balsam Root Field, Henninger Ranch**

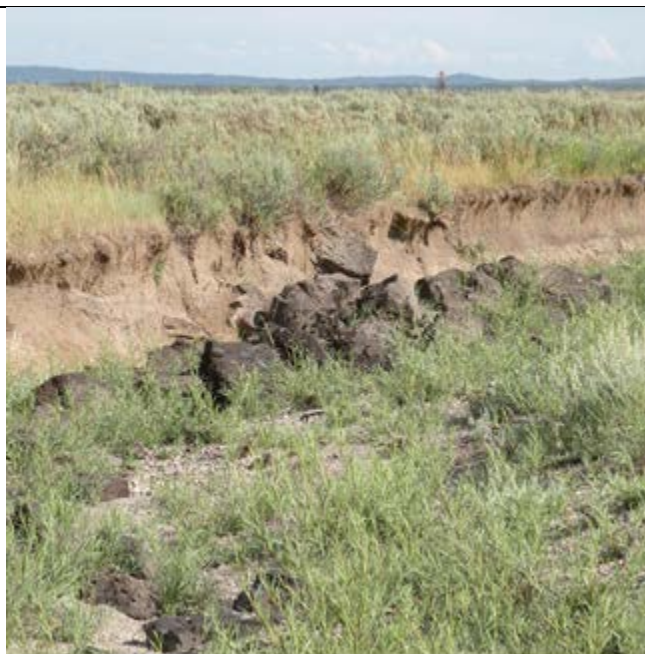
**Figure 33. Historical Rip-rapping, Dry Creek, Henninger Ranch**

themselves to the effects of wind erosion (Moser and Fryxell, 2008). Two PFC surveys were conducted at this property on Moose and Dry Creeks. Both received ratings of Functional at Risk due to flow diversion and rip-rapping.

Irrigation practices were ongoing at the Ranch prior to the purchase of the property by ARS, and a well-developed network of irrigation ditches is still present today (Jacobson, 2009a). The remains of an historical head-gate, located in the channel proper, are still present. Additional historical management of the channel is evidence by rip-rapping (Jacobson, 2009a). The rip-rap has been there so long that portions of it have become entrained as part of the channel bedload and pieces are found deposited within the channels banks (Figure 33).

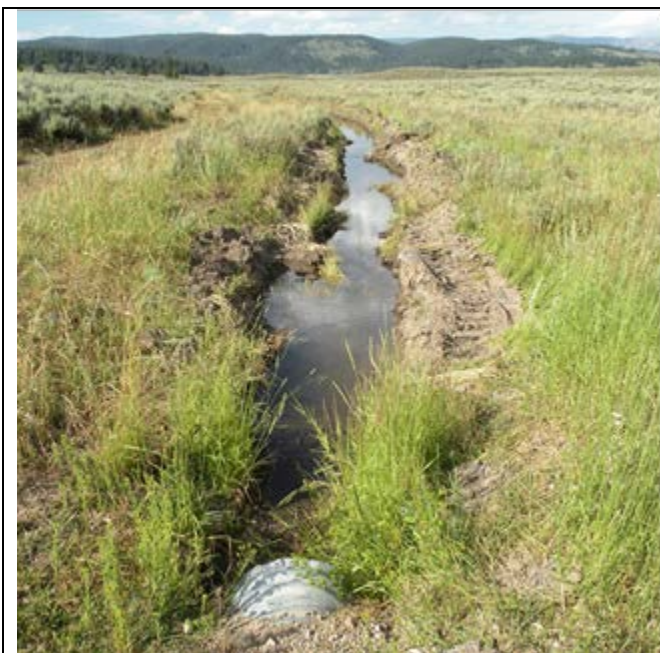
Much of the rest of the grazing area is covered by sage brush and underlain by basalts, resulting in little natural surface expression of water. The major drainage that does exist on the property is Dry Creek, which was classified as a Rosgen C4 channel type (Rosgen, 1994). A PFC survey was conducted, and a rating of Functional at Risk (FAR) with no apparent trend assigned. The FAR rating was due to alteration of channel flows due to irrigation that includes ditching, past agricultural practices, historical rip-rapping of the channel, possible influences related to the main road leading into the property.

**Figure 34. Ditching and Maintenance, Henninger Ranch**
