**ARS Field Station  
Lake Dam Rehabilitation  
Environmental Assessment**

**Woodward, Oklahoma**

**December 2019**

Rehabilitation of the ARS Field Station Lake Dam to meet NRCS high hazard dam and Oklahoma Water Resources Board safety criteria.

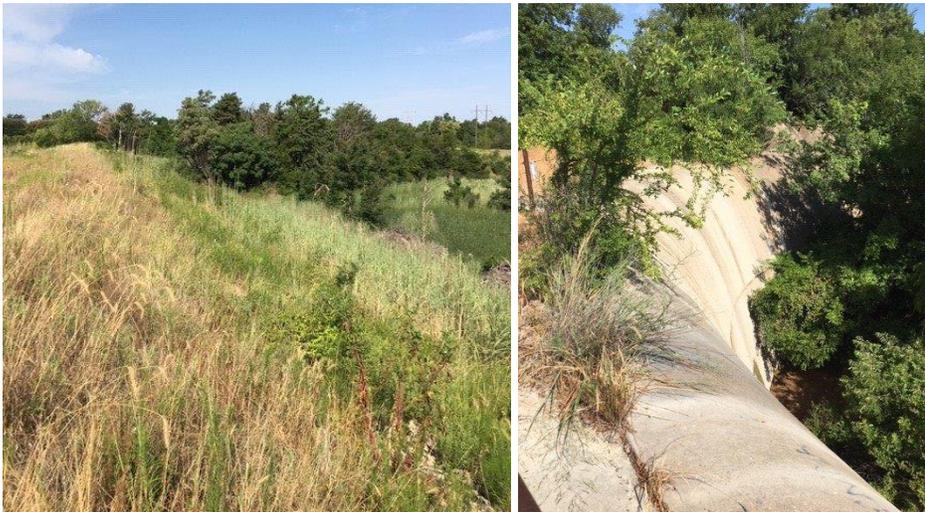
Figure 2. Existing Dam shown on left and Auxiliary Spillway with Vegetation on right

Under the “No-Action” alternative, the Field Station Lake Dam and associated features would be maintained as-is with no further improvements (Figure 2). Under this alternative, the ARS Field Station would be unable to resolve existing structural issues; meet the NRCS high-hazard dam criteria and OWRB safety criteria; provide capacity in the spillway to safely pass the PMF; or allow for lowering of lake levels in the event of a dam safety emergency.

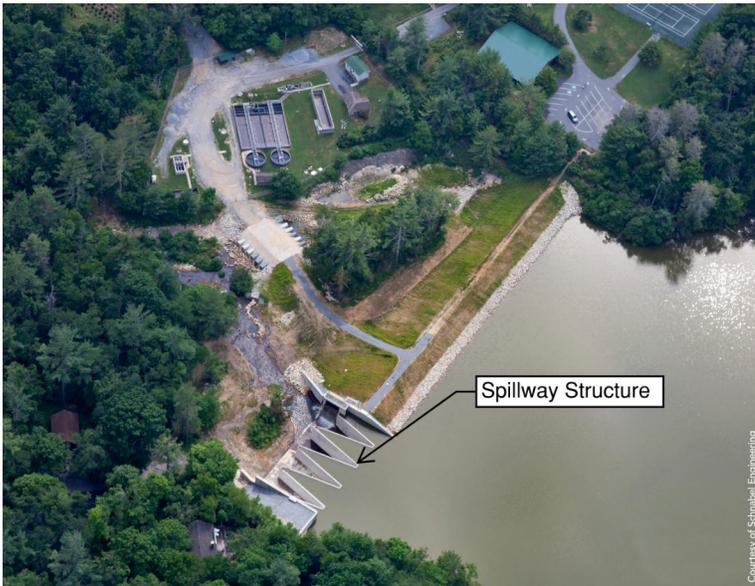
Figure 3. Labyrinth Spillway Located at the Abutment

Additionally, dense brush and woody vegetation would be removed from the dam and spillway. The existing crest of the dam would be graded to a constant elevation of 1985.0 feet and a width of 14 feet, and the downstream slope would be flattened to 2.5 feet horizontal by 1 foot vertical (2.5H:1V). An embankment filter and drain system would be installed to filter and collect seepage and the upstream slope near the normal pool elevation would be regraded and covered with riprap. Turf grass would be established on all disturbed areas outside of the proposed spillways and riprapped areas.

For this alternative, the existing concrete spillway control section would be demolished and removed from the site to create an outlet channel for the new spillway.

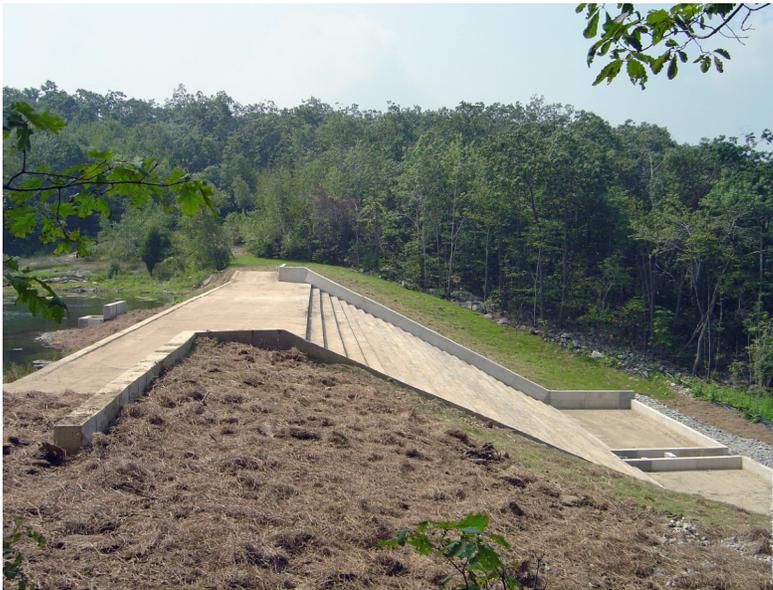
Figure 5. RCC Auxiliary Spillway Over the Embankment.

Use of the existing spillway location was evaluated and ruled out due to the presence of power line easements downstream; sandy soils within the spillway would not tolerate high stresses; and due to site topography, the spillway would need a curved outlet to direct water back into the main stream channel. Therefore, the existing auxiliary spillway would be abandoned in this alternative, and a new spillway constructed to maintain base flow and pass relatively frequent flows. A stilling basin would be provided for energy dissipation.

A reinforced concrete principal spillway would be required to pass flows up to the 10-year (10 percent storm) flood, above which there would be flow in the RCC auxiliary spillway. The principal and auxiliary spillways would be sized to have crest elevations of 1973.3 and 1977.5 and weir lengths of 50 and 415 feet, respectively. This meets the criterion to pass the PMF without overtopping the remaining portions of the embankment.

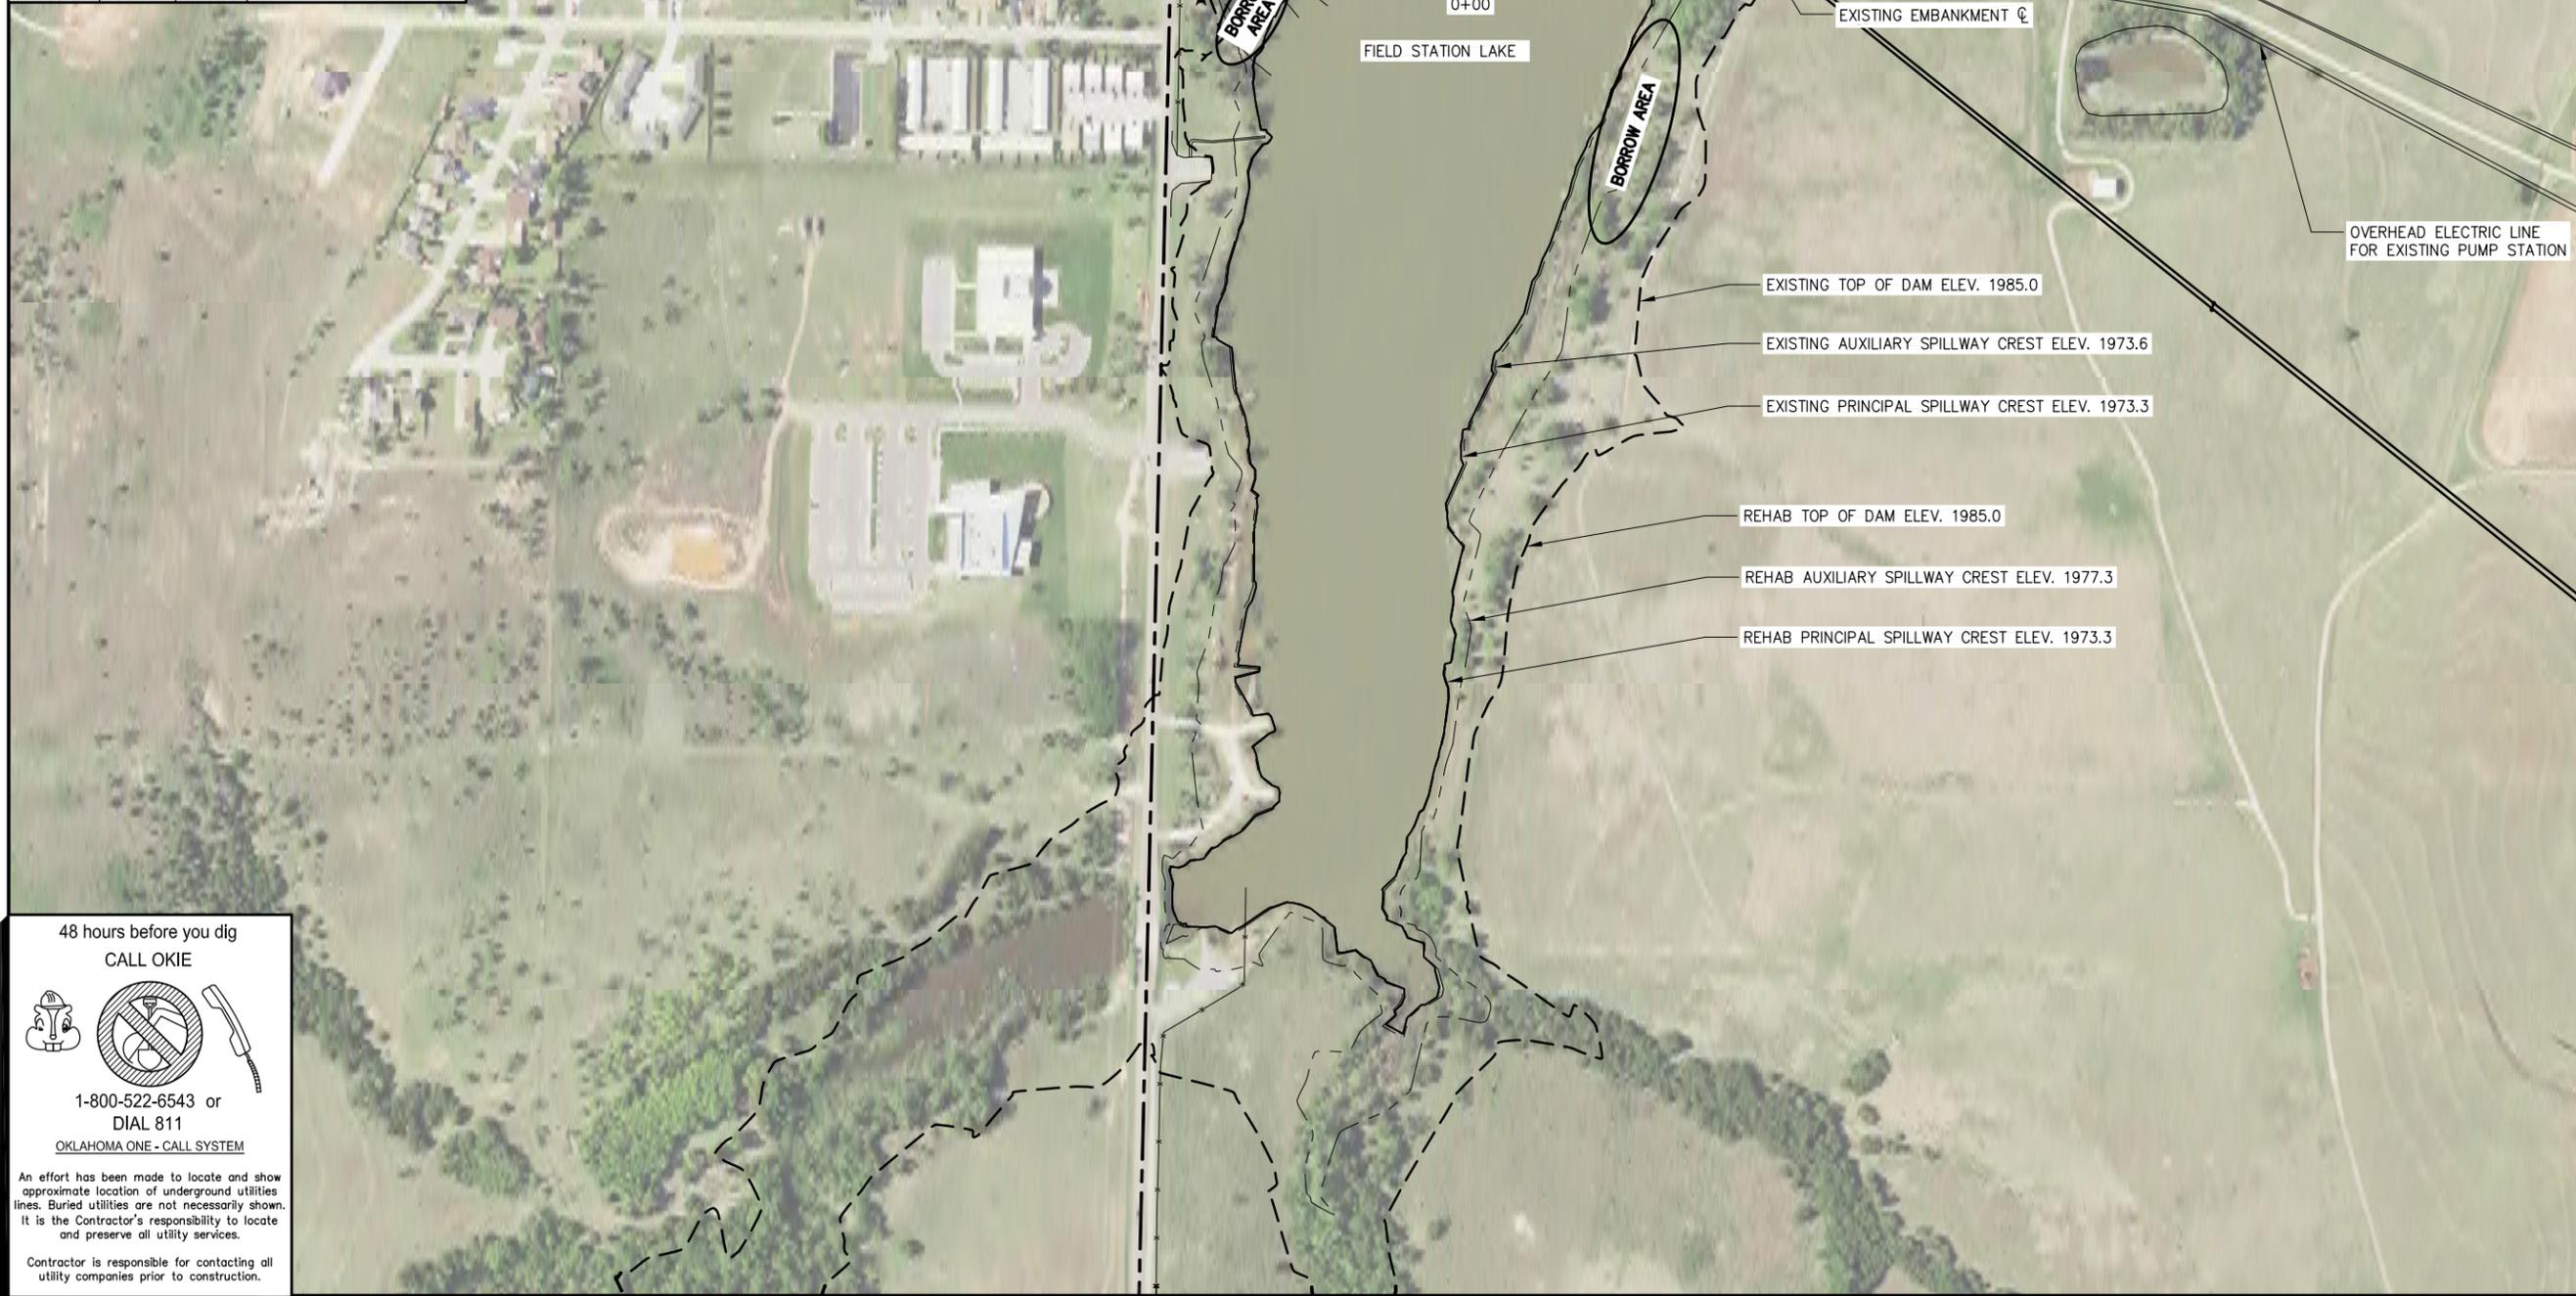
Sheet 01 of 36

REHAB STORAGE TABLE			
ELEVATION	ACRES	AC FT	LOCATION
1956.0	0.00	0.0	
1960.0	5.05	5.8	
1962.0	9.88	21.9	
1964.0	12.94	44.5	
1966.0	16.62	74.1	
1968.0	19.42	110.2	
1970.0	22.24	151.7	
1972.0	26.51	200.7	
1973.3	29.23	236.83	PRINCIPAL SPILLWAY CREST
1974.0	30.92	272.5	
1975.1	33.09	307.8	
1976.0	35.33	355.4	
1977.3	38.98	403.7	AUXILIARY SPILLWAY CREST
1978.0	40.72	451.1	
1980.0	46.37	538.3	
1982.0	51.26	635.9	
1984.0	66.39	757.5	
1985.0	69.85	825.65	TOP OF DAM
1986.0	73.86	897.5	
1988.0	83.67	1054.9

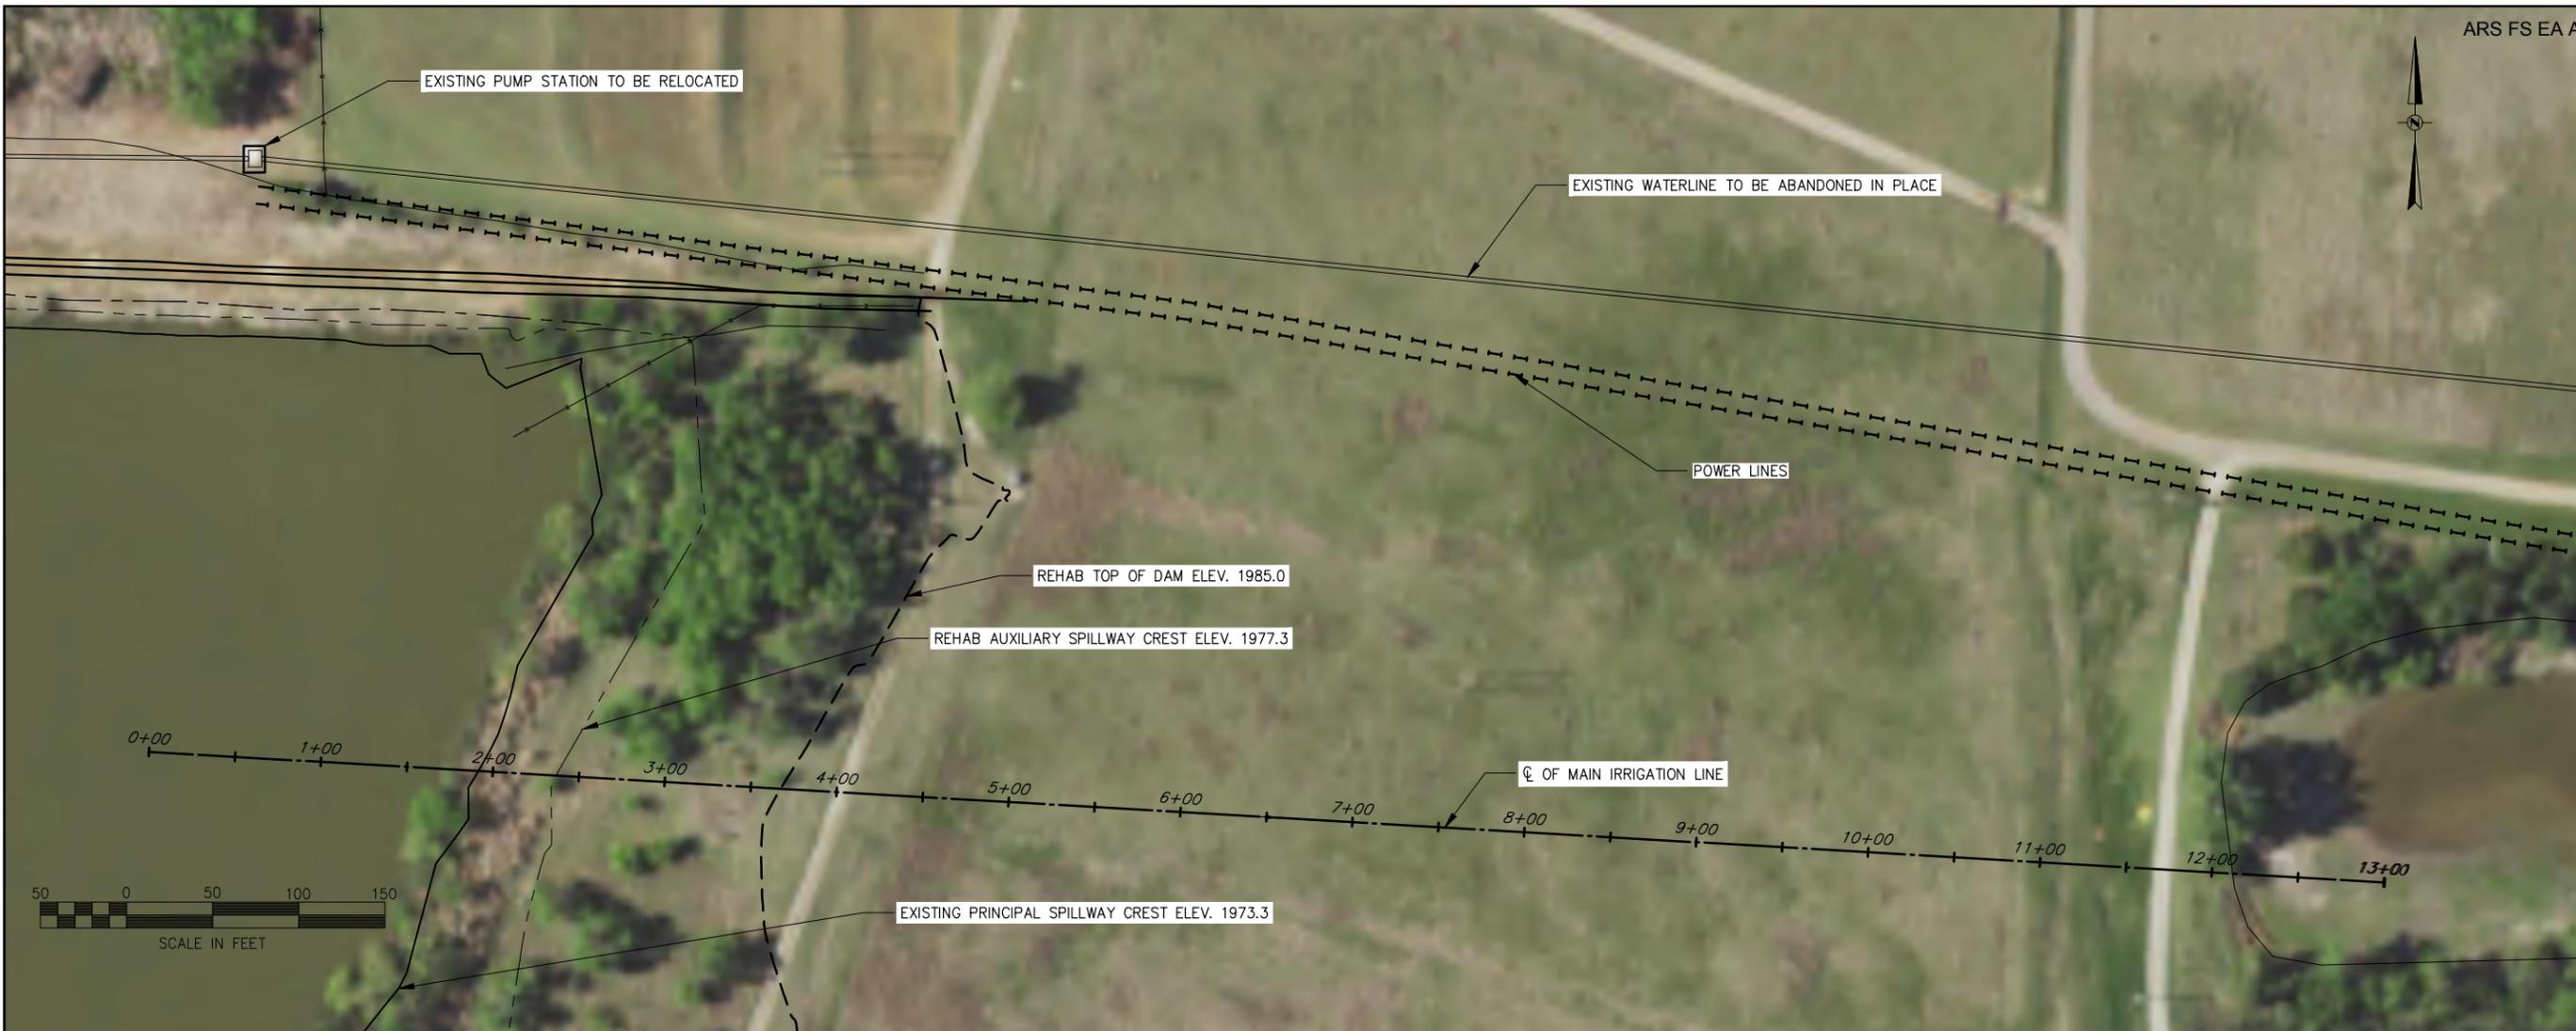
Drawing No.  
**OK-437**

PLAN

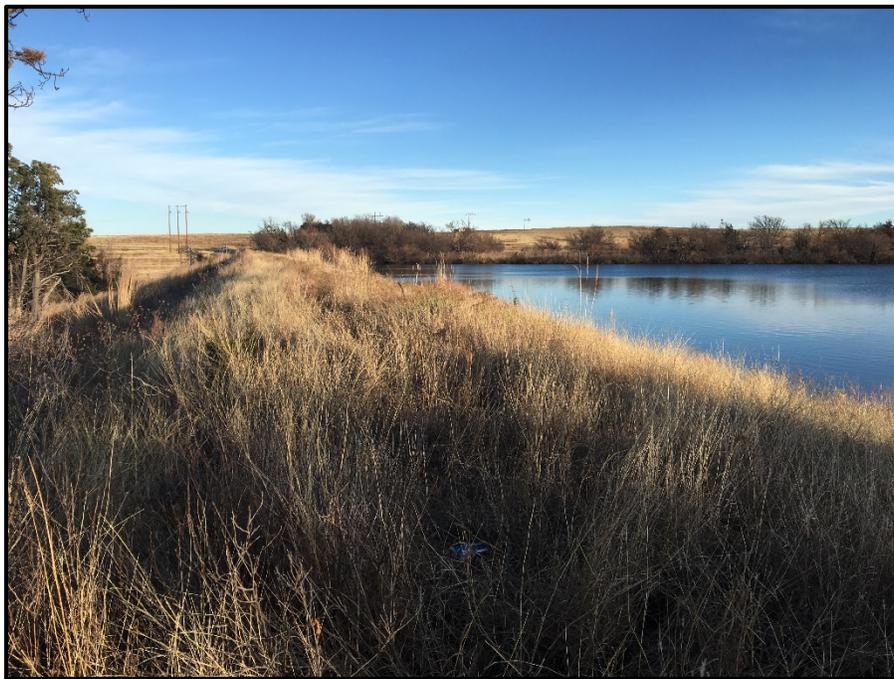
Figure 3. Field Station Lake Dam, View Looking East.

The downstream channel is also currently overgrown with trees and other vegetation. Erosion of soils is evident on the top of the eastern retaining wall as well as behind the wall (Figure 9). The lake, currently used for irrigation as well as recreational purposes, features grasses and other vegetation along its shores (Figure 10). Although the spillway is experiencing some issues such as erosion of soils and spalling and the dam is overgrown with vegetation, the dam and the spillway still retain a high degree of architectural integrity.

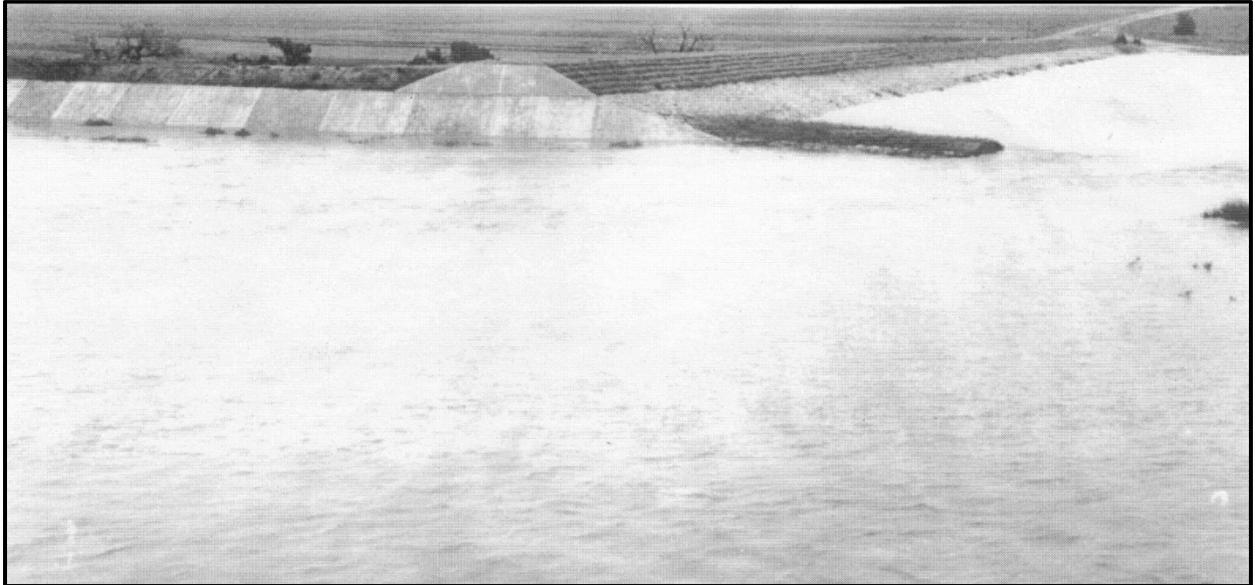
Alternative 4: RCC Auxiliary Spillway and Reinforced Principal Spillway - Effects on this resource concern would be the same as Alternative 2.

The Field Station Lake Dam, which is the focus of the current architectural survey, began construction at the end of 1938. While census records are not specific, 36 people are listed as employed in dam construction in 1940 and include laborers, pack hammer men, engineers, inspectors, foremen, truck drivers, and guards (United States Federal Census 1940). It is likely that crews overlapped with the building of the Fort Supply dam (see above). The dam was constructed for irrigating the grasses, in particular, at the experimental station as well as other grains and plantings. Siting for the dam was along Spring Creek to the northwest of the main experimental station complex and was designed to impound up to 50 acres of water (Figures 18 and 19). The dam, in the initial planning was intended to be approximately 40 feet in height and 1,000 feet in length (Woodward County Journal 1938). The dam still functions in its original capacity and along with a retention pond (see Table 1), supplies water to the experimental station for the grasses as well as provides recreational opportunities for the community of Woodward.

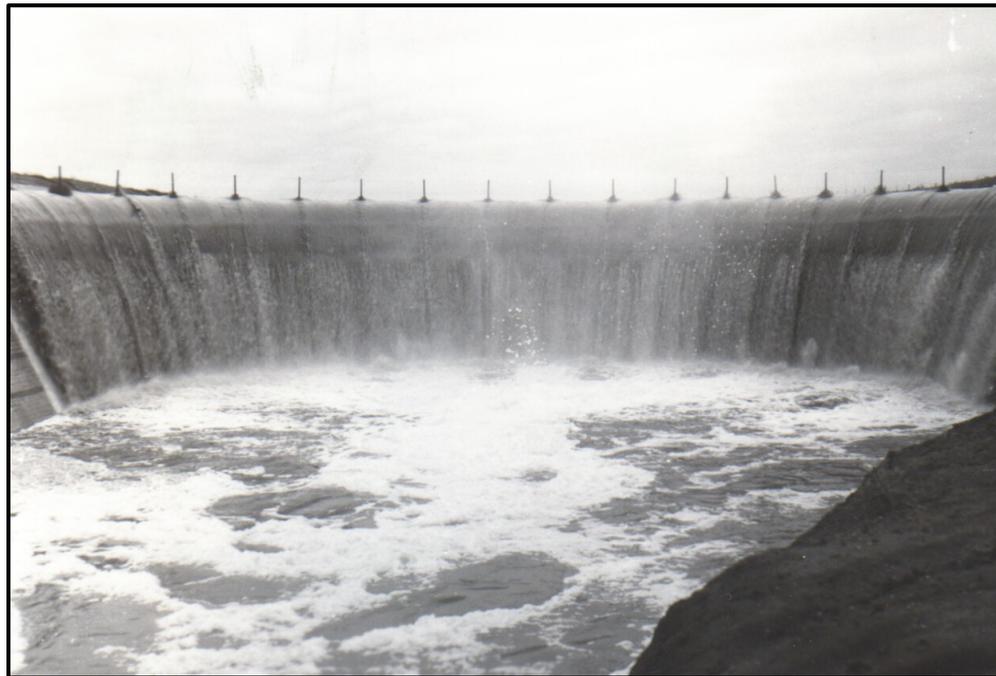
**Figure 19. Photograph of Field Station Lake Dam (date unknown) (Source: Southern Great Plains Research Station Collection).**
