# Effects of traffic on soil physical characteristics and vegetative resources of the NATIONAL MALL

G.B. Runion, H. H. Rogers, C. W. Wood, S. A. Prior, and R. J. Mitchell

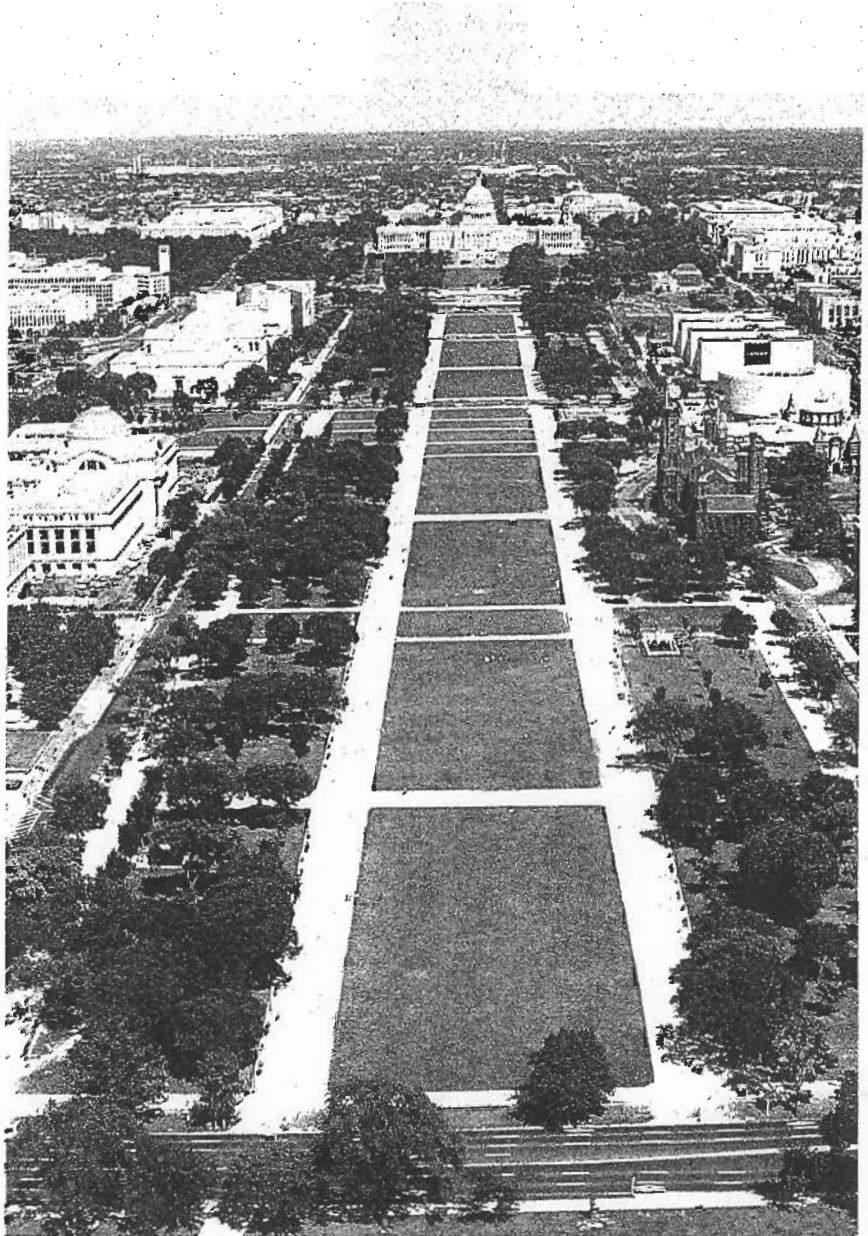
*Photograph of the National Mall taken from inside the Washington Monument. Panels in the center of the Mall contain grass, while panels on the left and right contain elm trees and groundcover (predominantly grass). All study panels were located on the Washington Monument end (bottom of photograph) of the Mall. Festival exhibits (high traffic) occupied the second and third left-hand and first right-hand elm panels; control plots (low traffic) were located in the first and second right-hand elm panels.*

Plots were established within six panels on the National Mall; a panel is an area bounded by sidewalks and access roads containing trees and/or grass. Three of these panels were occupied by exhibits for the Smithsonian's festival and were designated as high traffic areas; the remaining three panels, all low traffic areas, did not contain Festival exhibits but were adjacent to Festival panels. Within each panel, six trees were arbitrarily selected as plot trees.

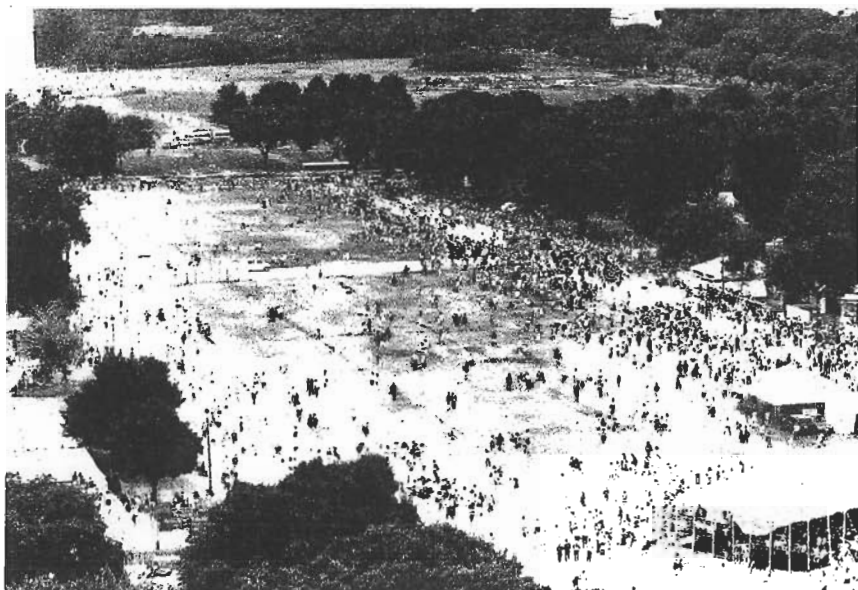
**Photograph of the National Mall showing pedestrian use during the 1990 Festival of American Folklife.**
