DESIGN OF LARGE WOODY DEBRIS STRUCTURES FOR CHANNEL REHABILITATION

**F. Douglas Shields¹, Jr., Research Hydraulic Engineer; Nathalie Morin, Research Assistant; and C. M. Cooper, Supv. Ecologist
USDA-ARS-National Sedimentation Laboratory, Oxford Mississippi.**

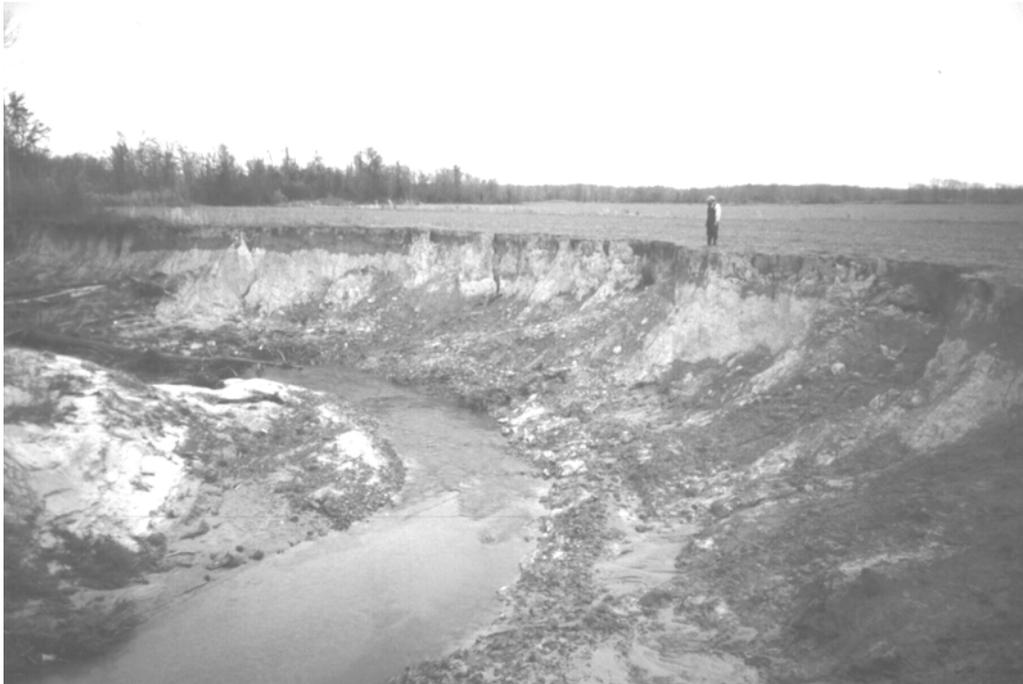
Figure 1. Typical bank erosion in study reach, 1999.

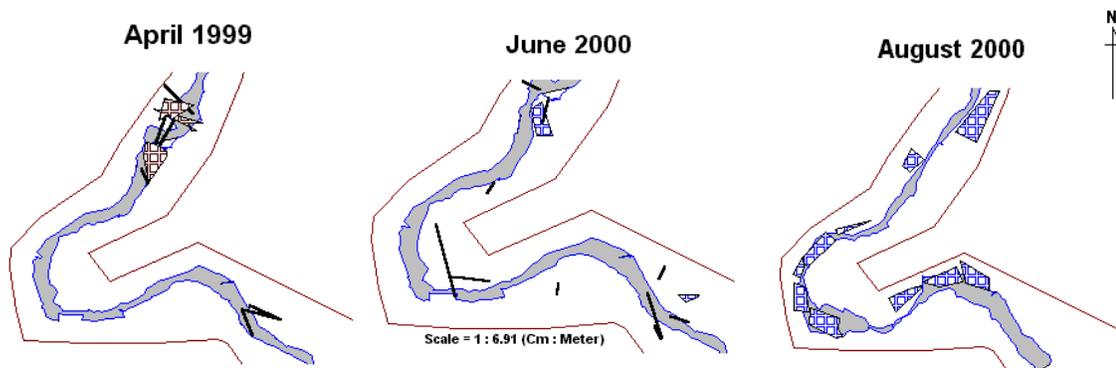
Figure 2. Map of selected segment of study reach showing top banks, water's edge at base flow, LWD formations and individual logs (April 1999 and June 2000) and LWDS (August 2000).

About 1500 m of eroding banks were selected for LWDS protection. LWDS were constructed using either woody debris (~10%) or living trees (~90%) harvested from designated areas including the channel. Living trees were larger than 200 mm diameter at breast height (DBH). Living trees were harvested by grubbing in order to retain root balls and crowns intact. LWDS were constructed by stacking trees as shown in Figure 3. Members running across the flow direction (“key members”) were ~9 m long and were keyed into the bank toes when bank slopes were gradual enough to permit key trench excavation. LWDS crest elevations were specified as either 2.4 m or 3.6 m above the adjacent streambed based on eroding bank height and channel alignment, but constructed LWDS were slightly lower. An average of 16 trees were used per LWDS. Structures were spaced to create nonuniformity, which is valuable for physical habitat recovery (Shields *et al.* 1998b), but aligned to enhance log stability and sediment deposition. In general, structures extended about 15 m in the streamwise direction, about 5 m transverse to the stream, and were spaced about 14 m apart. About one LWDS was constructed to protect each 20 m of eroding bank (Figure 2), which represented an order of magnitude increase in LWD loading.

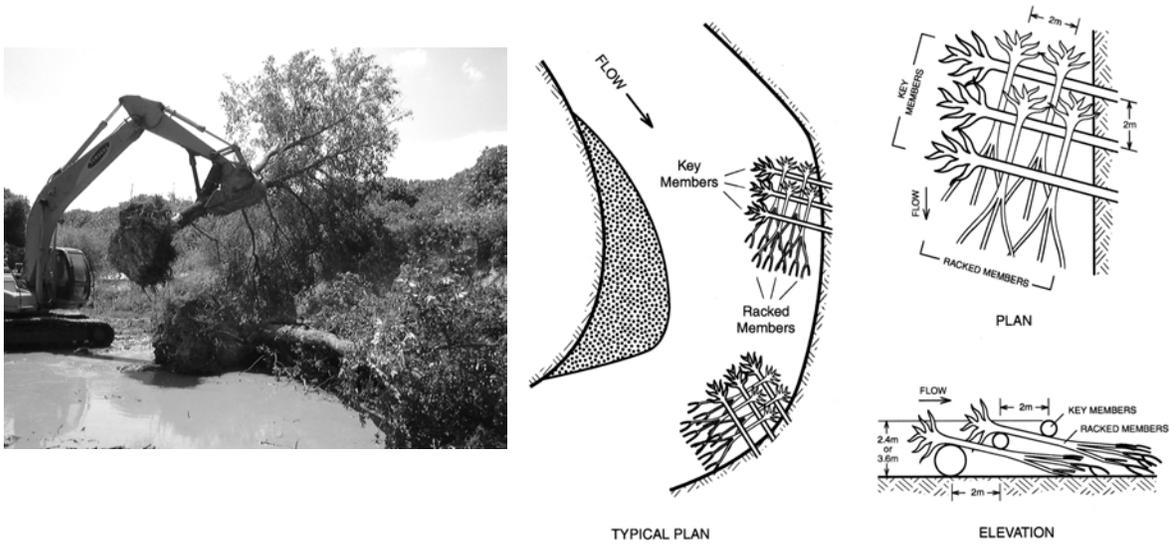
Figure 3. Typical plan and elevation of large woody debris structures. Inset photo shows LWDS under construction.

Design of LWDS was based on concepts from Edminster *et al.* (1949), Mott (1994), Abbe *et al.* (1997), Derrick (1997) and others adapted to our region (Figure 3). Structures simulate stable configurations of naturally-occurring debris (Wallerstein *et al.* 1997). Bed material gradations and thalweg profiles were available for design, as were limited cross-section survey data collected in 1997 and 1999.

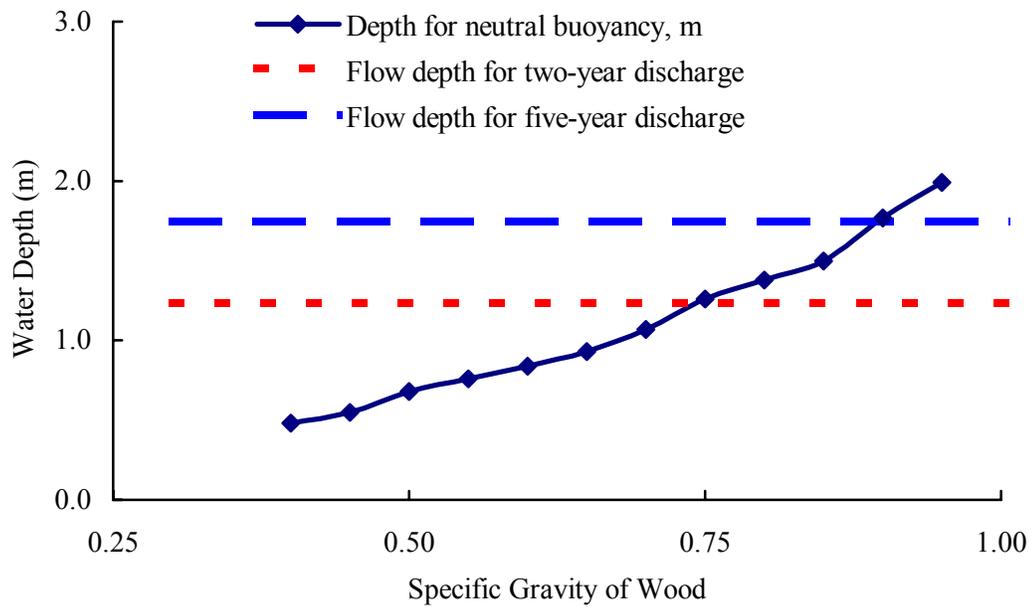
Figure 4. Flow depth required for buoyant force on large woody debris structure to equal weight of wood as a function of flow depth.

These depths were compared to those predicted by a steady flow model (Copeland *et al.* 1998) for typical cross sections using discharges determined for the two- and five-year return interval events using regional regression formulas (Landers and Wilson 1991). Results (Figure 4) indicated that LWDS stability is sensitive to wood density. Flow depths for frequent events are not adequate to submerge the upper portions of the structure, where the heavier parts of the members are concentrated. LWDS comprised of typical materials should be stable during frequent events. Discharges equivalent to the two-year event are required to float the LWDS if the specific gravity of wood = 0.75. Buoyant forces will be counteracted initially by the weight of fill in key trenches and by four earth anchors placed on opposite corners of each structure and load tested to a minimum of 4.4 kN. Anchors on opposite corners are attached by 6 mm wire cable. After a few flow events, buoyant forces should also be counteracted by the weight of sediments deposited on LWDS members.
