## **Effect of Large Woody Debris Structures on Stream Hydraulics**

F. Douglas Shields, Jr., Member, ASCE, N. Morin and R. A. Kuhnle, Member, ASCE

Research Hydraulic Engineer, Research Assistant, and Research Hydraulic Engineer, respectively,  
USDA-ARS-National Sedimentation Laboratory, P.O. Box 1157, Oxford, MS 38655-1157  
PH (662) 232 2919; FAX (662) 232 2915; email: shields@sedlab.olemiss.edu

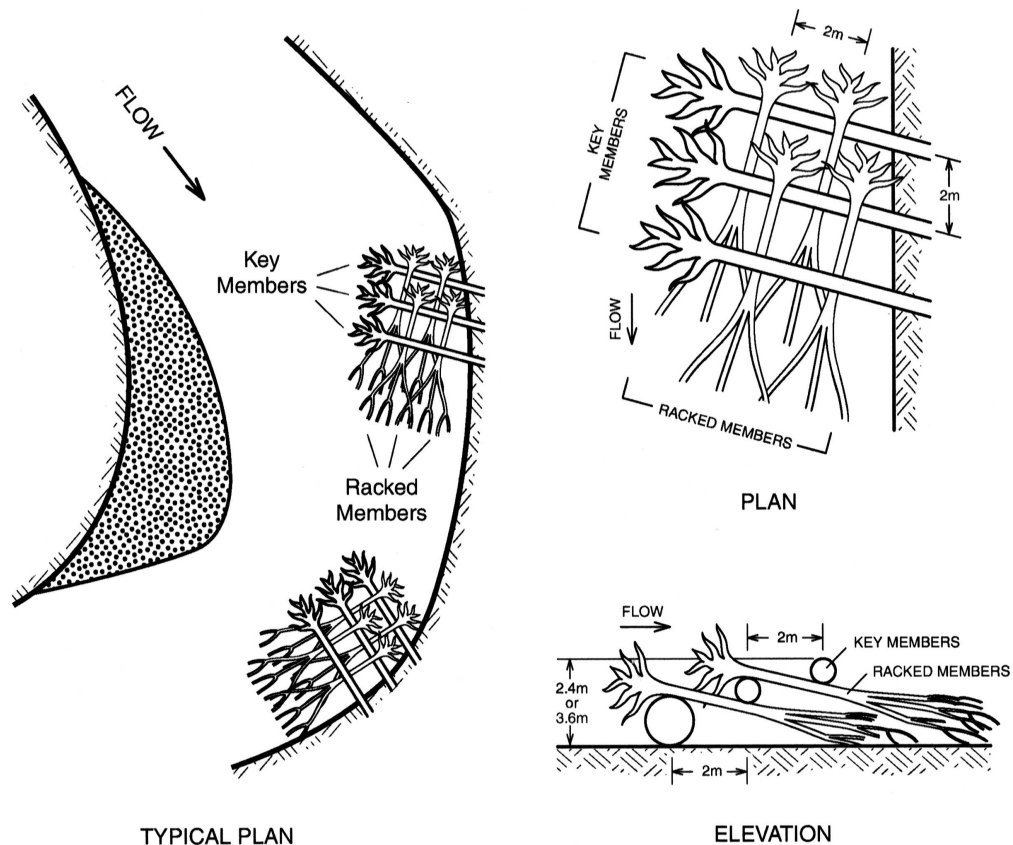
Figure 1. Typical plan and elevation for large woody debris structures.

Structures were built by stacking trees as shown in Figure 1. Members running across the flow direction were ~9 m long and were keyed into the bank toes (buried in trenches excavated in banks) when bank slopes were gradual enough to permit key trench excavation. Crest elevations were specified as either 2.4 m or 3.6 m above the adjacent streambed based on eroding bank height and channel alignment, but constructed LWDS were slightly lower, ranging from 1.1 to 3.2 m high. Structures were spaced to create nonuniformity, which is valuable for physical habitat recovery (Shields et al. 1998b), but aligned to enhance log stability and sediment deposition. Statistics for structure dimensions are presented in Table 2.

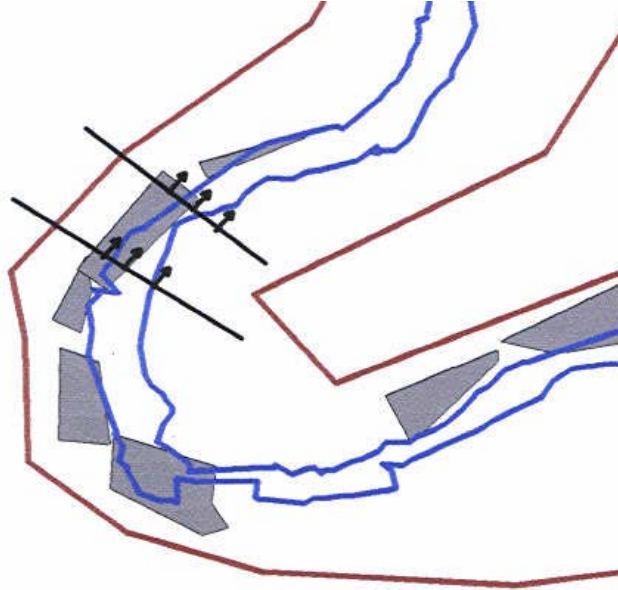
Figure 2. Location of cross sections for monitoring depth and velocity at bend apex. Arrows show approximate location of FADVs. Shaded polygons are large woody debris structures. Cross section 1 is upstream from cross section 2.

Initial impacts of the large woody debris structures on stream flow patterns were quantified using an array of FADVs installed along two cross sections about 7 m apart in the apex of a sharp bend (Figure 2). Similar records of flow depth and velocity were obtained for runoff events before and after construction. The FADVs were programmed to compute and record mean, maximum, and minimum values for each five-minute interval during preconstruction events and for intervals of one, three, or five minutes for events 8-10, 11, and 12-17, respectively, during the postconstruction period. Patterns of scour and deposition were monitored by surveying each of the two cross sections monthly. Annual surveys of the entire 2-km project reach are also underway.

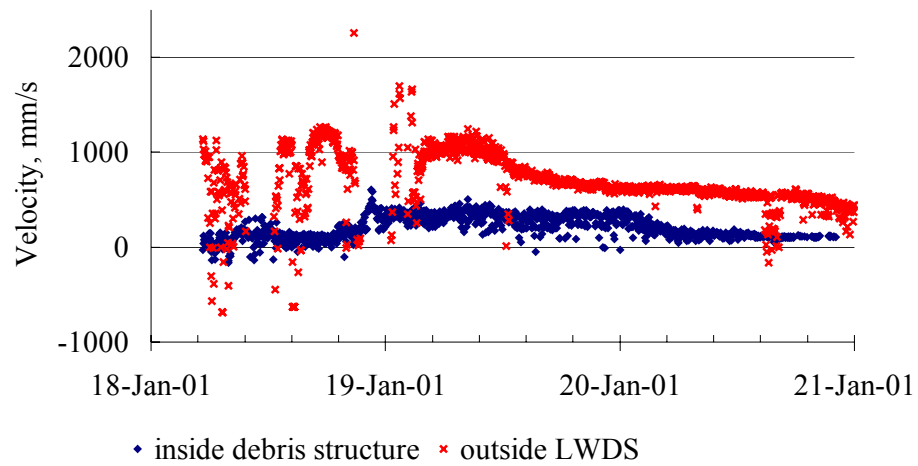
Figure 3. FADV velocity records at cross section 2 during flow event six months after construction.

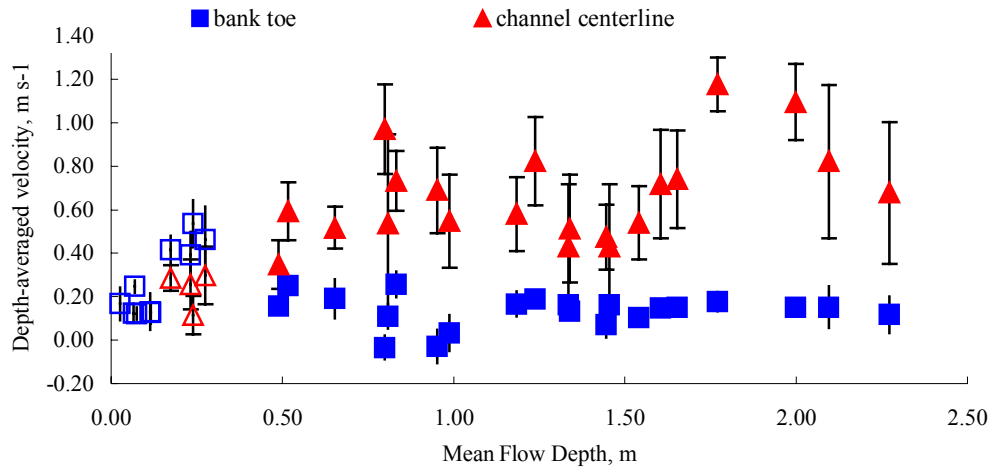
Figure 4. Means of simultaneous near-bed velocities recorded by FADV's within and adjacent to large woody debris structure. Locations for velocity sensors shown in Figure 2. Open symbols are from runoff events prior to woody debris structure construction; solid symbols are from postconstruction events; error bars are  $\pm$  one standard deviation.

FADV data indicated that woody debris structures created conditions conducive to deposition adjacent to the bank toe and within the LWD matrix. Near-bed flow velocities were reduced due to the presence of the structures. Measurements by others indicate that highest depth-averaged velocities in bends occur on the outside of the bend immediately downstream from the bend apex (e.g., USACE 1991, plate B-35). However, following placement of woody debris structures, maximum velocities were displaced away from the bank toe (Figure 3), thus preventing transport of failure blocks of cohesive soil and other sediments from the toe zone (Simon et al. 2000), and scouring deeper pool habitat at the streamward margin of the structure (Gough 1991). Simultaneous records of velocity adjacent to the concave bank toe and at the channel centerline during 10 events prior to construction and 21 events following construction showed that velocities at the bank toe prior to construction were 1.5 times as great as those at the channel centerline, but only 0.03 to 0.45 times the centerline velocity following construction (Figure 4). Mean near-bed velocities within the region covered by the LWDS were  $< 0.26$  m s<sup>–1</sup> while means of simultaneous measurements of velocities at adjacent points outside the debris structure ranged from 0.35 to 1.18 m s<sup>–1</sup>. We estimate that critical near-bed velocity for the median bed material size is  $\sim 0.15$  m s<sup>–1</sup> (Vanoni 1975), and much higher for failure blocks (Simon et al. 2000). Average deposition for the protected regions of the instrumented cross sections (Figure 2) fluctuated during the period of observation, but totaled about 0.4 m for cross section 1, which was located under the higher, upstream portion of the woody debris structure (Figure 5). About 0.2 m of scour occurred within the protected portion of cross section 2 reflecting formation of a small pool.

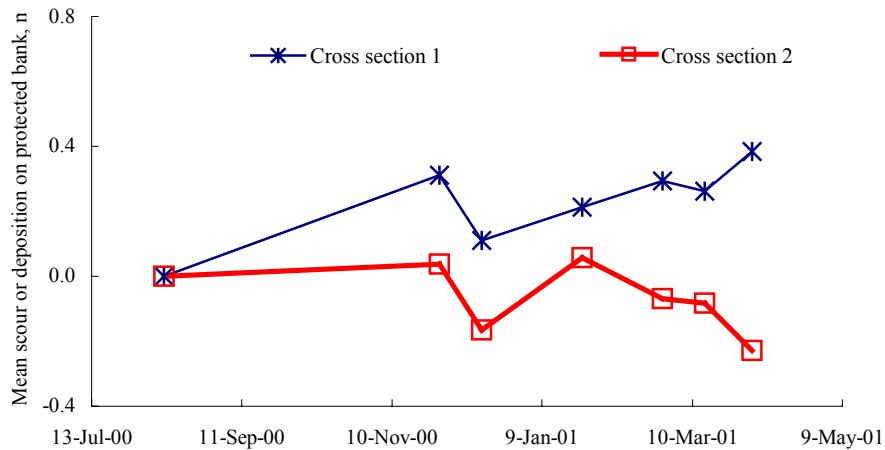
Figure 5. Average scour (-) or deposition (+) for bank protected by large woody debris along cross sections 1 and 2 shown in Figure 2. Scour and deposition were computed for segments of cross section between top bank and approximate streamward margin of large woody debris structure. Initial point (zero) represents conditions immediately following construction.
