CONTROL OF GULLY EROSION USING STIFF GRASSES

F. D. SHIELDS, Jr.¹, S. M. DABNEY², E. J. LANGENDOEN³ and D. M. TEMPLE⁴

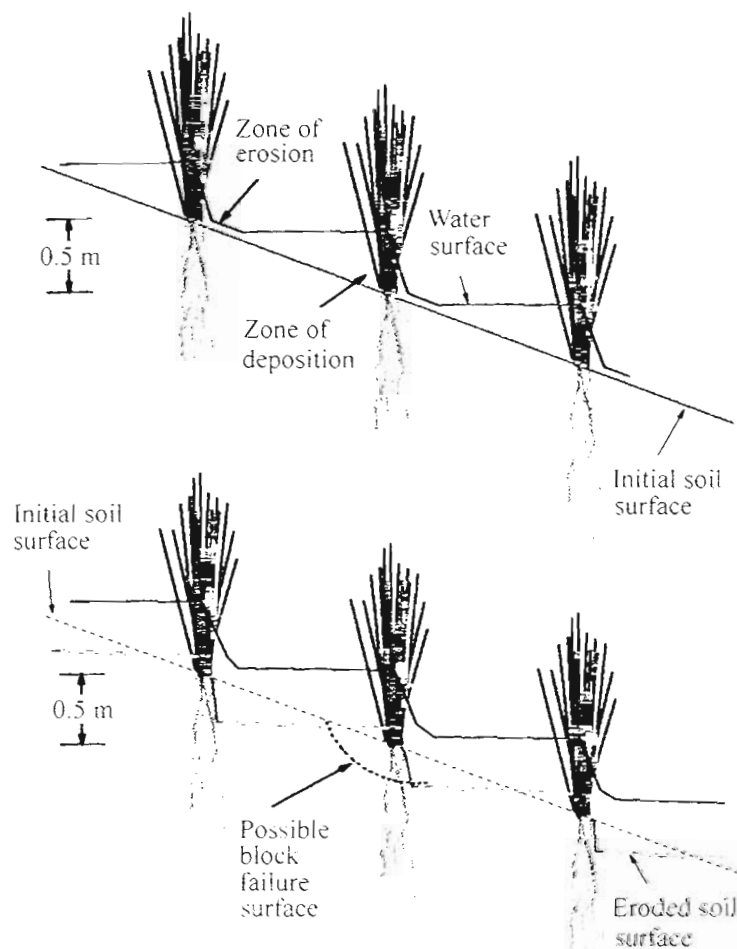
Fig. 1 Schematic of concept for stabilizing a gully with a series of grass hedges placed at vertical intervals of 0.5 m

The success of grass hedges for gully control, however, is uncertain during the period of plant establishment. For example, erosive flow velocities might develop just downslope of each grass hedge whenever backwater effects do not fully cover regions between hedges (Fig. 1). If the hedges are not

destroyed or flanked by erosion, trapped sediment will raise the bed level upslope of each hedge, while erosion lowers it downslope, producing a series of "steps" stabilized by the grass. Slopes between hedges will be reduced so that hydraulic conditions will be non-erosive for all flows. It was hypothesized that during this "mature" phase, the grass roots will likely play an important role in preventing mass failure of the "steps" and in attenuating the scour effects of the reverse roller developed below the overfall.

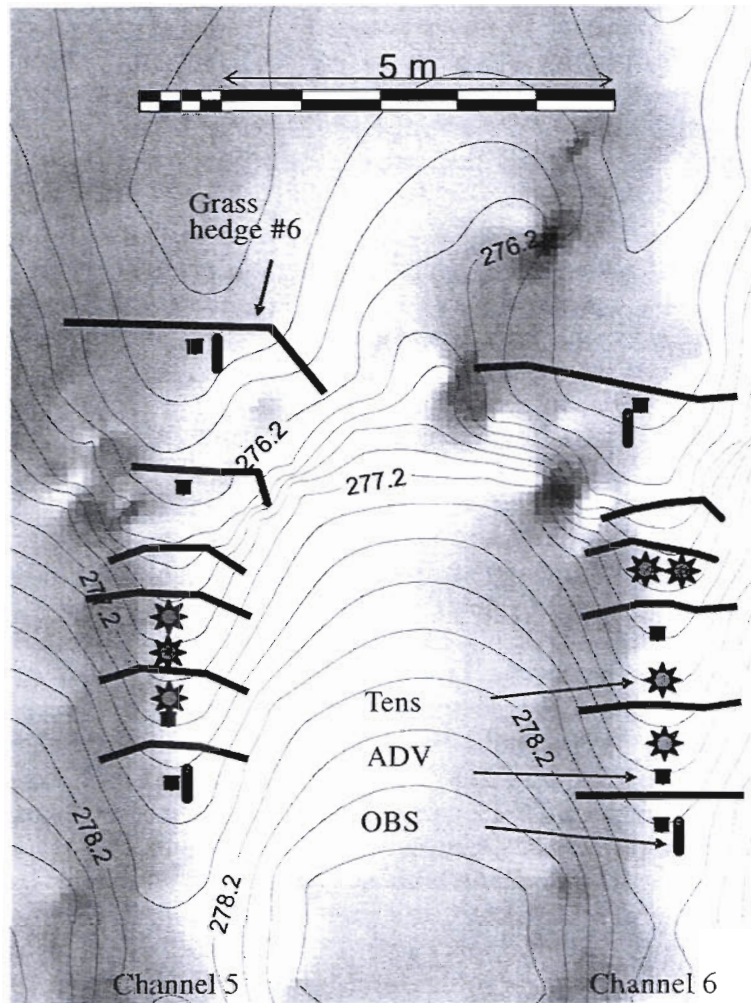
Fig. 2 Shaded relief contour map (0.2 m contour interval) of pre-test conditions of test gullies for Experiment 1, showing the extent of grass hedges, locations of turbidity sensors (OBS), acoustic Doppler depth and velocity transducers (ADV), tensiometer nests (Tens), and pre-existing headcuts at the toe of each gully. Channel 5 = S5, Channel 6 = S6

For Experiment 1, a series of six grass hedges in each of two outdoor test channels (sites S5 and S6) was established at the USDA – Agricultural Research Service (ARS) Hydraulic Engineering Research Laboratory at Stillwater, OK, USA (Fig. 2). These "gullies" were initially constructed as trapezoidal channels with 0.91-m-wide bases and 1H:1V side slopes cut into compacted fill borrowed from the 0.2 to 1.5 m depth of a nearby Pulaski fine sandy loam soil (Coarse-loamy, mixed, superactive, nonacid, thermic Udic Ustifluvents). The channels were built with an average 3H:1V slope. Channels were lined with bermudagrass (*Conodon dactylon* (L) Pers.), and used for simulating erosion of embankment dams subjected to overtopping (Temple and Hanson, 1998). Each channel was tested in 1997 with a flow rate of 1.1 m³/s for 64 to 75 hours, resulting in the formation of a gully with an approximately 1-m deep headcut near each toe (Fig. 2). These headcuts were left to weather in the eroded condition creating regions along the middle portion of the slope as steep as 2H:1V. Switchgrass hedges were transplanted in spring 2000, and protected from flow for two years while the switchgrass became established and shaded out remnant bermudagrass. Runoff was excluded from both Stillwater test gullies during switchgrass establishment, and supplemental irrigation was applied to ensure adequate grass growth. A pool of water was maintained in a depression near the crest of each channel to create a phreatic surface within the underlying soil.

The depth, velocity, and depth-velocity product (VD) presented for Experiments 1 and 2 are the range of time-averaged values recorded by four ADV loggers in each gully (Figs. 2 and 3) during the "peak" discharge. In a given flow event, the temporal variation in flow conditions recorded by a given ADV (coefficients of variation = 11% for depth; 29% for velocity; 31% for VD) was less extreme than the variation between sampling points. This reflects the different conditions immediately above and below individual grass hedges. However, even the variation between the four ADV loggers (Table 3) does not fully reflect the total variation in flow depth recorded with surveys and static manometers (Fig. 5). Flow was characterized by a series of hydraulic jumps. Usually, the jumps began upslope of a vegetative hedge but did not reach their sequent depths until they passed the hedge. Some flow passed through the hedges, but most passed over the top in the jump that cascaded down slope either as free-fall or adhering to bent over grass stems until plunging into the soil surface or a backwater pool created by the next downslope barrier. Water depth was least, and velocity and VD greatest, in the overfall nappe downslope of hedges on steep slope segments.

After Experiment 1, inspection showed that there had been some local scour of soil between hedges 3 and 4 (counted from the top, Fig. 2) in S5 and between 4 and 5 in S6. Both locations were on lower portions of the steepest regions of the gully (~ 2:1, or 27 degrees, Fig. 2). In S5, 3,700 roots/m² were counted protruding from exposed surfaces located about 0.3 m below the plant crown, and the mean root diameter was 0.38 mm, median diameter was 0.1 mm, and root area ratio (ratio of the total root cross sectional area to planar soil surface sampled) was 0.0015. In S6, 2,900 roots/m² were counted protruding, the mean root diameter was 0.69 mm, median diameter was 0.4 mm, and root area ratio was 0.0022. This curtain of exposed roots undoubtedly disrupted the impinging wall jet (Alonso et al., 2002) and reduced local scour during the period of the tests but may not have provided sufficient protection during prolonged flows. This local scour could have been more severe for a less compact, more erodible soil.

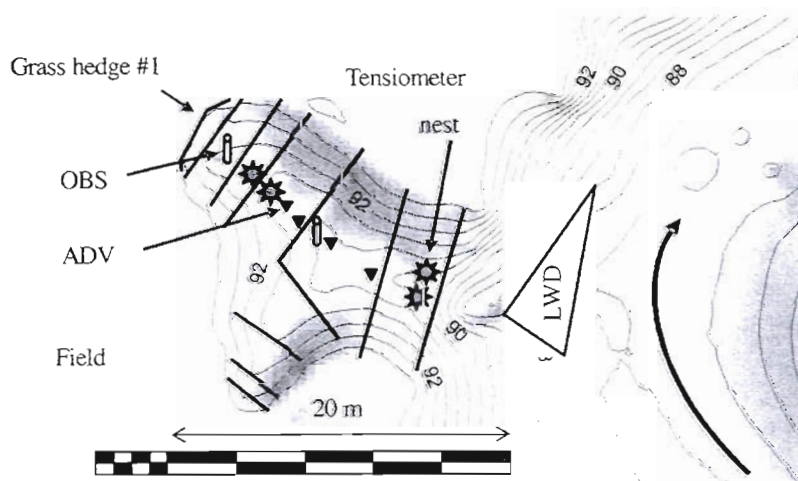
Fig. 3 Shaded relief contour map (0.5-m contour interval) of pre-test conditions for Experiment 2 (site L3) indicating locations of grass hedges, turbidity sensors (OBS), acoustic Doppler depth and velocity transducers (ADV), and tensiometer nests. Flow was introduced into the northern arm of the gully only. The location of a large woody debris structure that trapped creek sediments at the toe (LWD) is also indicated

Gullies tested during Experiments 2 (site L3, Fig. 3) and 3 (site R4, Fig. 4) were natural gullies draining from fields into a sinuous reach of Little Topashaw Creek (33.7457°N, -89.1750°W) in Chickasaw County, MS, USA. At the study location, the stream channel was incised about 6 m into the flood plain, had a top bank width of about 35 m, had a bed slope of about 0.002, and drained a watershed of about 37 km². Adjacent to the study reach, five fields comprising 75 ha were cropped to cotton (*Gossypium hirsutum* L.) and corn (*Zea Mays* L.). The dominant soil type was Arkabutla silt loam (Fine-silty, mixed, active, acid, thermic Fluvaquentic Endoaquepts). Gullies were "shaped" to smooth contours with a track hoe prior to planting hedges of transplanted switchgrass, producing slopes of about 2.5H:1V or more gradual. Shaping of the gully for Experiment 3 (R4) included placing uncompacted fill. This gully was protected during the period of grass establishment by diverting all runoff away from the upstream end of the gully for two growing seasons.

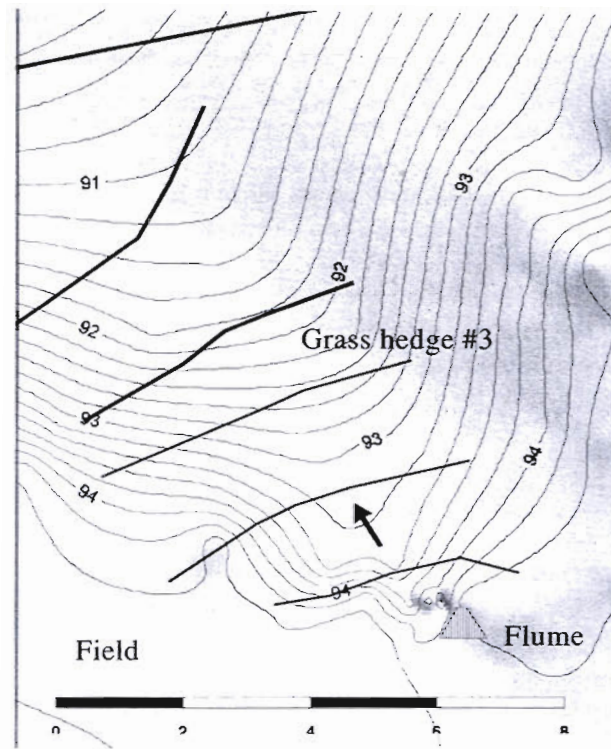
Fig. 4 Shaded relief contour map (0.5 m contour interval) of pre-test condition of test gully for Experiment 3 (site R4), showing the extent of grass hedges and location of H-flume

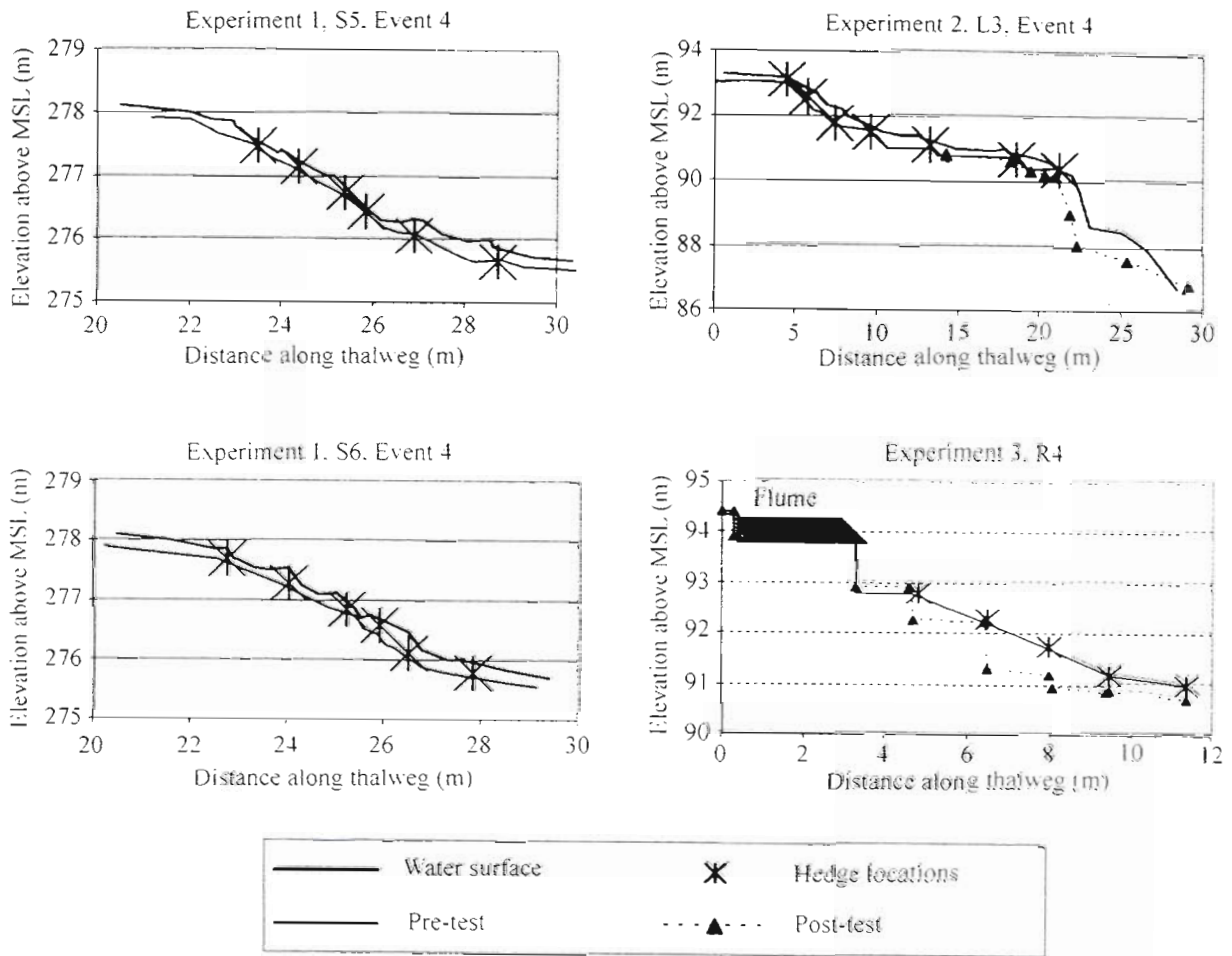
Fig. 5 Gully thalweg, high water profiles, and grass hedge locations during the first and last event at each location. Thalweg changes during Experiment 1 were not measurable. High water profiles for Experiment 3 were not measured. MSL = mean sea level datum

* Between turbidity sensors in tests 1 and 2. Erosion at L3 excludes about 70,000 kg eroded by mass failure of soil blocks at a large headcut at the gully mouth (Fig. 5).

The dominant erosion feature observed during Experiment 2 was the cantilever mass failure of soil blocks, one of which contained part of the most downslope vegetative hedge during the recession period of event 4 (Fig. 5). Failure was delayed until hydrograph recession by the time required to saturate deeper soil layers. This block failure followed deepening and widening of the plunge pool below the overfall, which initially was between 1 and 2 m high. Pre- and post-test surveying indicated a volume of 53 m³ was eroded during the tests. Most of the removal came from creek sediments previously deposited in and around a large woody debris structure (Shields et al., 2004) and from older creek bank materials. Much of the erosion was associated with widening of the gully downslope of the lowest hedge and is, therefore, not fully reflected in thalweg profile (Fig. 5). Based on the volume of erosion

When the bank stability model was applied to the pre-test L3 thalweg profile (Fig. 5), without any undercutting or root reinforcement, using geotechnical data from Table 1 and assuming a saturated profile, the estimated $F_s = 0.97$. Thus, the initial profile approximates an equilibrium bank shape for the site without vegetation or water surcharge. At the time that mass failure was observed at L3, measured pore water pressures included a saturated surface horizon, an unsaturated zone with pore water pressure = -5 kPa between 0.5 and 1.0 m depth, another deeper saturated zone with artesian pressure of 4 kPa below 1.0 m. The scour hole had created a 0.3-m undercut at the toe of the plunge pool where the shear plane emerged at a depth of 1.6 m below the hedge (about 89 m above MSL, Fig. 5). When these conditions were modeled, $F_s = 0.78$ without root reinforcement and $F_s = 1.72$ with root reinforcement. It is believed that in this case, the shear plane partially bypassed much of the switchgrass root zone so that root reinforcement was incomplete, resulting in mass failure. The computed factors of safety were also elevated by the assumption of a planar failure, when in fact, the undercut condition of the step produced a cantilever failure. In addition, the model (Simon and Collison, 2002) may overestimate the contribution of roots to soil strength because it assumes that all roots break simultaneously as soil shears. When applied to the gullies tested in Experiments 1 and 3, F_s was above 10 for the duration of the tests.

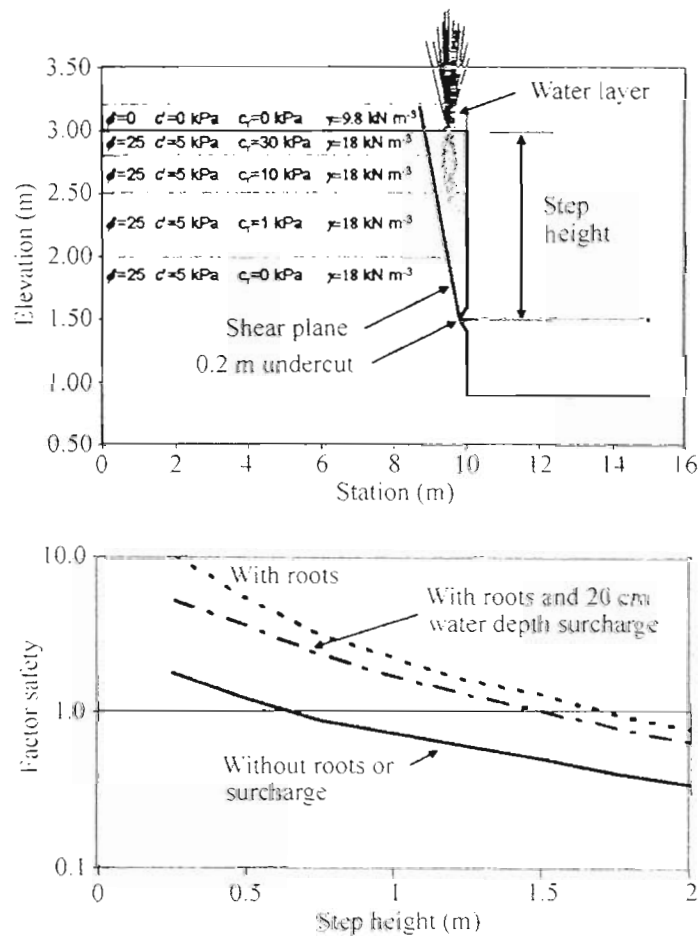
Fig. 6 Use of bank-stability model to determine the effect of switchgrass hedges on the likelihood of mass failure of steps in a silty soil as a function of step height

Figure 6 schematically illustrates how the bank stability model was applied to conduct an analysis of the influence of vegetative hedges on the likelihood of mass failure as a function of step height. In each test, a 57.5 degree (recommended for the given soil friction angle and cohesion) shear plane was assumed to emerge at a 0.2 m undercut of a vertical bank made up of uniform silty material (friction angle = 30 degrees; cohesion = 5 kPa; saturated unit weight = 18 kN/m³). The factor of safety, F_s , was calculated for step heights of 0.25 to 2.0 m under three test cases: (1) saturated step with no grass roots, (2) saturated step with added cohesion due to switchgrass roots (Simon and Collison, 2002), c_r , in layers 2, 3, and 4 (Fig. 6), and (3) a 0.2-m deep water surcharge (layer 1) on top of a bank reinforced with switchgrass roots. Water surcharge was modeled as a soil layer with a density 1000 kg/m³ and zero strength (Fig. 6).

Modeled results indicate that the saturated step would be unstable for heights exceeding 0.7 m, while a saturated step reinforced with switchgrass roots would be stable up to a height of 1.7 m. Even with the extra weight of ponded water, the vegetated step was predicted to be stable to a height of about 1.5 m. However, this level of stability would be achieved only if the roots intersect the shear plane in layers 2, 3, and 4 (Fig. 6). As step height increases, the shear plane moves away from the step edge and from the root zone of a narrow strip of vegetation located at the edge. The shear plane from a 1.5 m step height

would emerge 1.2 m from the bank edge and could bypass much of the root-reinforced area of a narrow grass hedge. Root zone bypassing could be even more pronounced for cantilever failures (not modeled here), since lateral roots would be required to intercept a vertical failure plane. For root reinforcement to have the modeled effect, the width of the vegetation would have to increase as step height increased. For step heights up to 0.5 m, used as a design value in the current study, the shear plane would be completely contained within the root-reinforced zone of even a narrow hedge. For this design step height, $F_s = 3.6$ even with a 0.2-m water surcharge, so no mass failure would be expected. In fact, even when soil cohesion was set to zero other than that provided by switchgrass roots, the model predicts $F_s > 1$ for step heights up to 1 m. However, this analysis does not apply to cracking soils where roots might be severed by desiccation cracks.
