Rehabilitation of an Incised Stream Using Plant Materials: the Dominance of Geomorphic Processes

*F. Douglas Shields, Jr.*¹, *S. Reza Pezeshki*², *Glen V. Wilson*¹, *Weiming Wu*³, and *Seth M. Dabney*¹

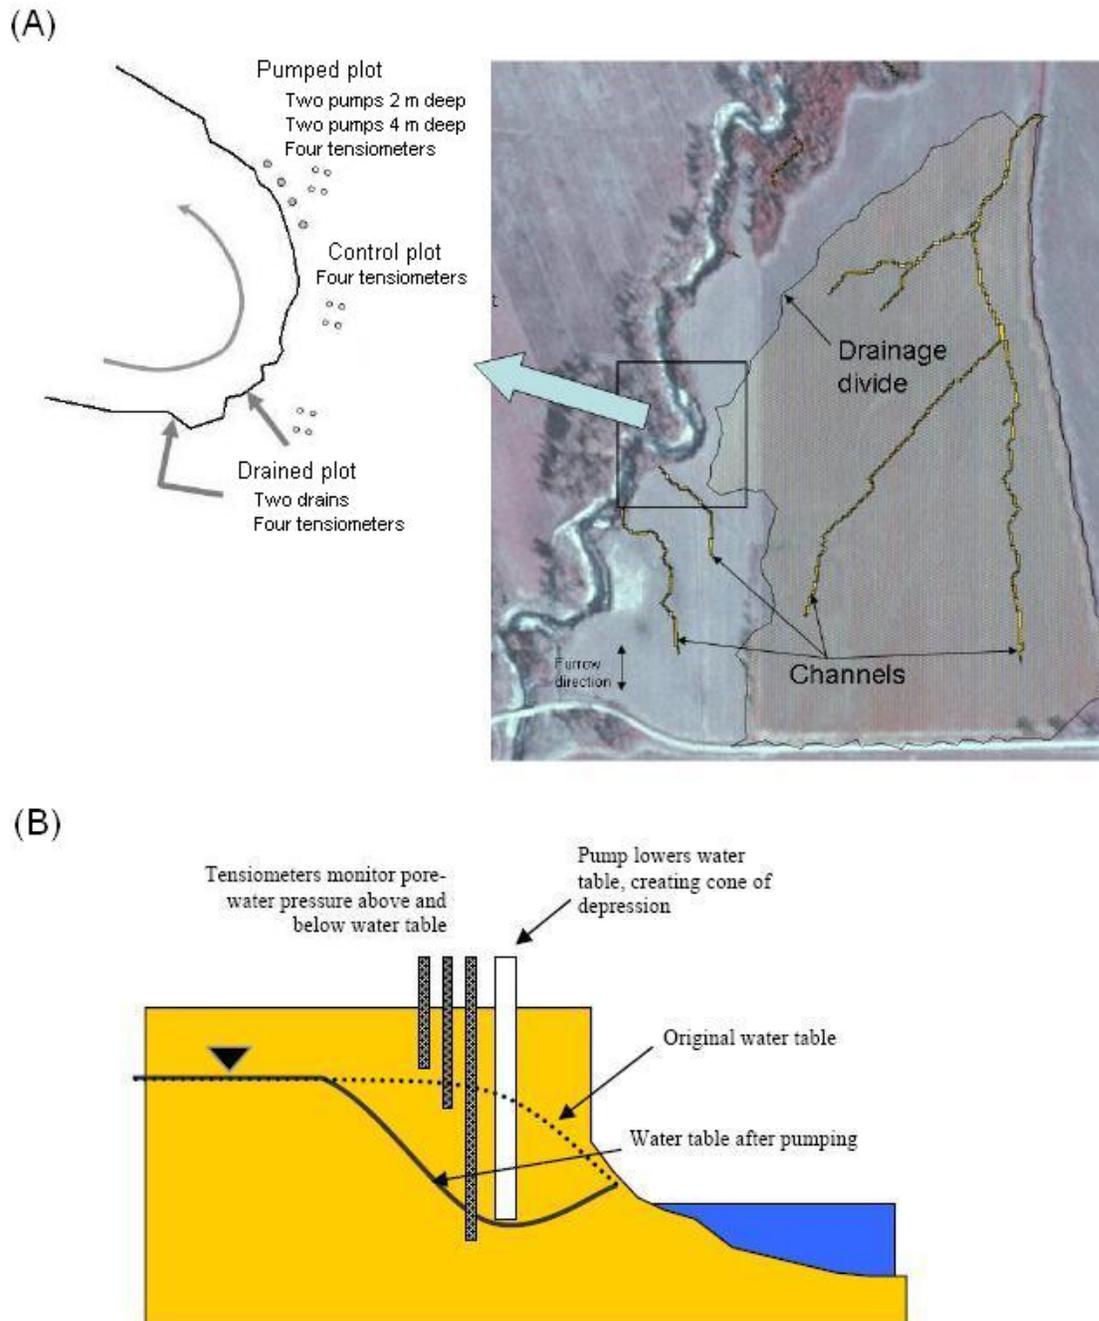
Fig. 7. Bank dewatering using pumps and drains. (A) Plan of the dewatering plots. (B) Schematic profile of the pumped plot.

Streambank instability as a result increasing soil-water pressure (Simon and Curini 1998, Casagli et al. 1999, Simon et al. 2000, Rinaldi et al. 2004) and seepage erosion (Fox et al. 2007a, Chu-Agor et al. 2008) were addressed by dewatering the soil profile that composed parts of a 6 m high eroding bank (Shields et al. *unpublished manuscript*; Figs. 3A and 7A). The outside bank of a bend was divided into three study plots separated from each other by approximately 25 m. At the first plot, two pairs of 5 cm diameter boreholes were installed 15 m apart to depths of 2 and 4 m (Fig. 7B), and a solar-powered peristaltic pump was installed in each borehole. Pumps discharged into the creek. The pumps were activated by float switches controlled by tensiometers. The second plot was an untreated control equipped with a nest of tensiometers to monitor the soil-water pressure profile. The third plot was treated by installing two 10 cm diameter perforated plastic drain tile lines ~1.5 m deep perpendicular to the bank and extending ~10 m into the field. The drain lines were placed approximately 20 m apart. One of the lines had an additional 10 m of tile that turned 90 degrees and ran an additional 10 m parallel to the top bank (Fig. 7A).

High, sandy banks were harsh habitat for planted or natural vegetation during dry periods, but elevated soil moisture and the attendant loss of matric suction (negative pore-water pressure) contributed to mass failures during wet periods. The solar-powered pumps and passive drains reduced soil moisture and provided improved stability relative to the adjacent untreated control (Shields et al. *unpublished data*). Over the course of two wet seasons, the average bank retreat for the control, pumped, and drained plots was 0.43, 0.21, and 0.23 m, respectively. At the pumped site, the matric suction was 3–4 kPa higher than that at the control site during the most critical periods. Accordingly, computed factors of safety were above the failure threshold at the pumped site, but fell below unity (i.e., became unstable) at the control site on 11 occasions over the period of observation. Similarly, the drained site generally displayed higher matric suction and higher factors of safety than did the control site, except during two events when the drains were evidently overwhelmed by the volume of local surface and subsurface flows.

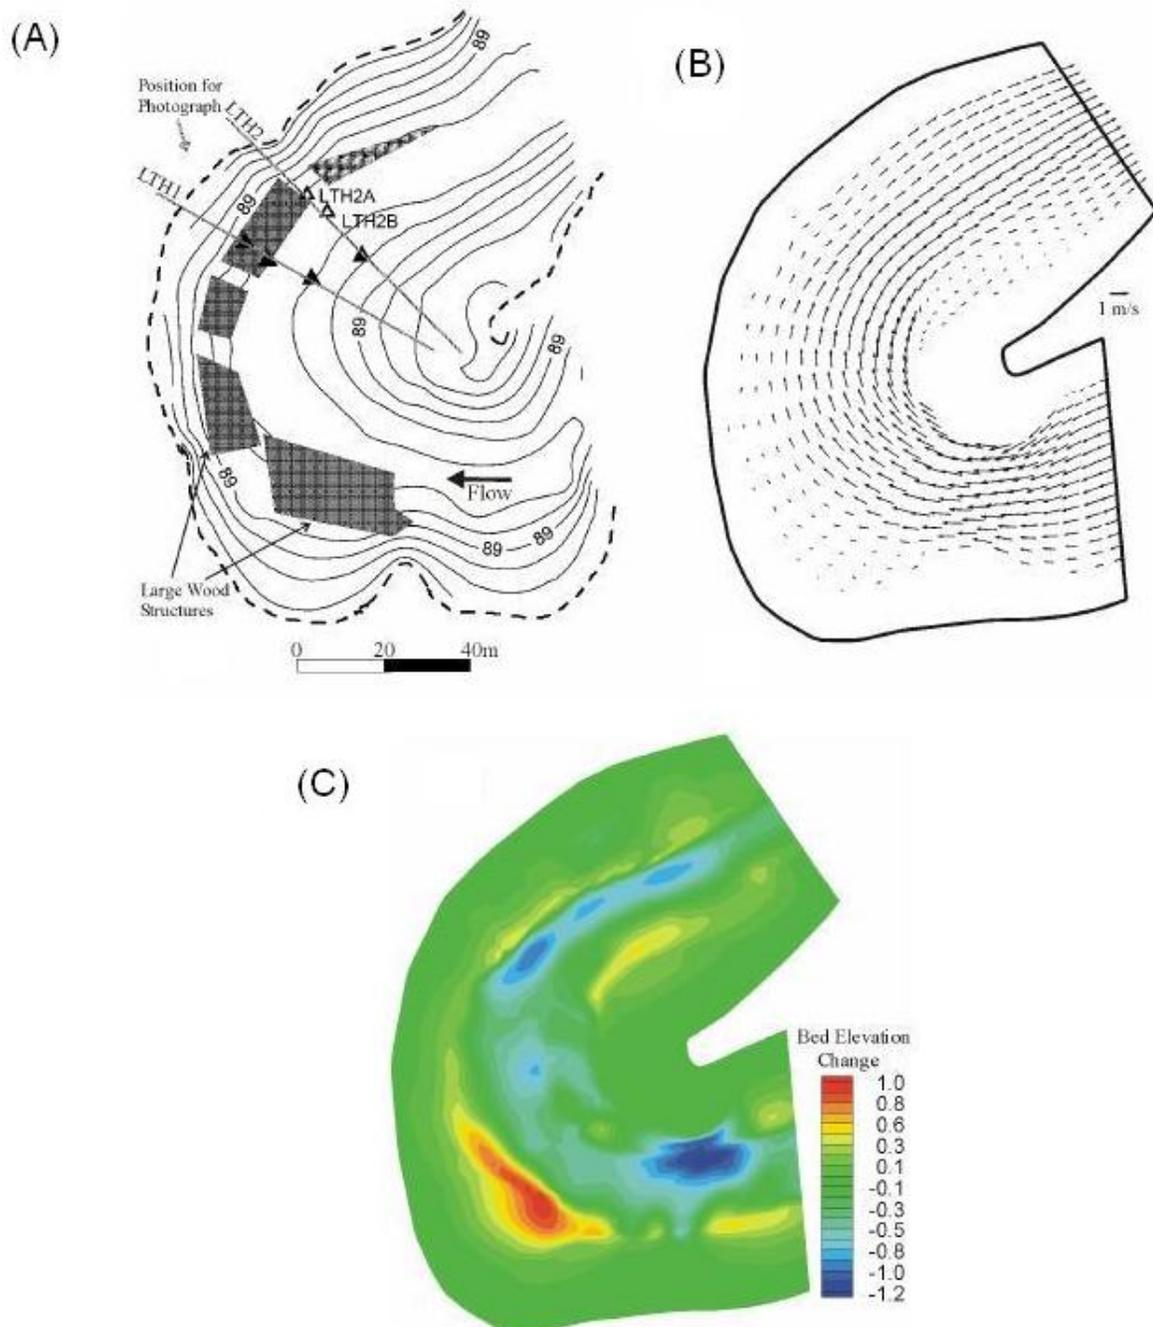
Fig. 8. Numerical simulation of the effects of large wood (LW) structures on a meander bend on Little Topashaw Creek. (A) Topography and LW locations. (B) Simulated flow field at a discharge of 43 m³/s. (C) Simulated bed change after 1 yr due to erosion and deposition.

LW also exerted an important influence on habitats during high flow events (Shields et al. 2003, 2006). Acoustic Doppler loggers were used to record high flow current velocity magnitudes at the bank toe and at the channel centerline adjacent to the structures in a tight bend. Prior to the placement of LW structures, the highest velocities within bends occurred at the bank toe, but an LW structure placed at the bank toe created a velocity shelter. Velocities within the LW structure were usually < 0.10 m/s, even during events that were large enough to produce flow depths > 3 m. Such low velocities are well within the preferred ranges for centrarchid and ictalurid fishes (McMahon and Terrell 1982, Stuber et al. 1982). Velocities measured in the channel adjacent to the structure were approximately three times greater than those within the LW matrix. The measured velocities were used to calibrate a two-dimensional model of flow and sediment transport for the entire meander bend. The model incorporated the effects of the LW structures and secondary currents typical of bends (Fig. 8; Wu et al. 2005). The model output showed significant regions of velocity shelter and sediment deposition associated with LW structures (Fig. 8C).
