STREAM CHANNEL STABILITY

Investigations of Vegetation for Stabilizing Eroding Streambanks

A. J. Bowie

Technology Application Project Report No. 14

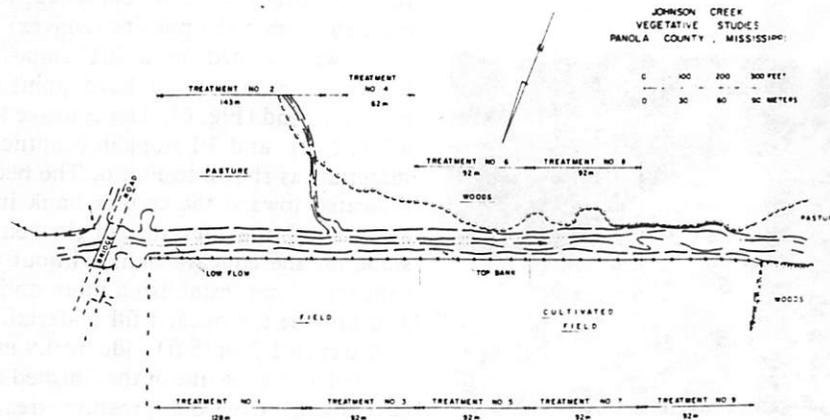
FIG. 2 Site plan of Johnson Creek study reach No. 2.

A schematic for Johnson Creek Study Reach 2 is shown in Fig. 2. Nine treatment sites ranging from 61 to 143 m (200 to 470 ft) in length are included in the study. The materials used for treatment are listed in Table 1. The top 0.6 m (2 ft) of soil along both sides of the channel was stockpiled during bank shaping and later used on the prepared seedbeds.

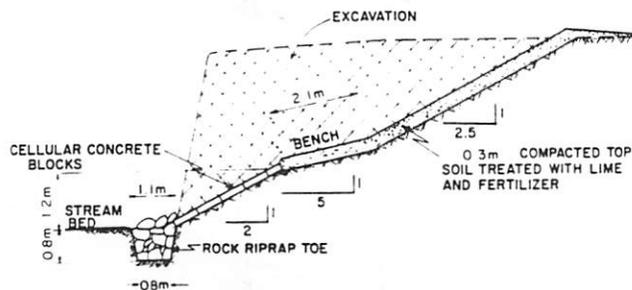
FIG. 3 Johnson Creek study reach No. 2—excavated bench section with lower bank and entrenched toe protected with structural materials.

The excavated-bench method, with lower bank and toe protection by structural revetment, was used for bank sloping treatment sites 1, 2, 3, 4, and 6. The purpose of the excavated bench is to provide a better environment for establishing woody vegetation. The toe of the lower bank along sites 1, 2, and 4 was provided with extra protection consisting of large rock placed in a trench excavated to a minimum of 0.76 m (2.5 ft) below the existing channel bottom (Fig. 3). The gradation or rock size was determined from the Soil Conservation Service design criteria, which required 50 to 75 percent of the stones to weigh more than 34 kg (75 lb) each. The align-

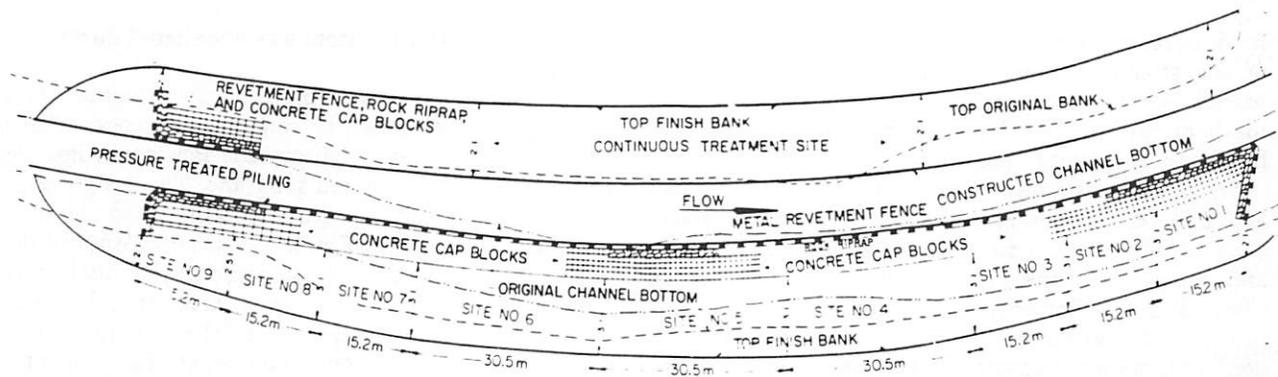
FIG. 6 Site plan of Johnson Creek study reach No. 1.

A schematic for the Johnson Creek Study Reach 1 is shown in Fig. 6. Nine treatment sites ranging from 15 to 30 m (50 to 100 ft) in length were included on the shaped concave bank of the bend. The entire length of the concave bank was considered as one treatment site. The materials used for treatment are listed in Table 1. The

finished concave bank consisted of fill material excavated from the opposite (convex) bank. The convex bank was shaped to a 2:1 slope without structural materials, except for a hard point constructed at the upstream end (Fig. 6). The concave bank was shaped to a 2:1, 2.5:1, and 3:1 slope in conjunction with structural materials as shown in Fig. 6. The bed of the stream was relocated toward the convex bank in order to decrease and smooth the curvature of the bend, flatten the bank slope for the concave bank without infringing on adjacent farm land, establish a more uniform bottom width, and provide the needed fill material.

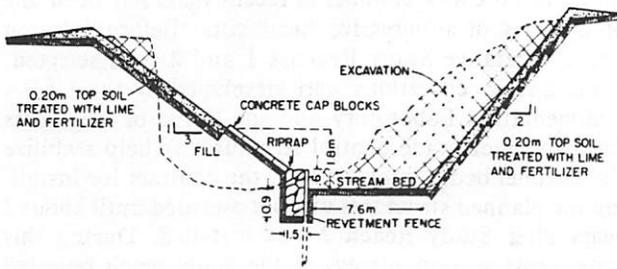
FIG. 7 Typical finished cross section of Johnson Creek study reach No. 1.

minimum tip diameter of 0.20 m (8 in.) and 4.9 m (16 ft) in length, were driven on 2.4 m (8 ft) centers in the excavated toe trench and adjacent to the channel bottom. The piling was driven to a depth of 4.3 m (14 ft) with 0.6 m (2 ft) above the finished grade of the stream bed. A chain link fence of 9 gauge galvanized steel fabric, 1.5 m (5 ft) in height, was attached to the bank side of the piling and even with the top of the piling. The toe trench was backfilled with rock to the top of the fence (Fig. 7). The lower bank was protected with 0.10 x 0.20 x 0.41 m (4 x 8 x 16 in.) concrete cap blocks placed between and anchored by 11-gauge galvanized wire netting, which in effect forms an articulated matting. The design height of 1.8 m (6.0 ft) of structural revetment on the lower bank, as shown in Fig. 7, was approximated by the maximum depth of flow for 90 to 95 percent of the estimated annual storm events and the additional erosive force expected on the concave bend. The upper bank was planted to herbaceous and woody vegetation.

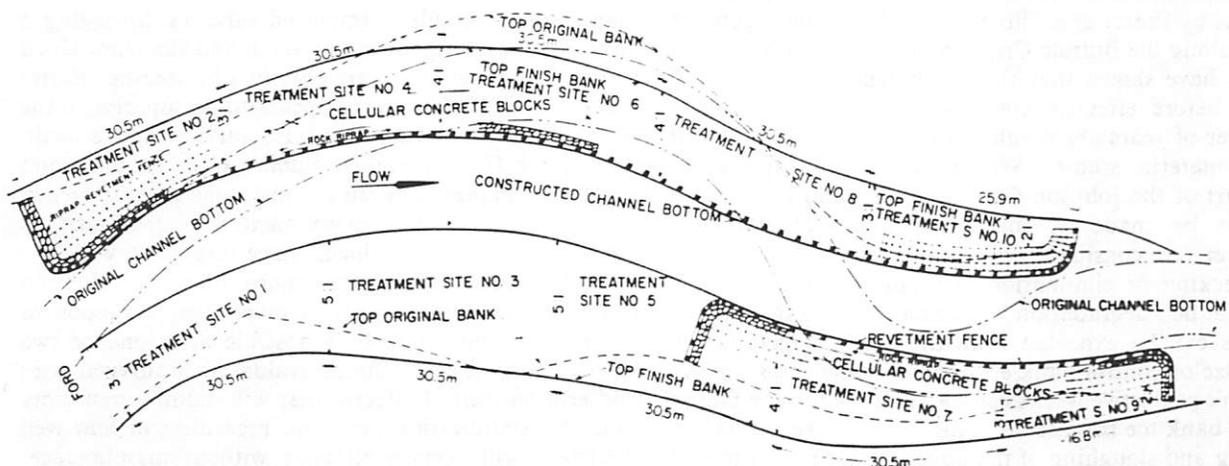
FIG. 10 Site plan of Goodwin Creek study reach.

A schematic for the Goodwin Creek study reach is shown in Fig. 10. Construction of this study reach was completed in April 1981. Seven treatment sites with lengths ranging from 17 m to 30 m (55 to 100 ft) were included on the concave banks. Three treatment sites, each 30 m (100 ft) in length, were included along the convex bank. The materials used for treatment are listed in Table 1. Soil excavated from the convex bank was used for fill material along most of the concave bank. The concave bank was shaped to a 2:1, 3:1, and 4:1 slope in

conjunction with structural materials as shown in Fig. 10. The convex bank was shaped to a 3:1, 4:1, and 5:1 slope without structural materials.

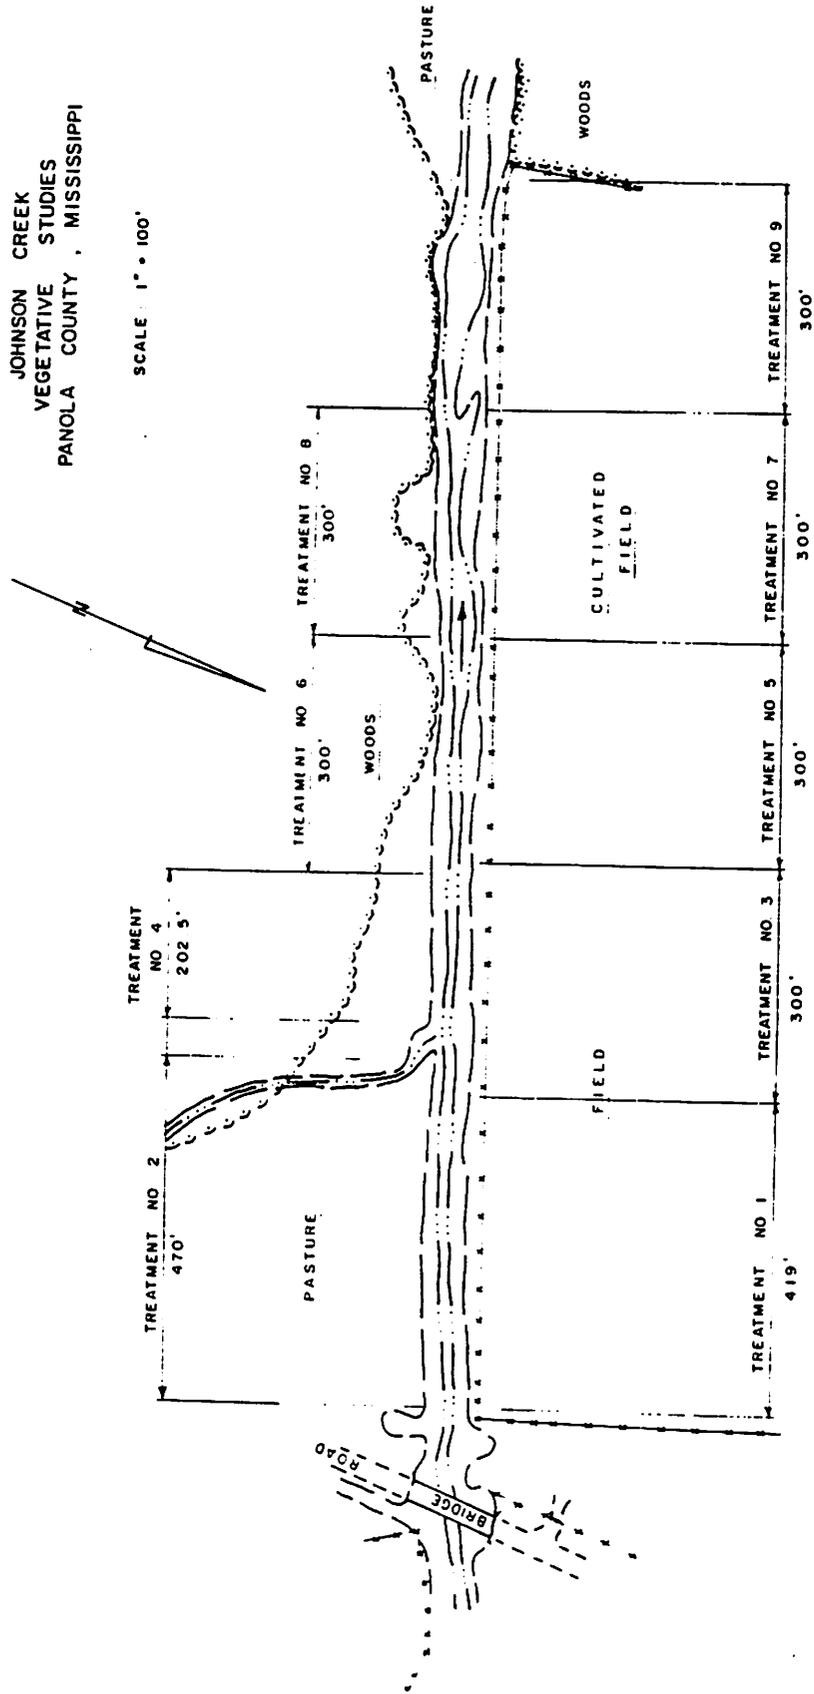
Figure 4 Site Plan of Johnson Creek Study Reach No. 3

In the design of the Goodwin Creek and the Johnson Creek study reaches Nos. 3 and 4, the above established criteria were utilized to the fullest extent possible. A schematic of the site plan for the Johnson Creek study reach No. 3 is shown in Fig. 4. Nine treatment sites ranging from 200 to 470 ft. in length are included in the study. The combination of treatments for each site is listed in Table 1. The top two feet of soil along both sides of the channel was stockpiled and later used on the prepared seedbeds.

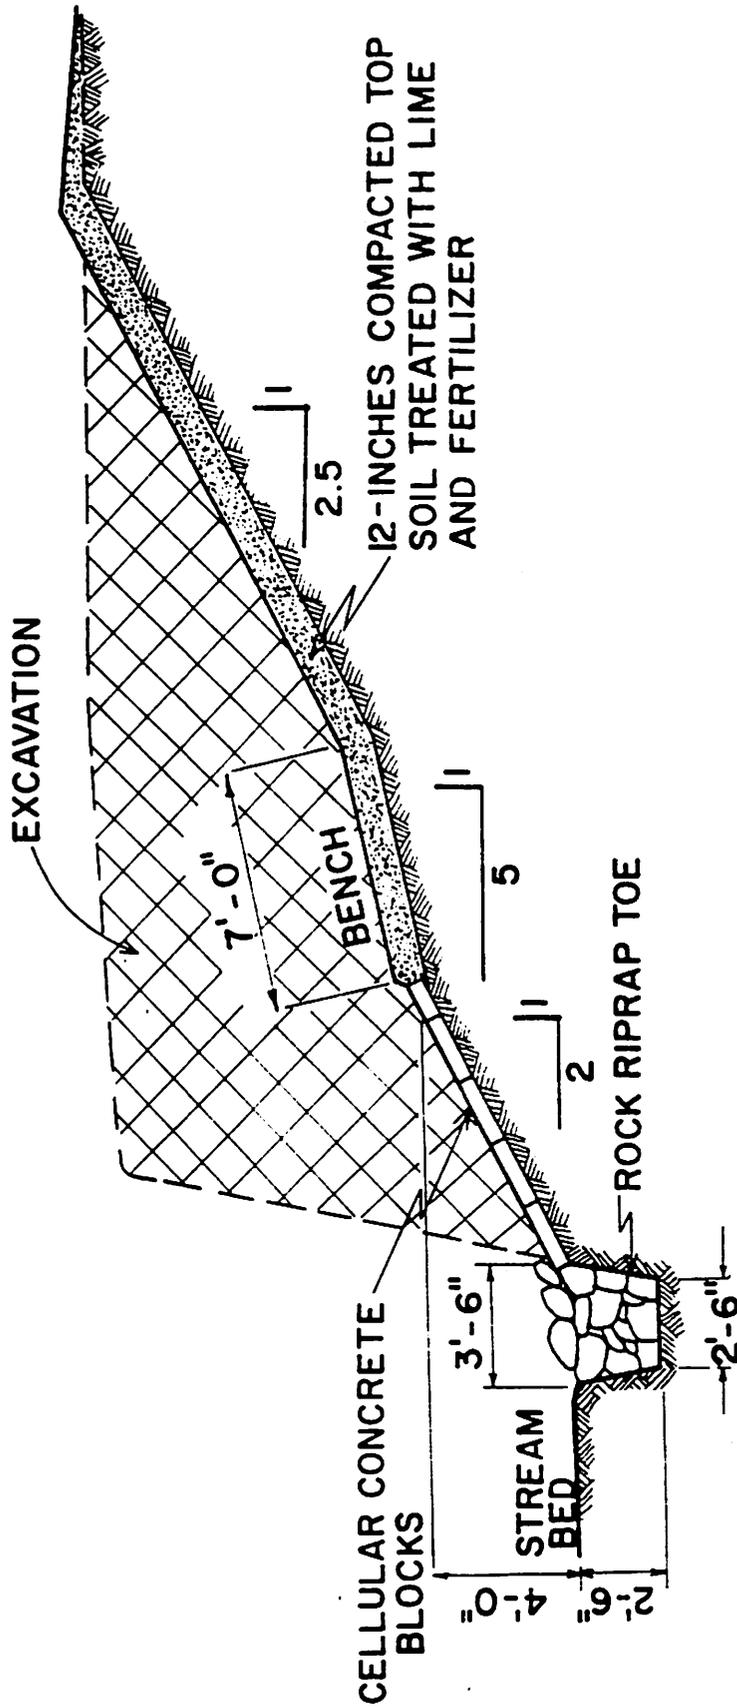
Figure 5 Johnson Creek Study Reach No. 3 - Excavated Bench Section with Lower Bank and Entrenched Toe Protected with Structural Materials

The excavated-bench method, with lower bank and toe protection by structural revetment, was used for bank sloping treatment sites no. 1, 2, 3, 4, and 6. The purpose of the excavated bench is to provide a better environment for establishing woody vegetation. The toe of the lower bank along sites no. 1, 2, and 4 was provided with extra protection by heavy rock riprap placed in a trench excavated to a minimum of 2.5 ft. below the existing channel bottom (Fig. 5). The course of the channel bottom was not

altered during construction. The lower bank was protected with either rock riprap, cellular concrete blocks, or concrete cap blocks. Plastic filter cloth of woven polypropylene fabric was installed between the revetment and subgrade. The design height of 4.0 ft. of structural revetment on the lower bank was approximated by the maximum depth of flow for 90-95 percent of the annual storm events. The lower bank is constructed to a 2:1 slope, the 7.0 ft. wide bench to a 5:1 slope, and the upper bank to a 2.5:1 slope. The bench is planted to woody species and the upper bank to herbaceous species. Sites no. 7, 8, and 9 were constructed to a 2.5:1 slope without structural materials (Fig. 6). The entire bank is planted to herbaceous vegetation. All of the bank seedbeds were treated with 800 lbs. of 13-13-13 commercial fertilizer and 4,000 lbs. of lime per acre, incorporated into the top 8 inches of soil, seeded, and covered with erosion control mulch material.
