RESEARCH REPORT NO. 425 *(Jan. 1971)*

AUTOMATIC SEDIMENT VOLUME RECORDER
TESTS ON LABORATORY CREEK, OXFORD, MISSISSIPPI

William C. Harmon and Robert F. Piest

USDA Sedimentation Laboratory
Southern Branch
Soil and Water Conservation Research Division
Agricultural Research Service
United States Department of Agriculture

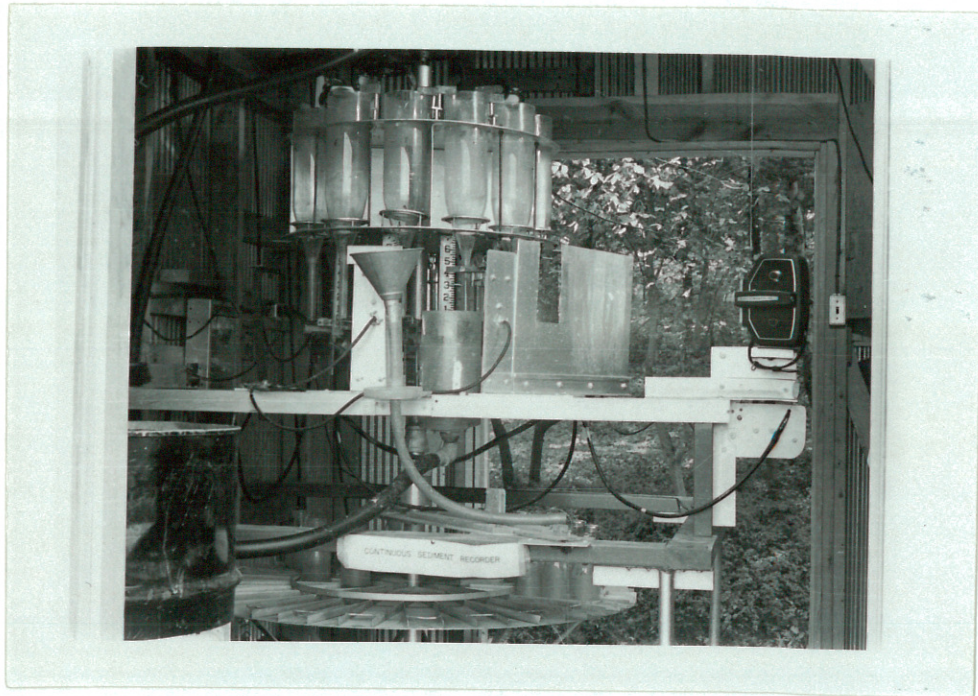
Figure 1.--Sediment volume recorder installation, with sedimentation tubes at top of photo and partially filled bottle rack at bottom.

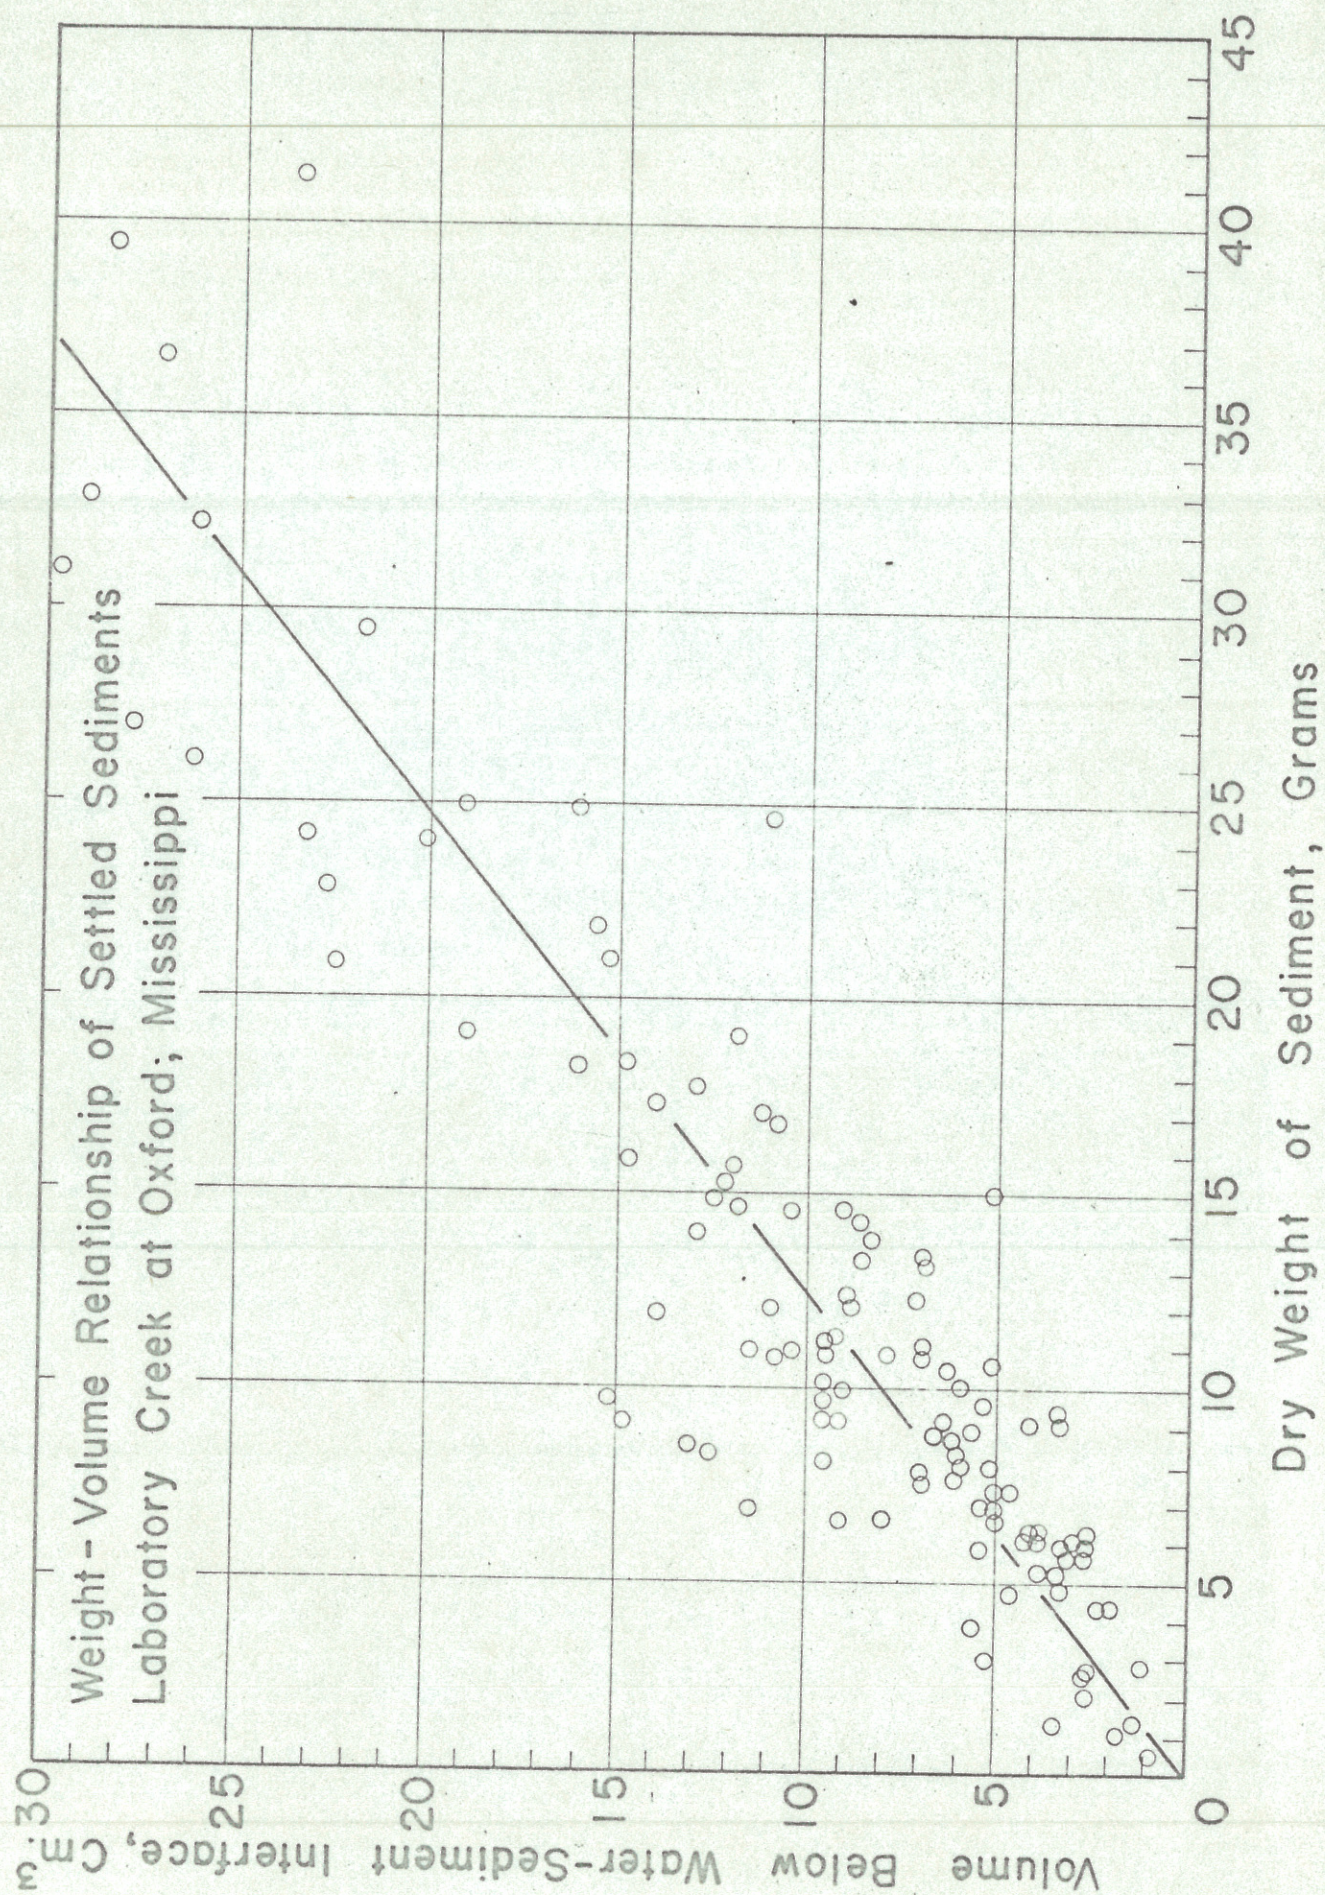
Figure: 3

Weight–Volume Relationship of Settled Sediments
Laboratory Creek at Oxford, Mississippi

The Laboratory Creek tests showed the sediment-volume relationship
to be the greatest problem in the determination of sediment concentration
for pumped samples. A plot of dry weight versus the volume of deposited
sediments in the sedimentation tube, as shown in Figure 3, reveals a
scatter from .5 to 2.5 grams per cubic centimeter. This range of values
is obviously too great and there is strong indication that it resulted
from the inability to read the volumes accurately when the total volumes
were small. This is illustrated by Figure 4, in which densities of
settled materials from the sedimentation tube samples are plotted against
total volumes of settled materials. The greatest scatter occurs at low
total volumes. Figure 5 shows that the densities of the settled materials

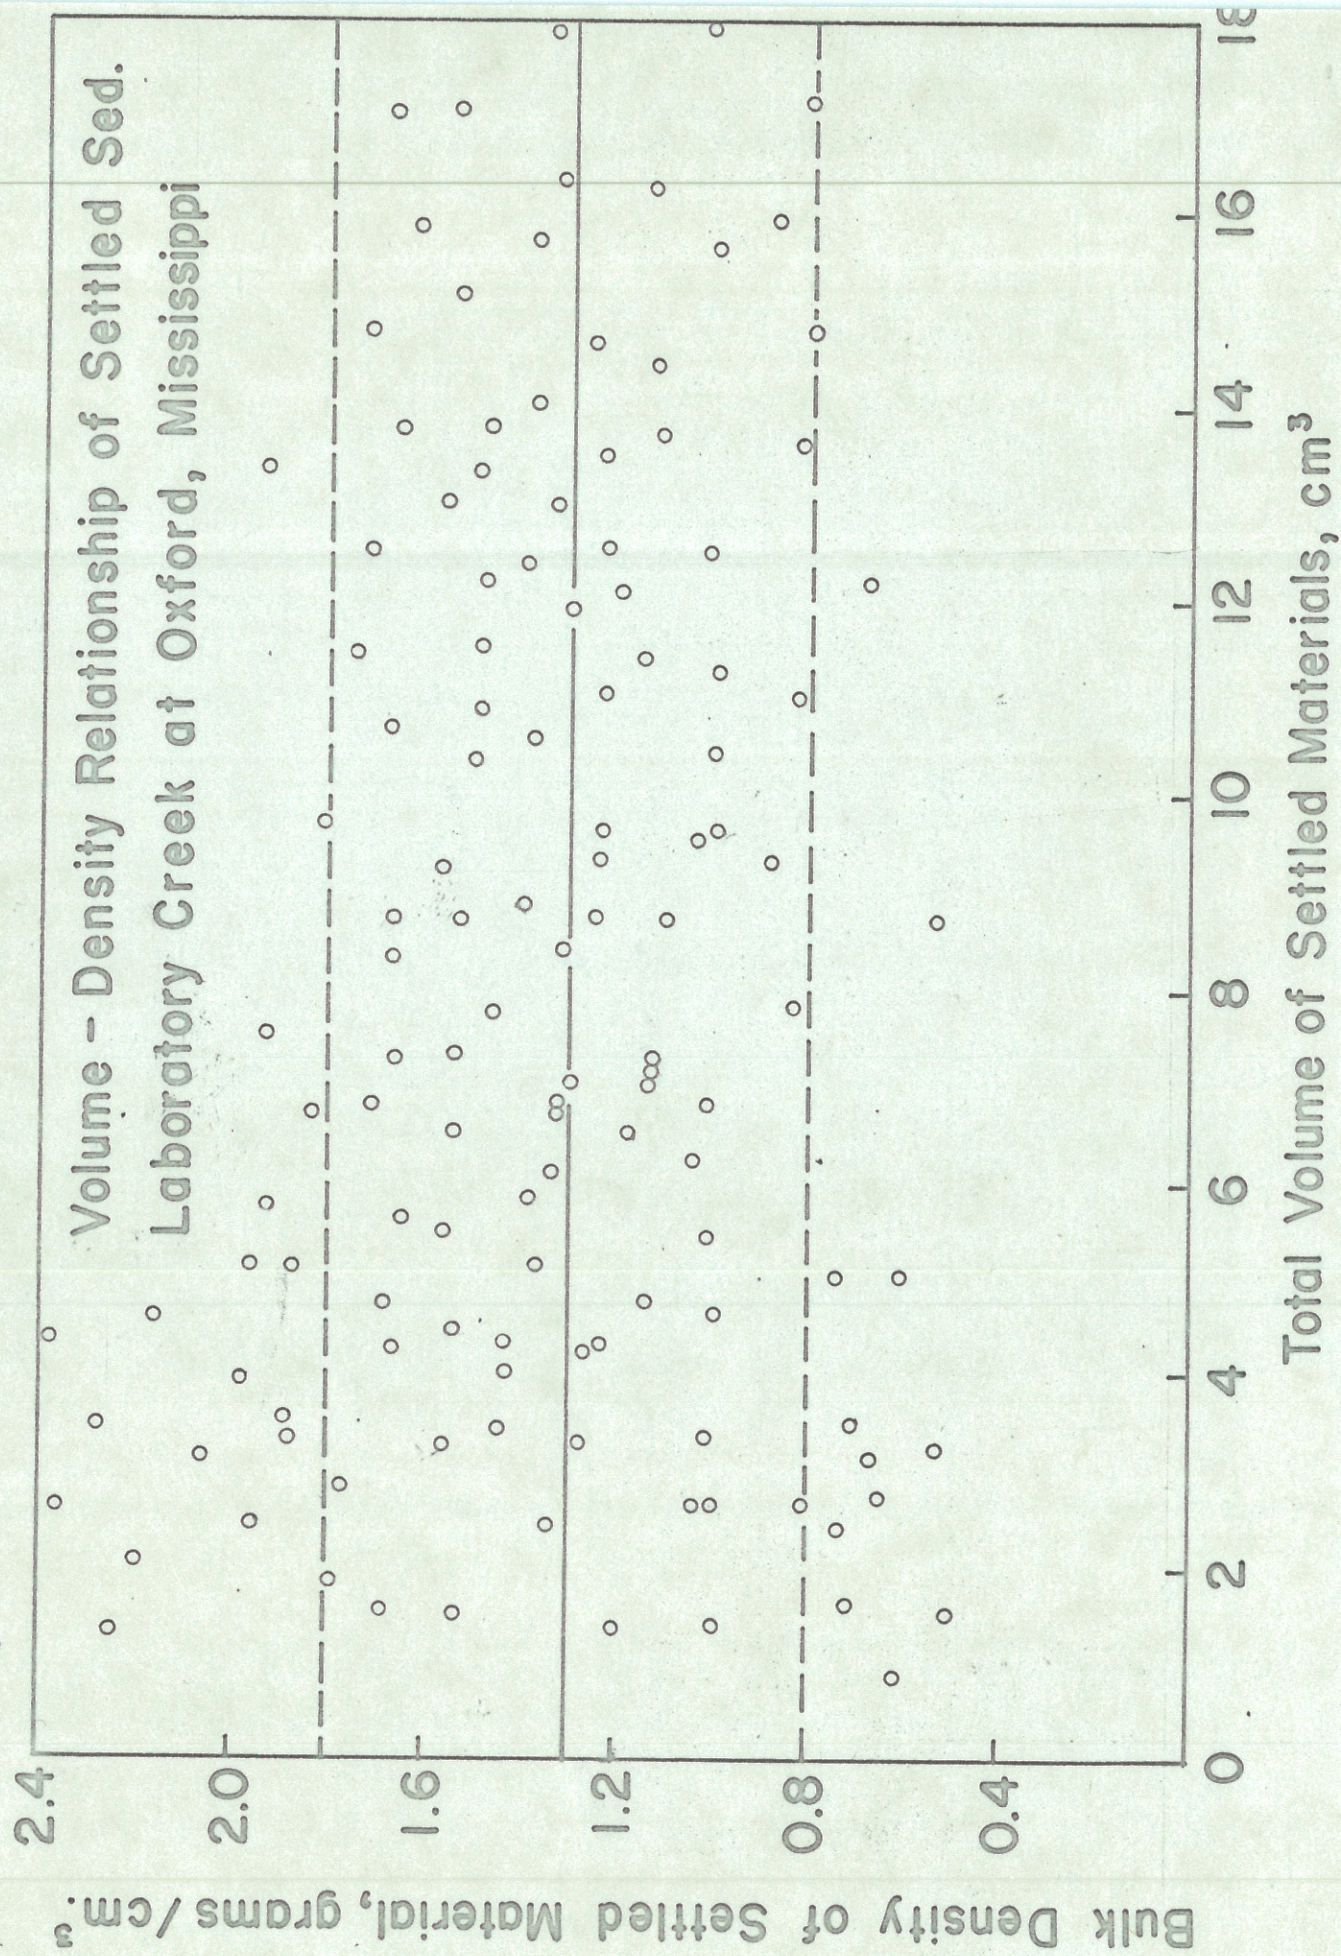
Figure 4

Volume – Density Relationship of Settled Sed.
Laboratory Creek at Oxford, Mississippi

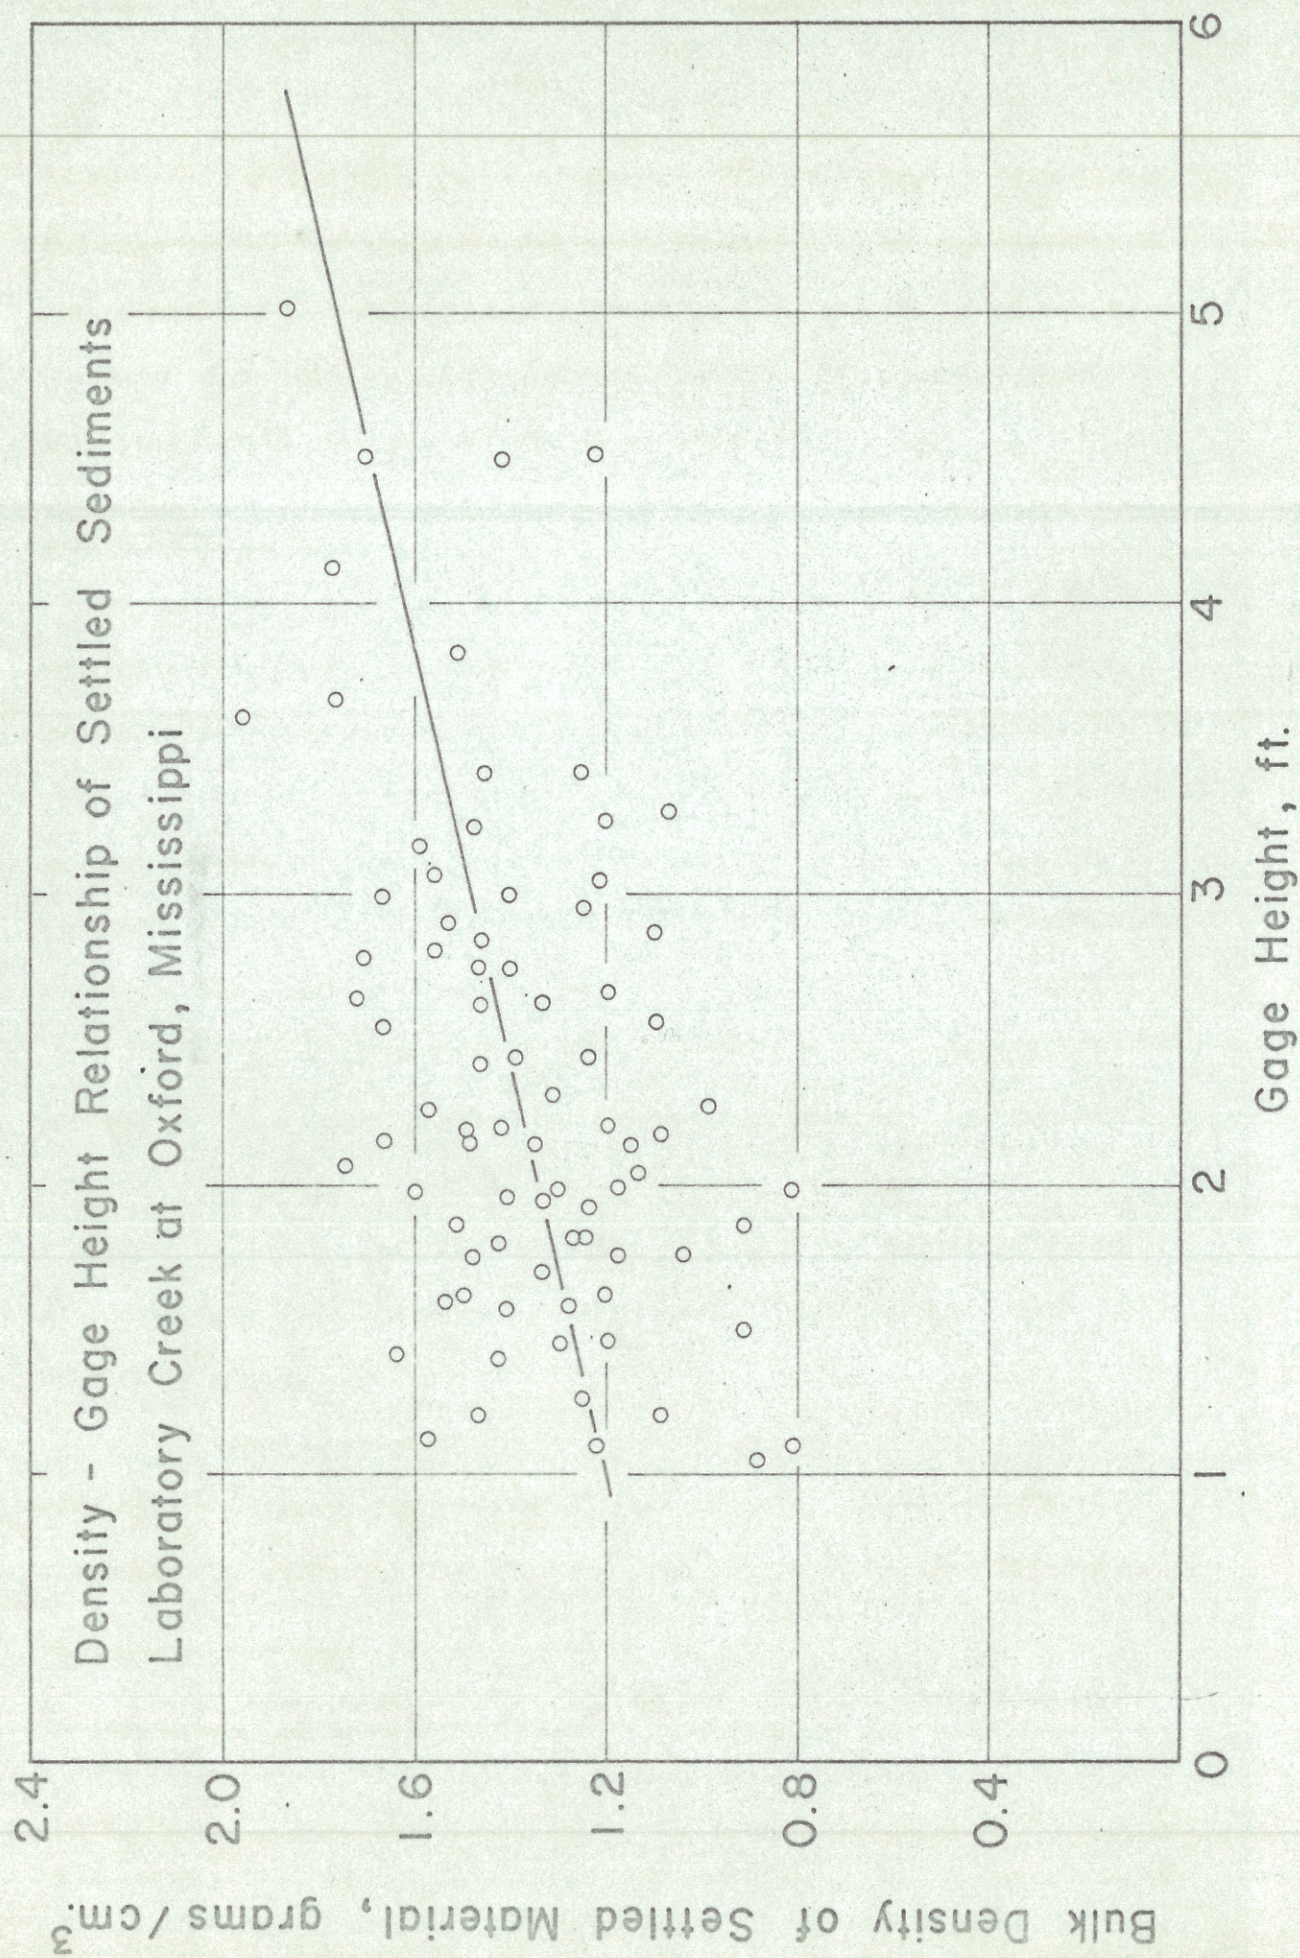
Figure 5

increased with increases in gage height. This relationship between density and gage height was probably influenced considerably by the increase in sand content with increase in gage height. The fact that sand content increased with gage height is shown in Figure 6, and Figure 7 shows that this increase in sand content caused an increase in density.

Density – Gage Height Relationship of Settled Sediments
Laboratory Creek at Oxford, Mississippi

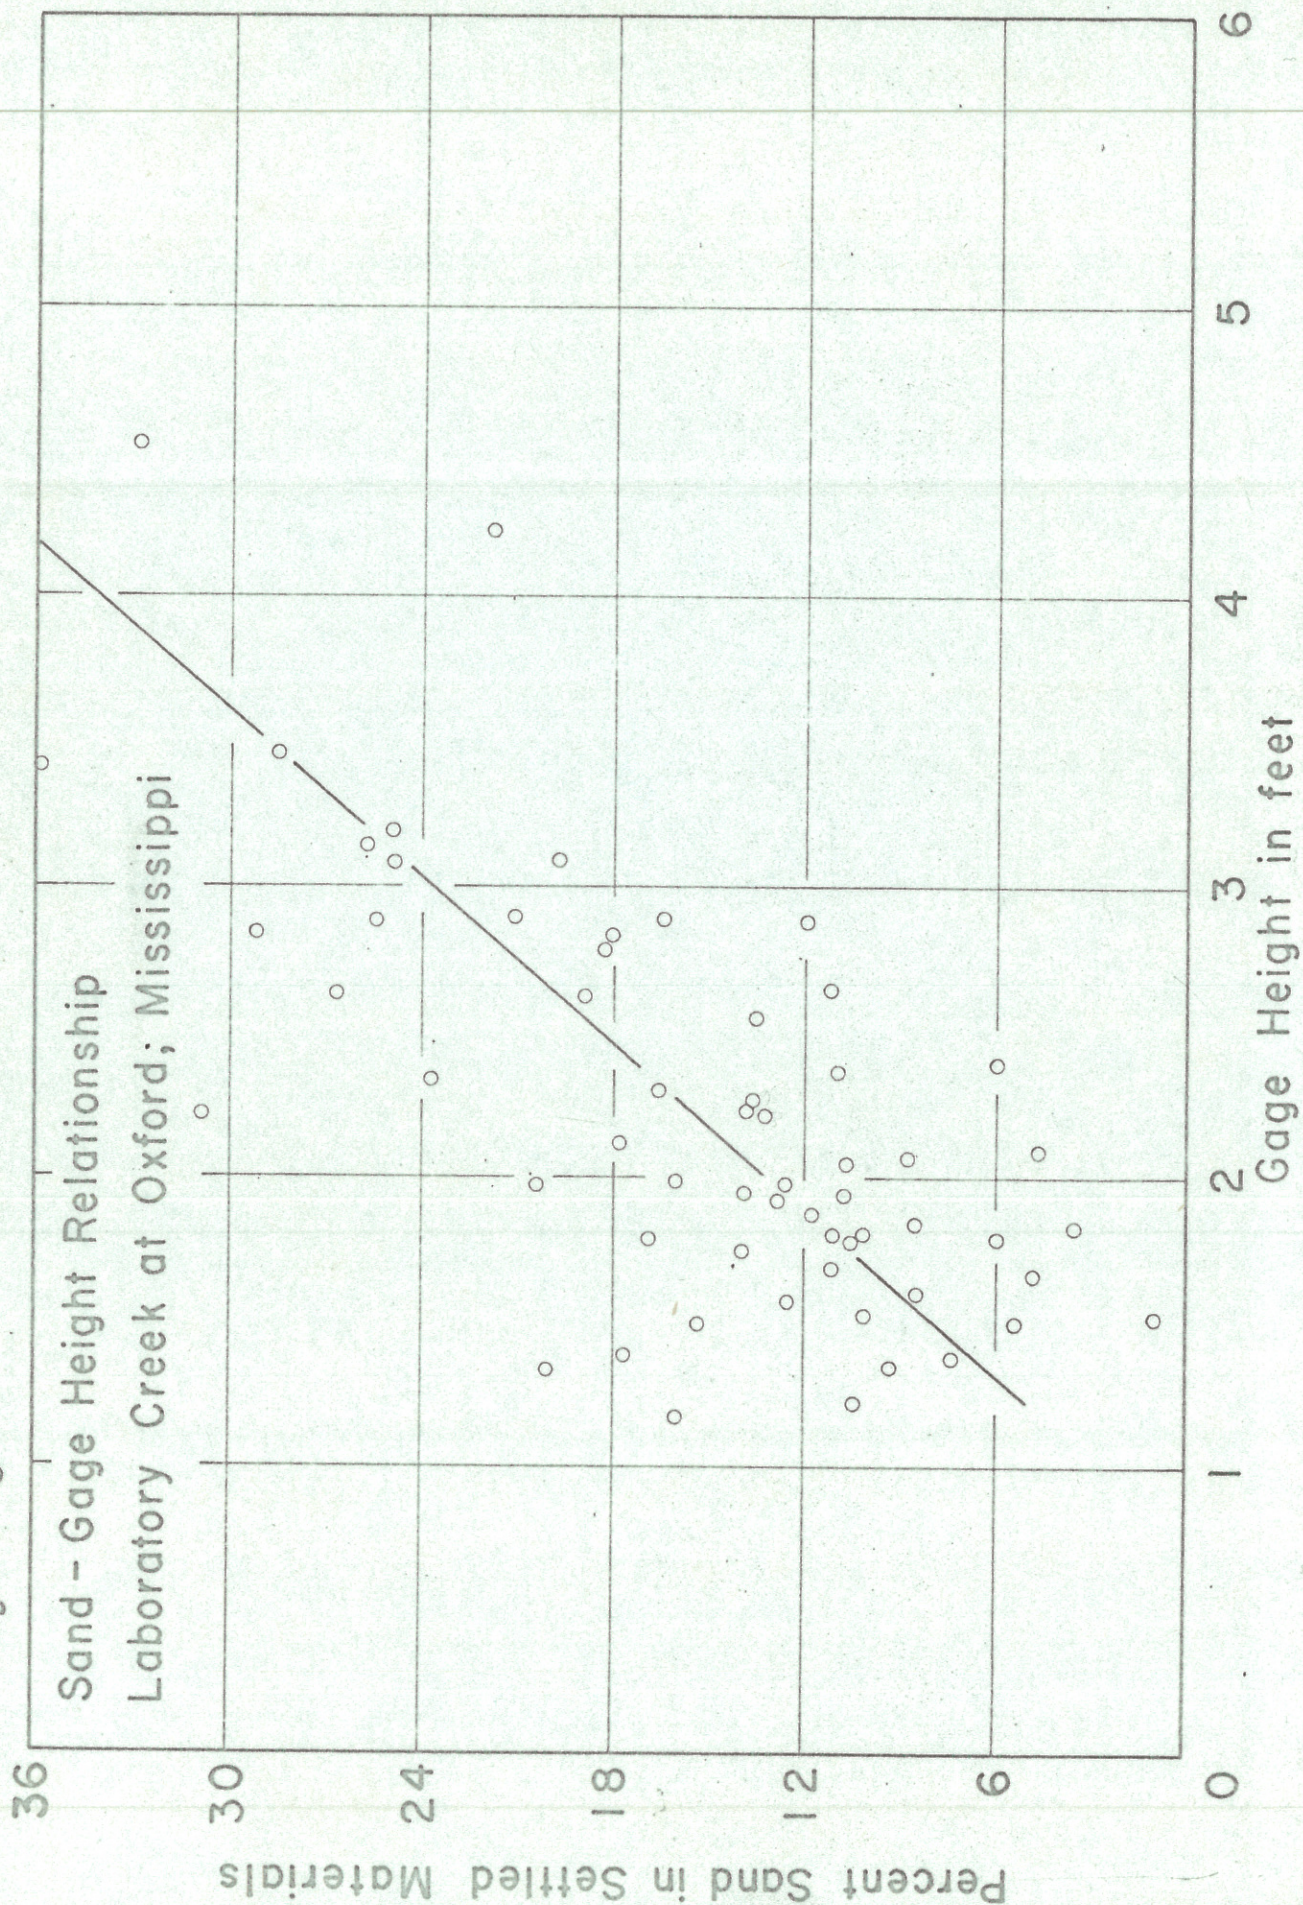
Figure 6

Sand – Gage Height Relationship
Laboratory Creek at Oxford, Mississippi

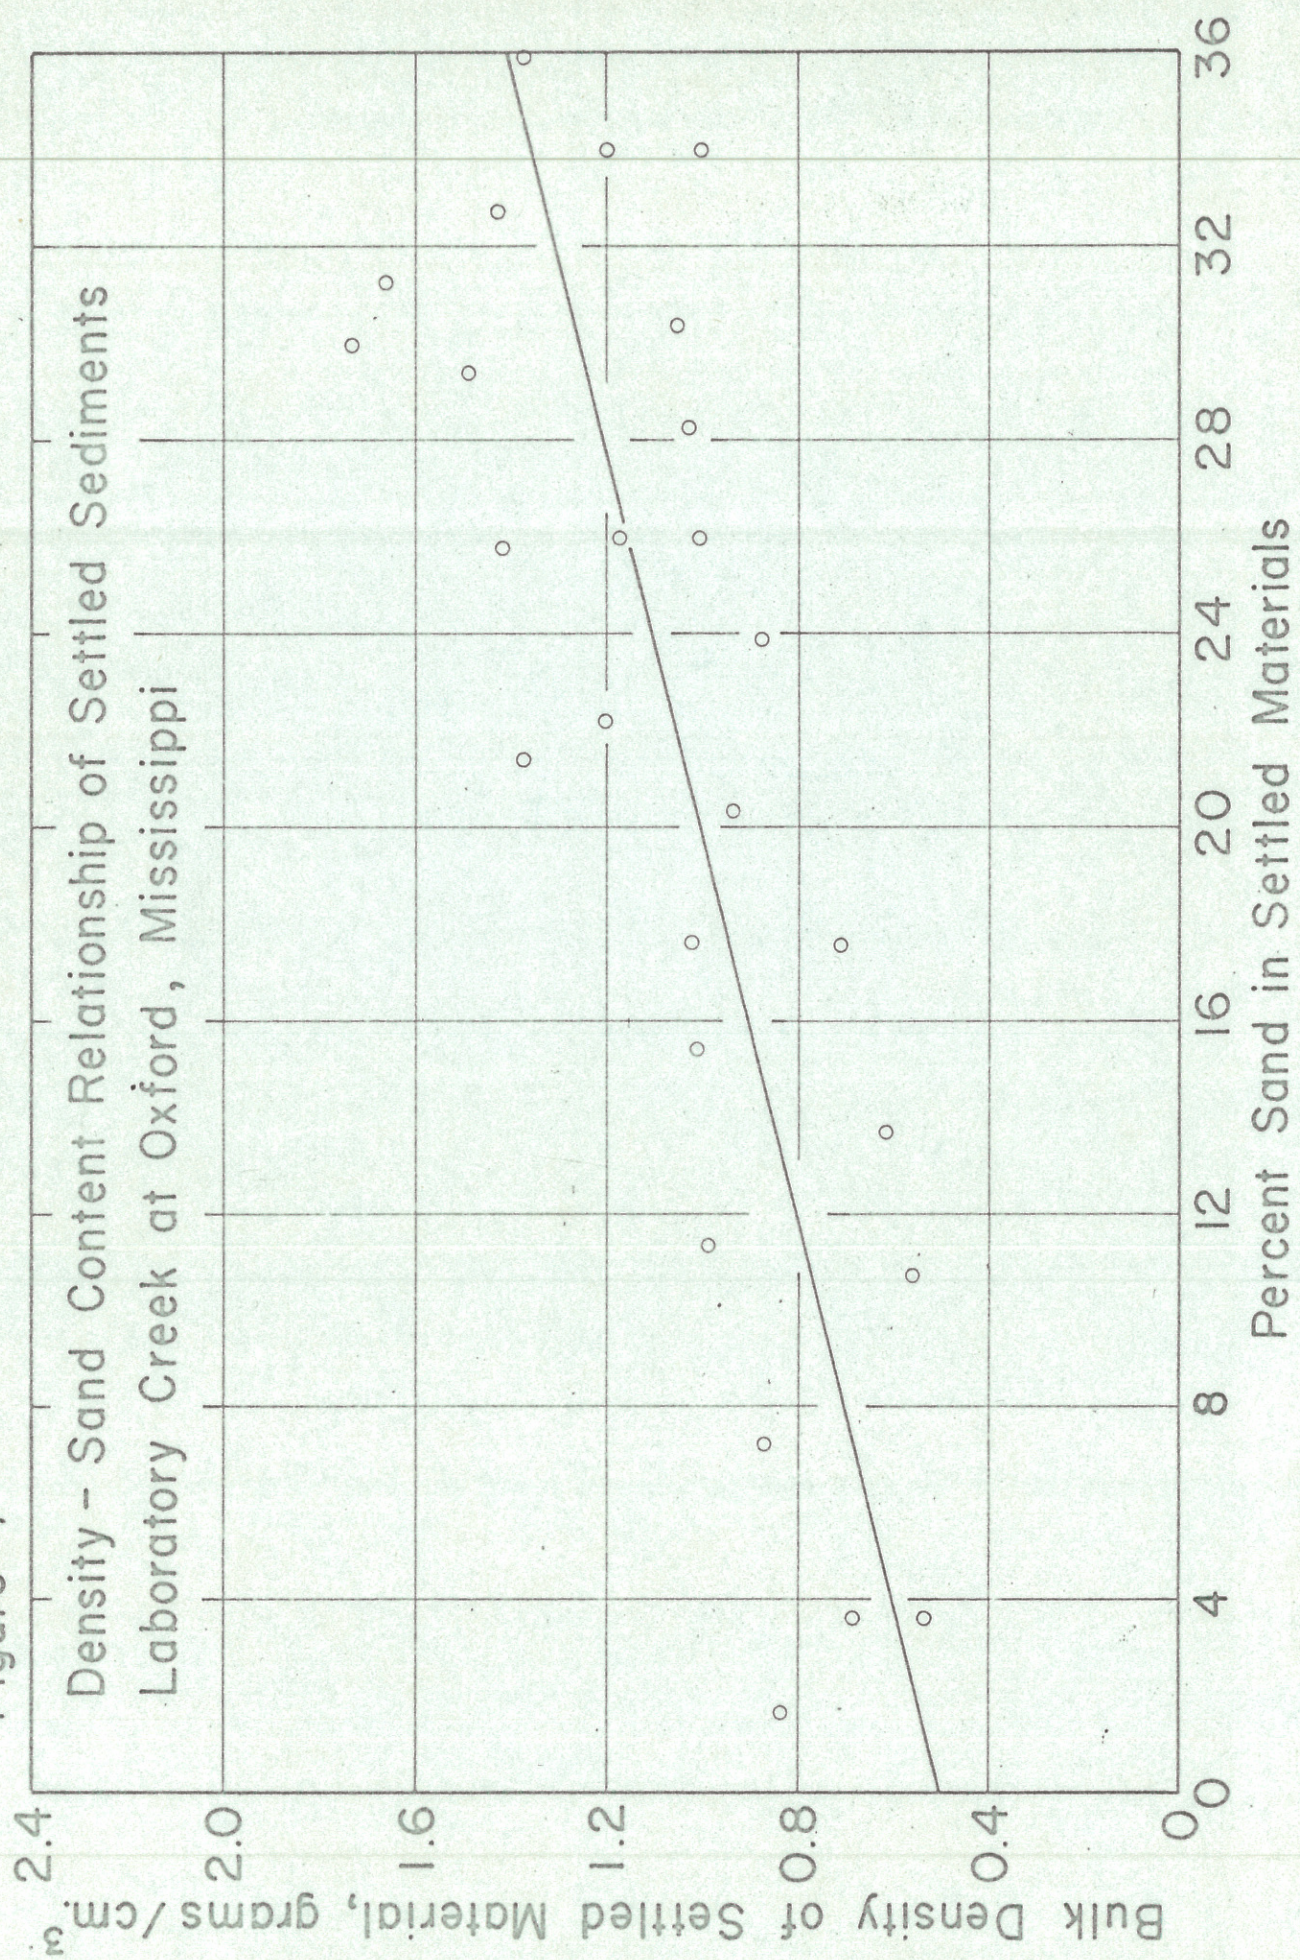
Figure 7

Density – Sand Content Relationship of Settled Sediments
Laboratory Creek at Oxford, Mississippi
