# Field Validation of An Improved Process-Based Model for Streambank Stability Analysis

## Abstract

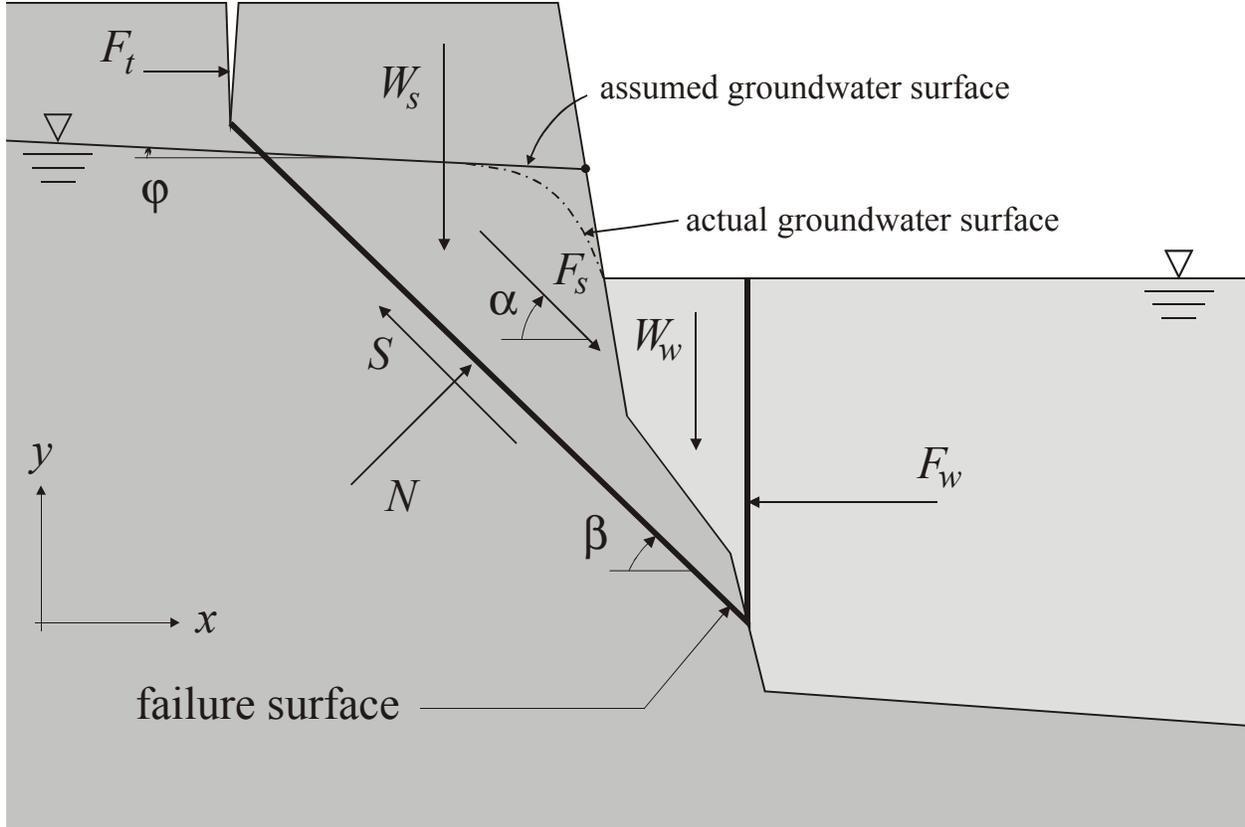
Figure 1 Definition sketch of forces acting on a streambank.

Following Huang (1983) the surface water on the failure block is modeled by assuming it is a material with no strength (cohesion and angle of internal friction are set to zero). Hence, the slip surface is extended vertically through the water, and a horizontal hydrostatic force is applied on the vertical portion of the slip surface (see Figure 1). The forces acting on the failure block are (Figure 1): (1) the weight of the failure block,  $W_S$ ; (2) the weight of surface water on the failure block,  $W_w$ ; (3) the hydrostatic force exerted by surface water on the vertical slip surface,  $F_w$ ; (4) the hydrostatic force exerted by water in the tension crack,  $F_t$ ; (5) the seepage force,  $F_s$ ; (6) the shear force at the base of the failure block,  $S$ ; and (7) the total normal force at the base of the failure block,  $N$ .

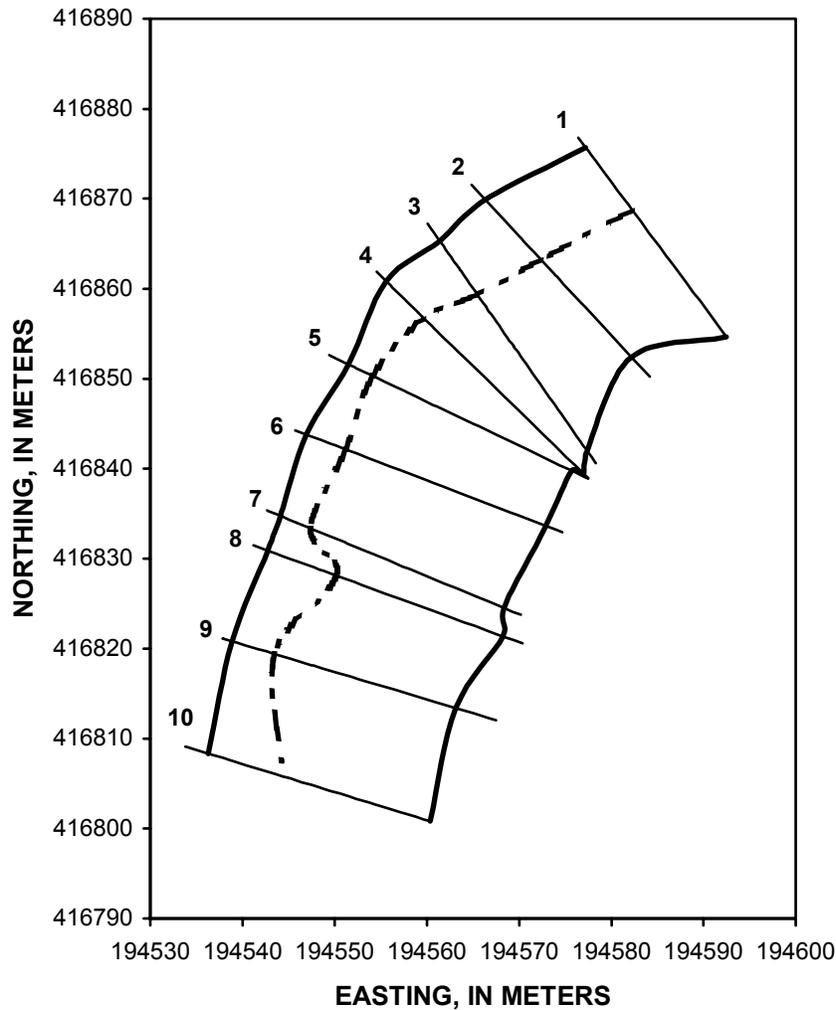
Figure 2 Plan view of the Goodwin Creek Bendway site showing the locations of the ten cross sections. Flow is from top to bottom. The dashed line is the channel thalweg.

Since February 1996 NSL conducts extensive research on streambank failure mechanics along a bendway of the Goodwin Creek, northern Mississippi (Simon and Darby 1997). The following data are being collected: cross section geometry, water surface elevations, bank material properties, bank material shear strength parameters, pore-water pressures in the bank, root mapping and tensile strength, and plant stem flow. Two flow measuring flumes (flumes #3 and #4, Alonso 1997) in upstream tributaries provide continuous discharge and fine sediment data. Figure 2 shows a plan view of the bendway with the locations of ten surveyed cross sections. The flow is from top to bottom.

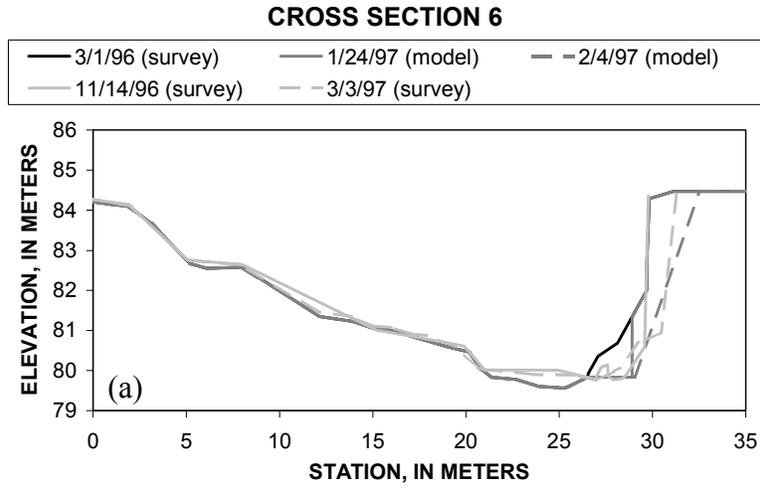
Figure 3 Streambank failure simulations: (a) surveyed and computed cross section 6, (b) surveyed and computed cross section 8, and (c) calculated factor of safety.

The right bank of cross section 6 underwent two successive failures on December 1, 1996 and midwinter 1997. The retreat of the top bank was 0.6 m and 1 m respectively. CONCEPTS simulated failure of the bank on February 4, 1997, the top bank retreating 2.7 m (Figure 3a). CONCEPTS underpredicted the rate of basal scour. Also, the observed failure plane angle is greater than that computed. Cantilever failures will generally occur along steeper slip surfaces than planar failures. The cantilever failure mechanism is not implemented in CONCEPTS.
