Large Wood for Stream Habitat Restoration in Sand-bed Channels: Harder Than It Looks!

by F. Douglas Shields, Jr. and Scott S. Knight

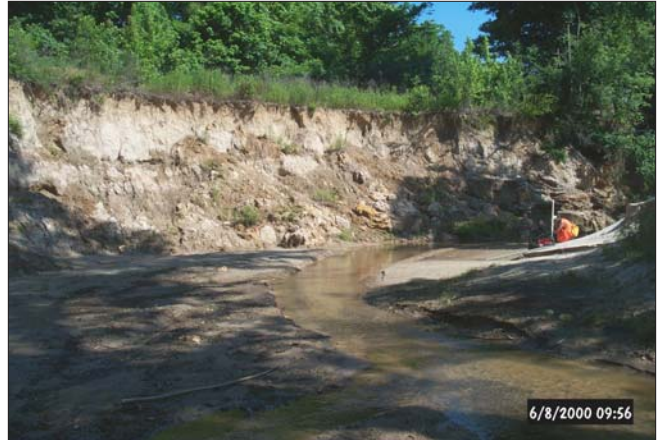
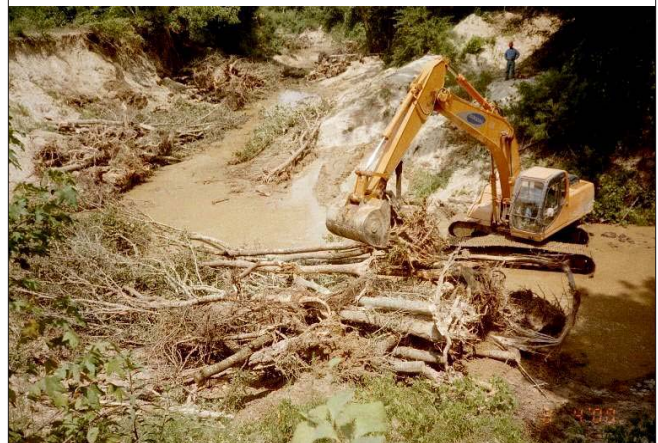
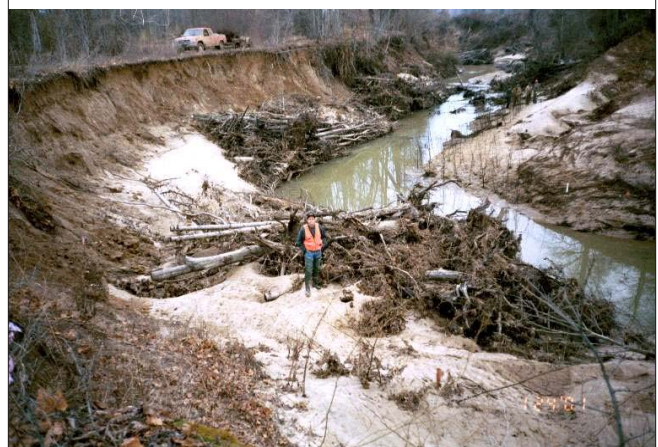
Figure 1. Typical meander bend along Little Topashaw Creek, Mississippi shown just prior to, during, and six months after placement of large wood structures.

In order to test concepts for low-cost rehabilitation of habitats associated with a severely incised, meandering sand bed stream, we constructed 72 LW structures along eroding banks of an incised, sand-bed stream (figure 1). We monitored fishes and their habitats before and after construction within the modified reach, upstream, and downstream for a total of five years. We also monitored the response of the stream channel and the status of the LW structures. Findings should be relevant to those interested in restoring similar and less severely disturbed stream systems.

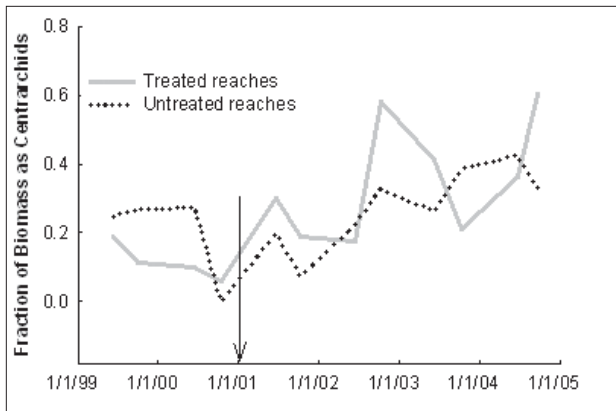
Figure 2. Relative abundance (biomass) of centrarchids in treated and untreated reaches of Little Topashaw Creek before and after LW addition. Approximate date for LW addition is shown by the vertical arrow.

Fish numbers (catch per unit of effort) and species richness increased following LW addition in both treated and untreated reaches, but differences between the two reaches were not significant (p > 0.1) (figure 2). These responses were consistent with previous observations and a conceptual model of response to
